# SERVICE BULLETIN

EL03-030d

August 8, 2008

## EXTERIOR LAMP FOGGING

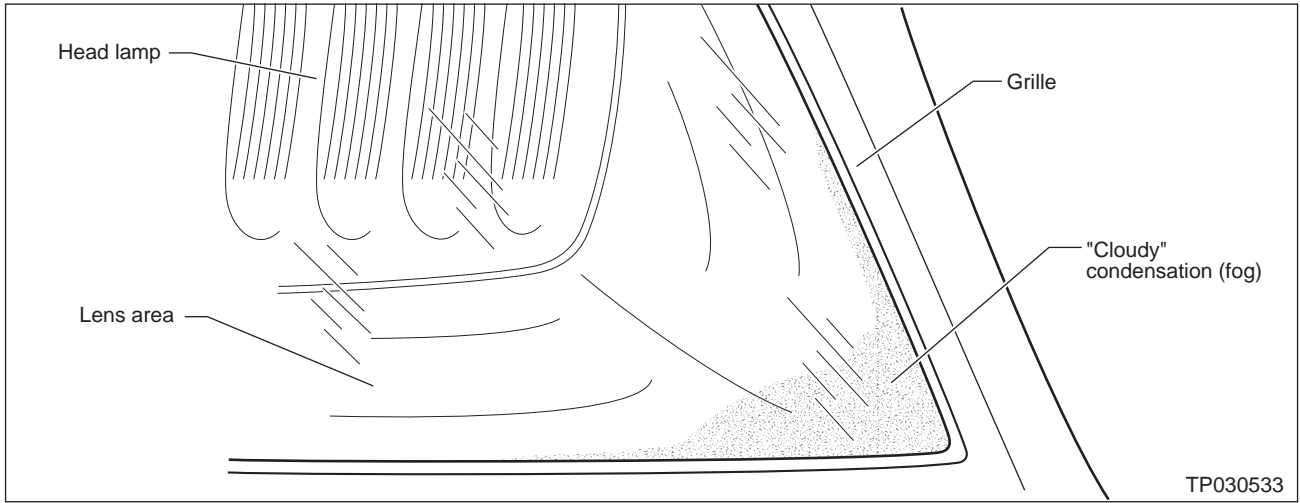
Fog may temporarily form inside the lens of the exterior lights based on environmental conditions or sudden temperature changes, such as a car wash, may cause. This is normal. See Figure 1.

Figure 1: Example of normal condensation, ok

**NOTE:** This condensation can appear anywhere on the outer lens, typically at its coldest location.

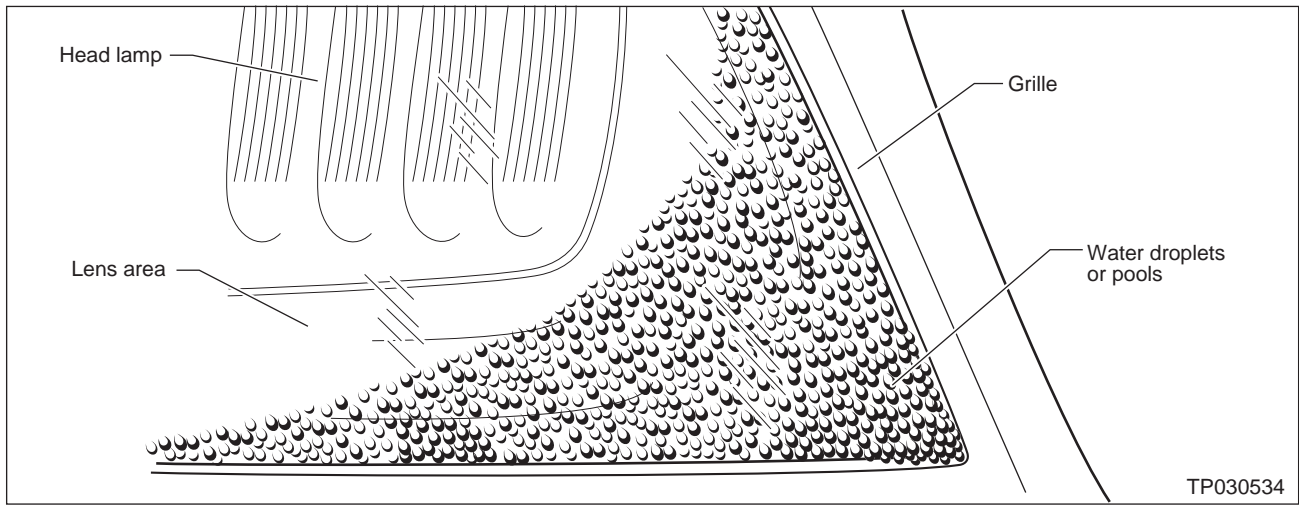
Figure 2: Condition may not be normal

If the moisture trickles, drips, or pools, it may not be considered normal and the lamp assembly may have a water leak path. See Figure 2 for an example.

If large drops of water collect inside the lens, refer to the flow chart on page 3 to find the next step.
