SHOULDER RUMBLE STRIPS:

A METHOD TO ALERT "DRIFTING" DRIVERS

Neal E. Wood, P.E.
Bridge Engineer (Retired)

January 1994

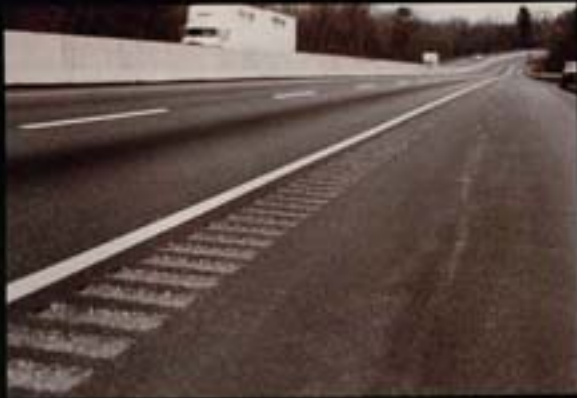
1

Sonic Nap Alert Pattern (SNAP) A Method to Alert "Drifting" Drivers

This paper presents the Pennsylvania Turnpike's development of a new safety feature, the Sonic Nap Alert Pattern, appropriately abbreviated as "SNAP." The Pennsylvania Turnpike's SNAP is a narrow, continuous rumble strip located in the right shoulder, just outside of the edge line of the pavement as shown on our Title Slide ([Slide 1](#)). The actual geometrics of the SNAP will be discussed later.

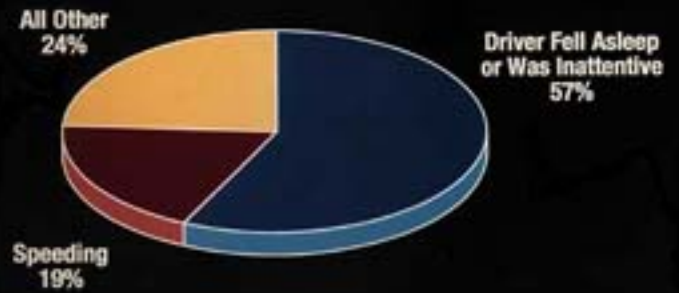
2

Drift-Off-Road (DOR) Accidents 1986

1985 accident data for the Turnpike showed an increase in DOR accidents from 48 percent in 1984 to 51 percent. After analyzing 1986 accidents, it was found that DOR accidents had jumped even higher to 57 percent as shown in the next slide ([Slide 2](#)). The Chief Engineer for the Turnpike Commission agreed it was time to proceed more seriously with testing of SNAP.

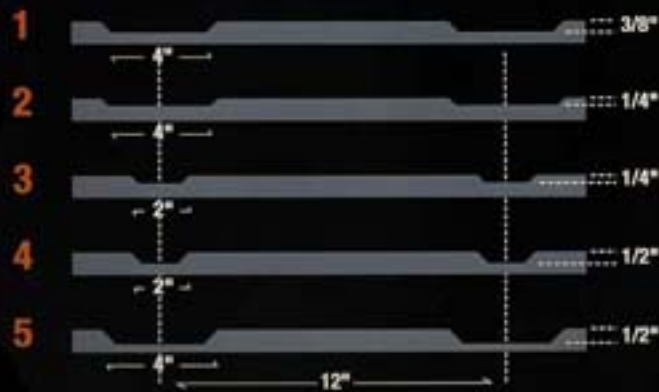
3

SNAP Test Patterns

Since there were questions about the effectiveness of the proposed 4 inches wide by 1/2-inch deep pattern, it was decided to test various widths and depths as described in the next slide ([Slide 3](#)). These included a mix of 2 and 4-inch widths and depths of 1/4 and 1/2 inch. Actual testing was conducted on a 13-mile portion of abandoned Turnpike just east of Breezewood, Pennsylvania. Incidentally, the Commission agreed to redesignate this abandoned roadway as a Safety Testing And Research facility, or "STAR" facility, which is included in the Transportation Research Board Circular ([3](#)) on facilities available for highway research. STAR is listed as available for outside use for a variety of research purposes. It is routinely available for Turnpike researchers to try ideas and test products away from traffic.

On June 21 and 22, 1988, the five different SNAP test patterns as shown were pressed into a once-rolled, hot asphalt (ID-2) wearing course at the STAR facility. On July 15, 1988, tests were run using a variety of vehicles, including a Turnpike dump truck and a motorcycle. Vehicles were driven at various speeds over the test patterns with results as shown in [Slide 4](#) for sedans and [Slide 5](#) for the dump truck. The numbers shown for each run and pattern are sound level readings recorded by a decibel meter within the test vehicles. The decibel meter readings favored Pattern 5, which was also the unanimous choice of the various drivers conducting the tests. Effectiveness for trucks was required since they are such an important part of the Turnpike traffic mix.

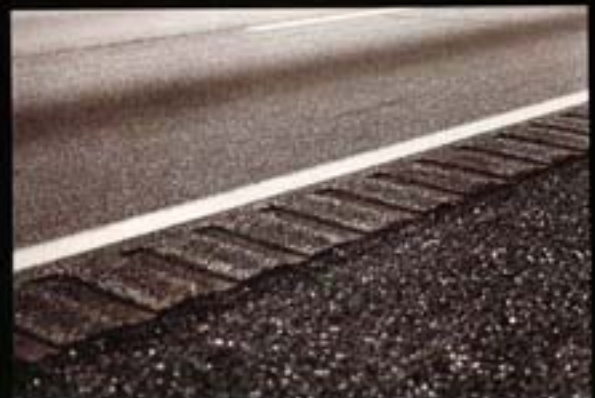
6

Sonic Nap Alert Pattern (SNAP)
