SECTION AV

AUDIO, VISUAL, NAVIGATION & TELEPHONE SYSTEM

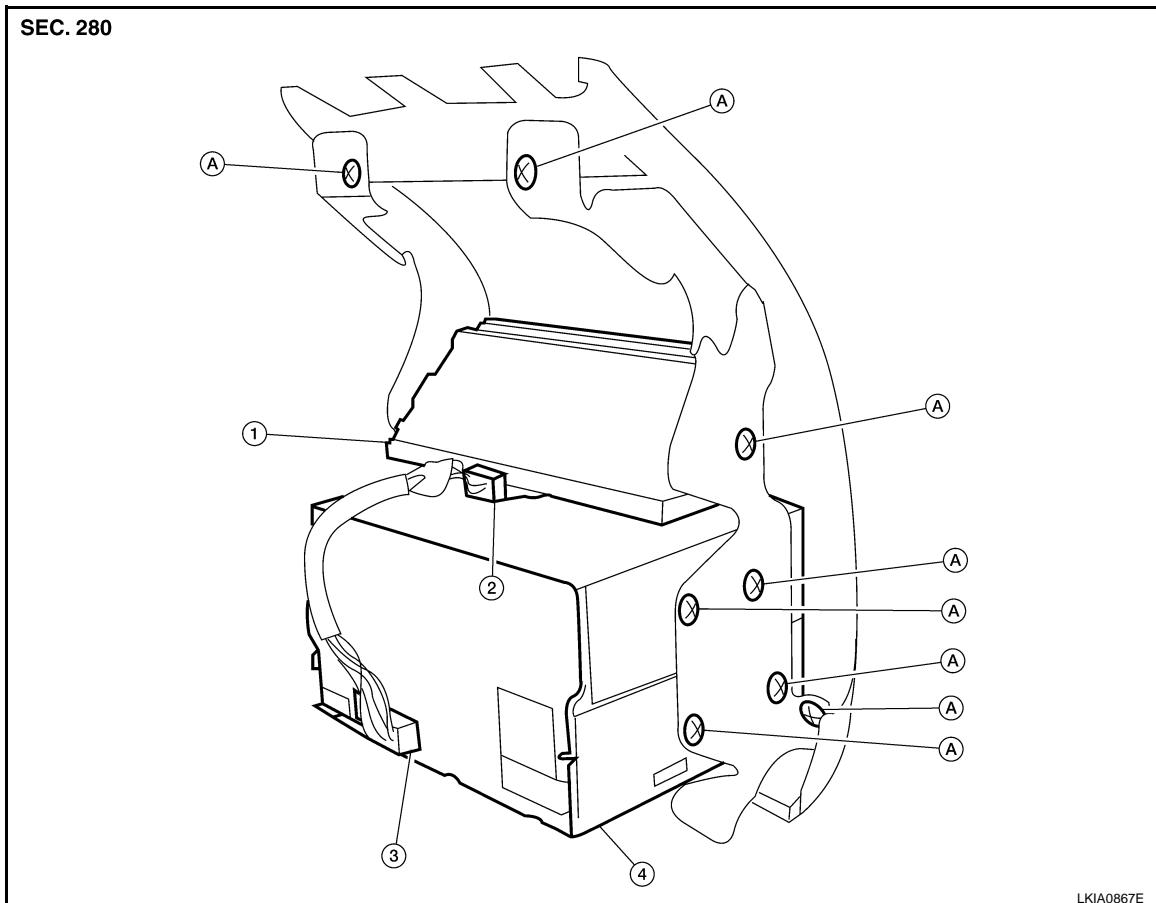
AUDIO UNIT

| 1. Display unit | 2. Display unit connector | 3. Audio unit connector |

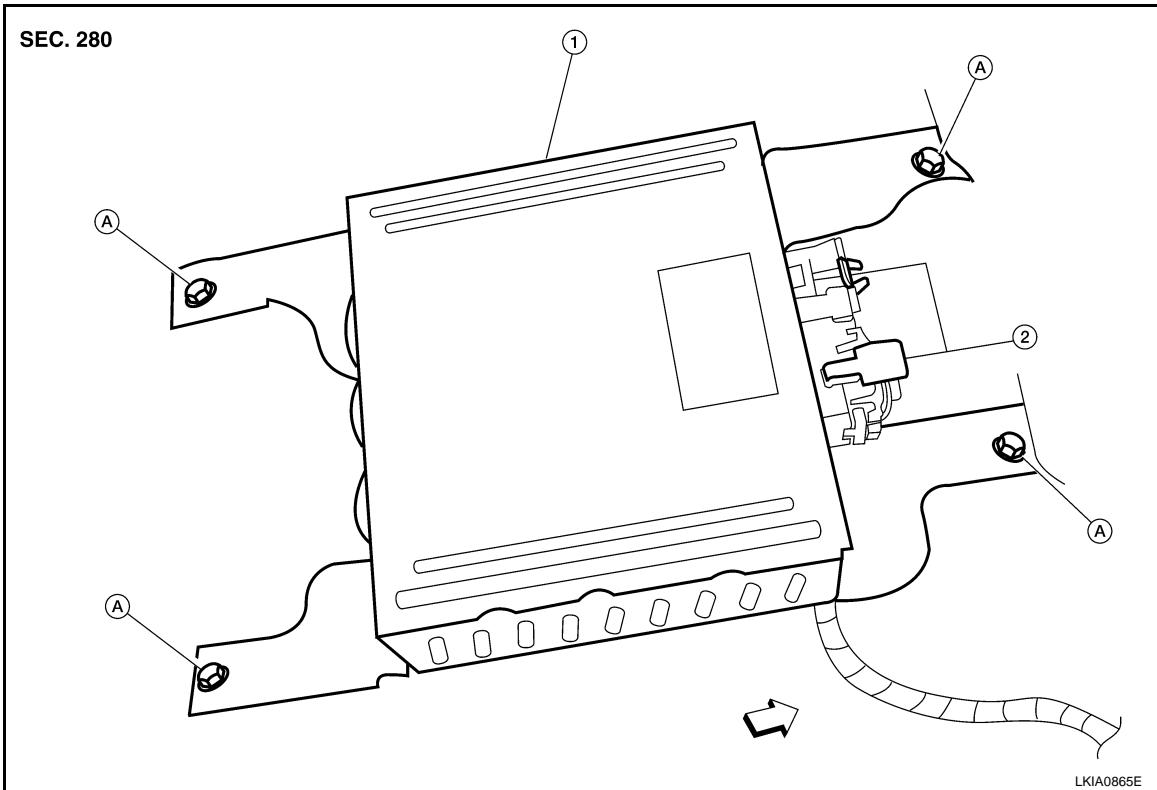
1. Audio amplifier

2. Audio amplifier connectors

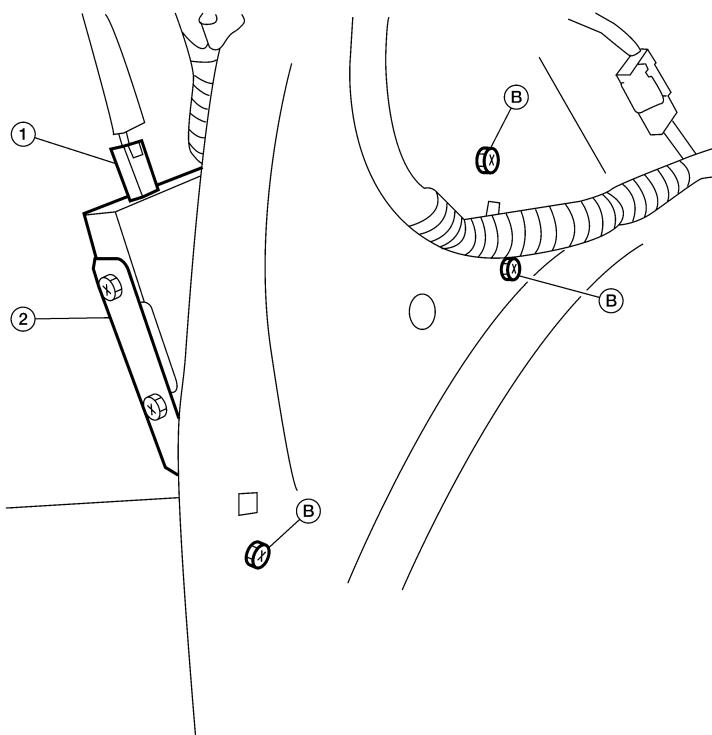
SEC. 280

1. Satellite radio tuner connector 2. Satellite radio tuner B. Bolts
⇒ Front

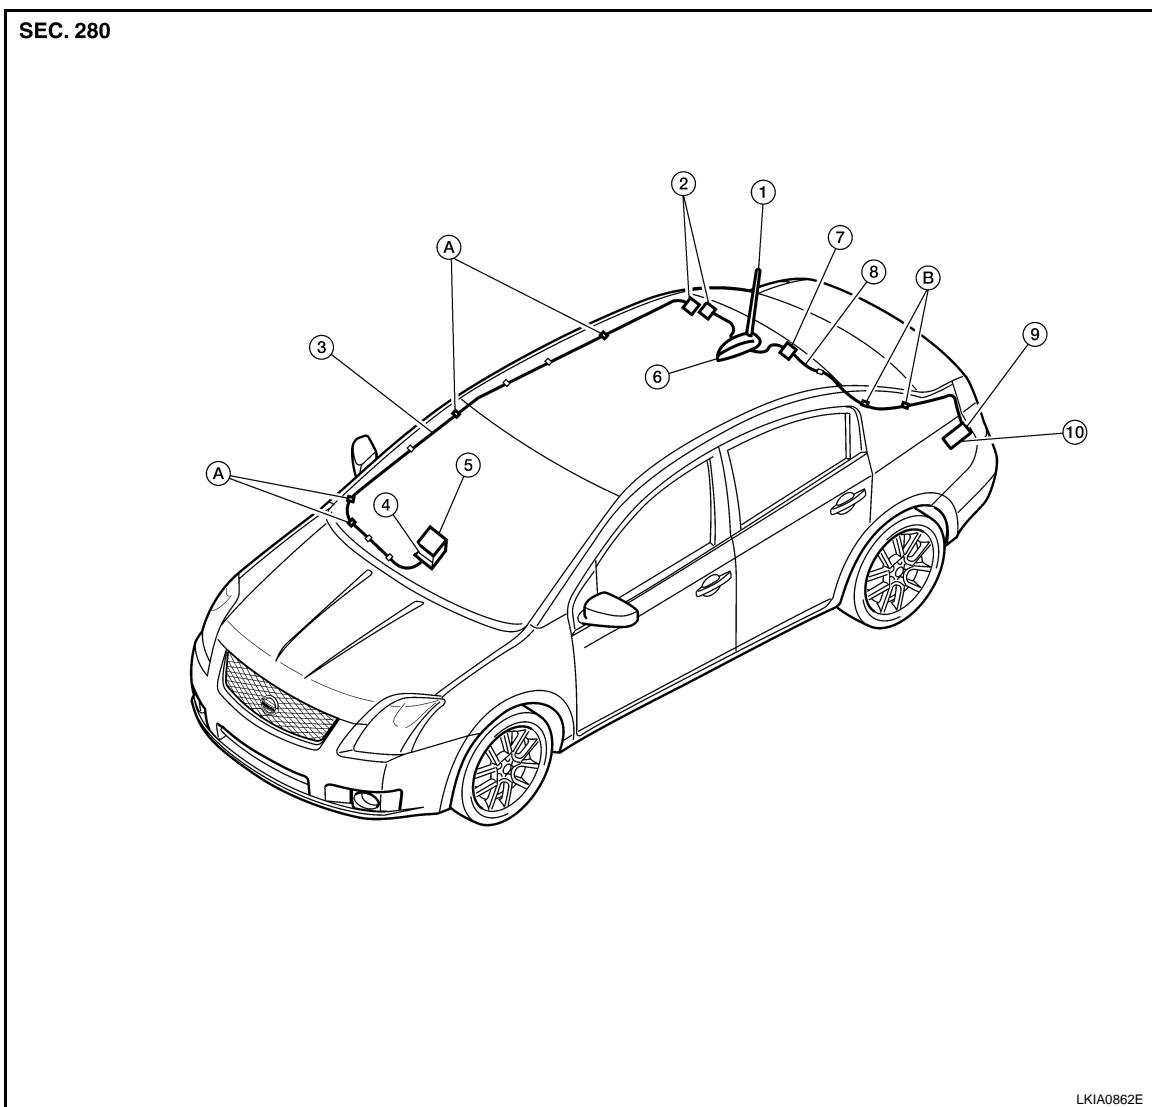
| 1. Roof antenna | 2. Roof antenna base connectors | 3. Antenna feeder |

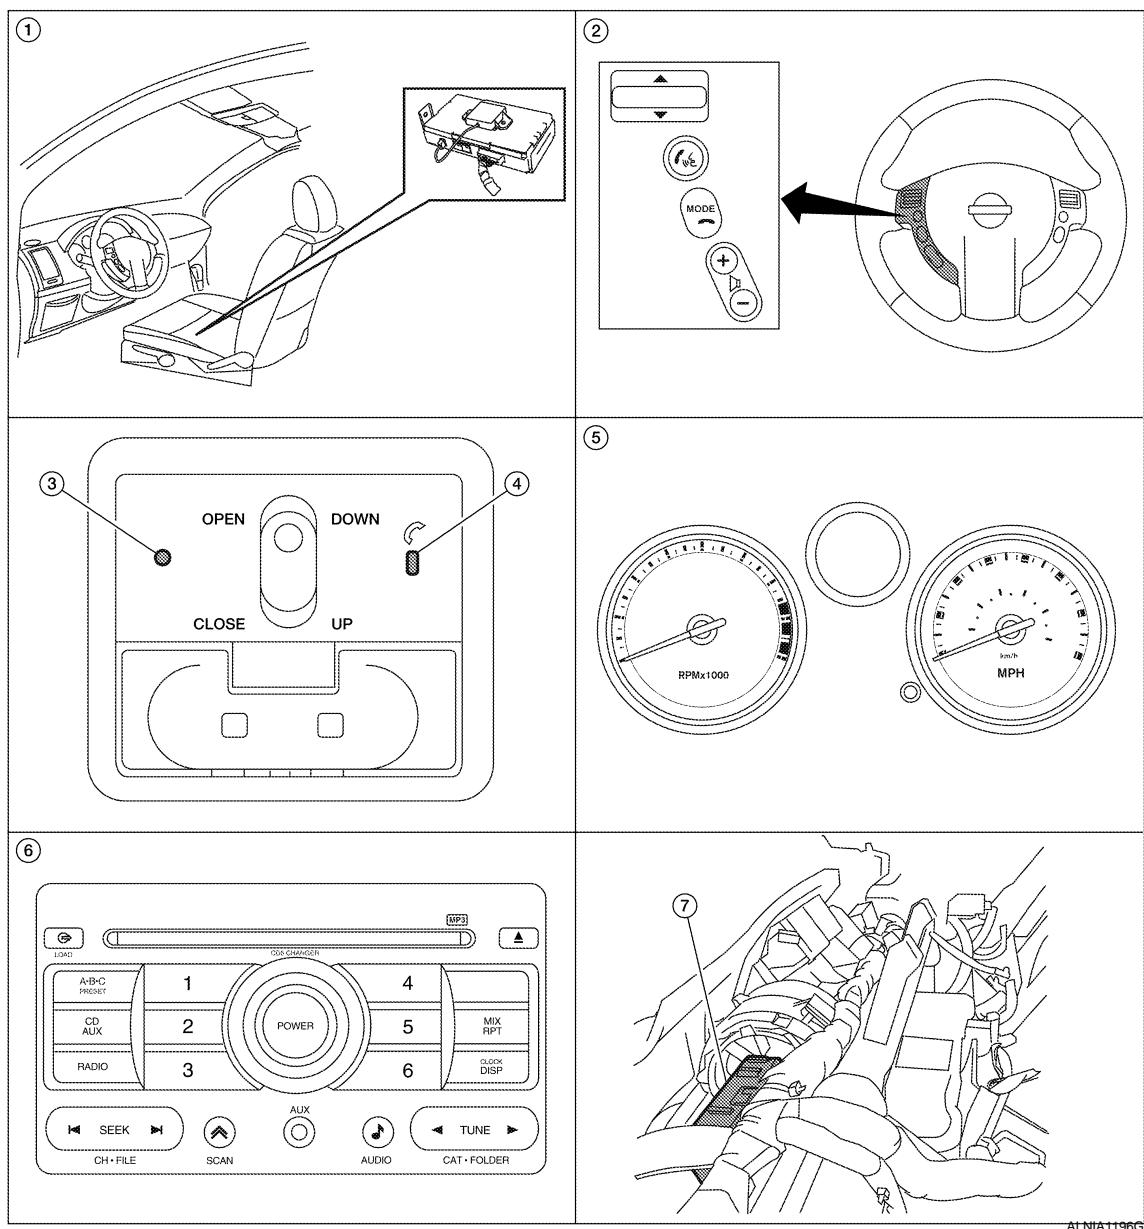
1. Bluetooth control unit B15, B62
2. Steering wheel audio control switches
3. Microphone R4
4. Bluetooth ON indicator R2
5. Combination meter M24
6. Audio unit M43, M53
7. BCM M18, M20 (view with instrument panel removed)

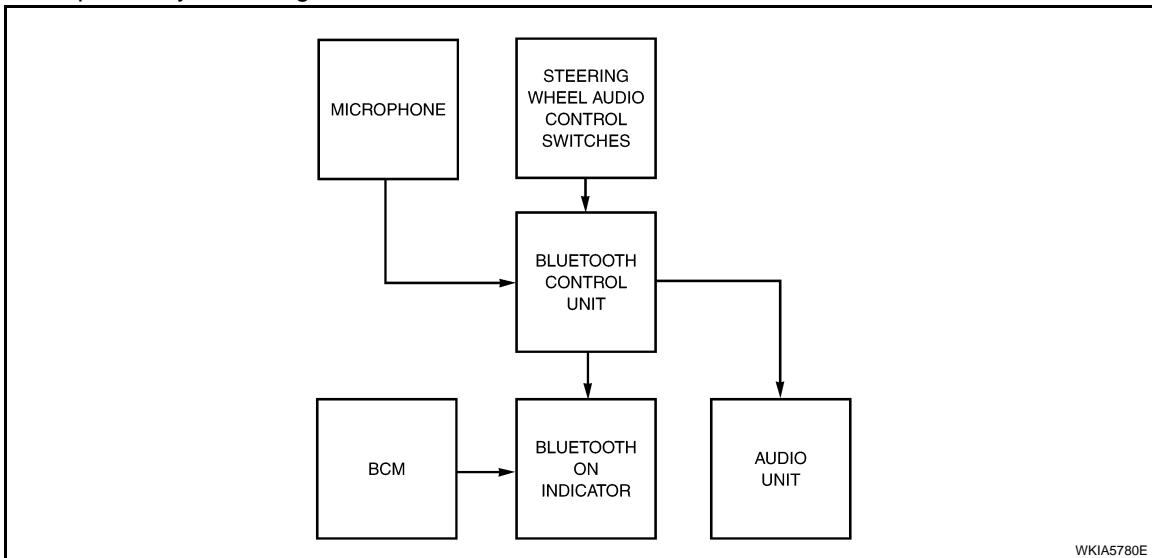
Bluetooth Telephone System Diagram

Bluetooth telephone system allows users who have a Bluetooth cellular telephone to make a wireless connection between their cellular telephone and the Bluetooth control unit. Hands-free cellular telephone calls can be sent and received. Personal memos can be created using the Nissan Voice Recognition system. Some Bluetooth cellular telephones may not be recognized by the Bluetooth control unit. When a cellular telephone or the Bluetooth control unit is replaced, the telephone must be paired with the Bluetooth control unit. Different cellular telephones may have different pairing procedures. Refer to the cellular telephone operating manual.

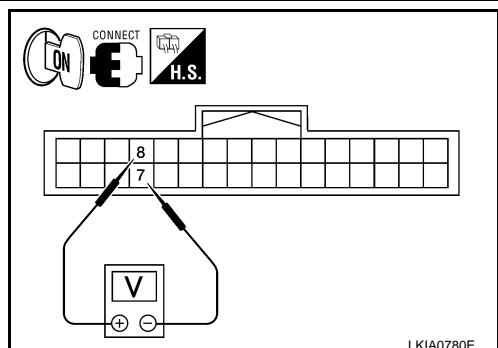
3.CHECK MICROPHONE SIGNAL

Check signal between Bluetooth control unit harness connector B15 terminals 7 and 8.

7 – 8:

OK >> Replace Bluetooth control unit. Refer to [AV-71, "Removal and Installation".](#).

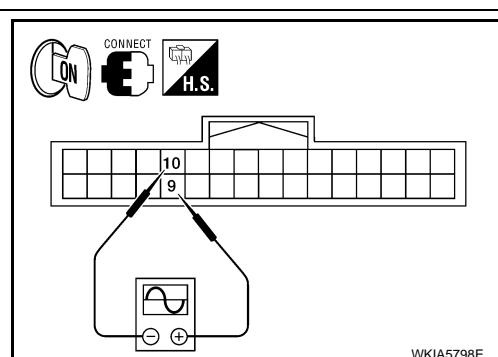
4.CHECK BLUETOOTH VOICE SIGNAL

Check signal between Bluetooth control unit harness connector B15 terminals 9 and 10.

When giving a voice

OK >> Replace audio unit. Refer to [AV-51, "Removal and Installation".](#)

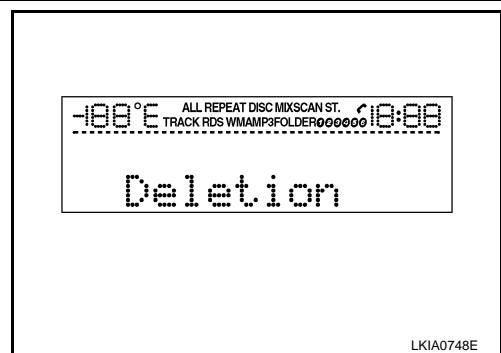
3. To delete diagnostic items press "TUNE" to display all diagnostic items then press "TUNE" up/down to select the desired diagnostic item, "Deletion #" will be displayed.

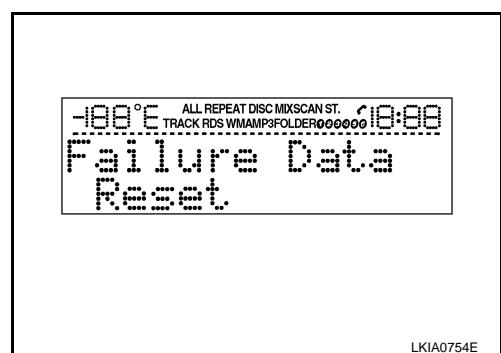
4. Press and hold the "SCAN" switch for more than 6 seconds to delete the desired diagnostic item. "Failure Data Reset" will be displayed, followed by a return to the "CAN check diagnostics" screen.
