Lucent Technologies
Bell Labs Innovations

DEFINITY[®]
Enterprise Communications Server
Release 6
Maintenance for R6vs/si
Volumes 1 & 2

555-230-127
Comcode 108215591
Issue 3
May 1998

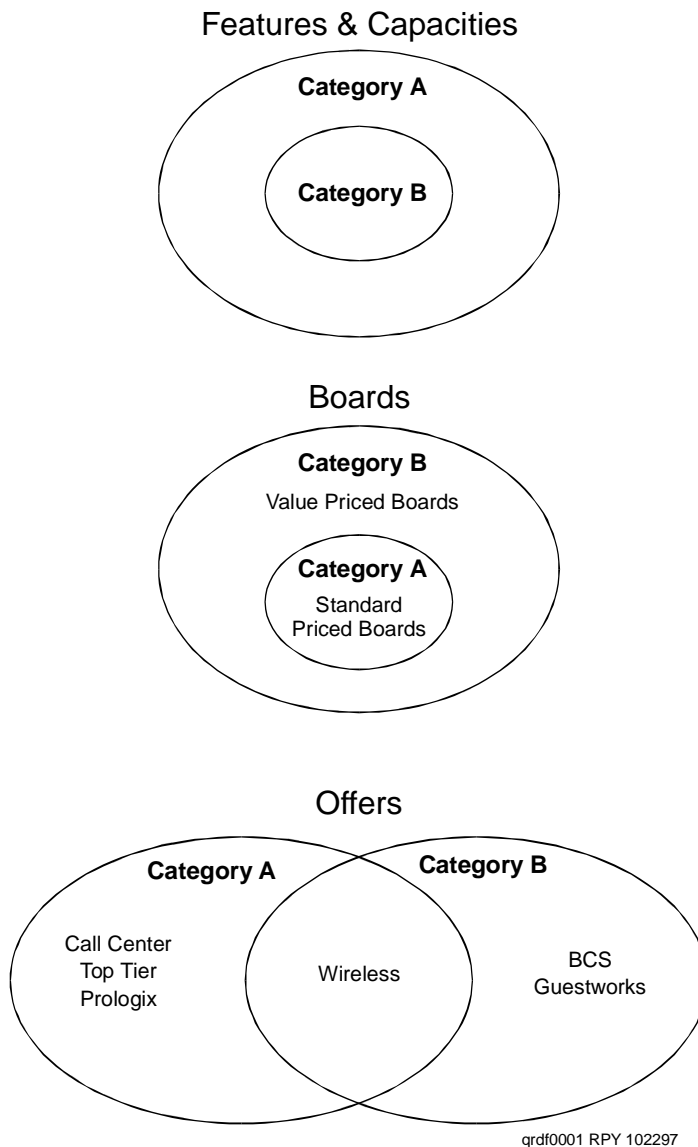
Figure 1-1. Offer categories and related hardware, features, and capacities

Features are classified into two offer categories as depicted in [Figure 1-1](#):

- **Category A** refers to top-tier offers and encompasses all current DEFINITY (including ProLogix Communications Solutions) systems.
 - All customer options allowed
 - All features allowed
 - Standard capacities

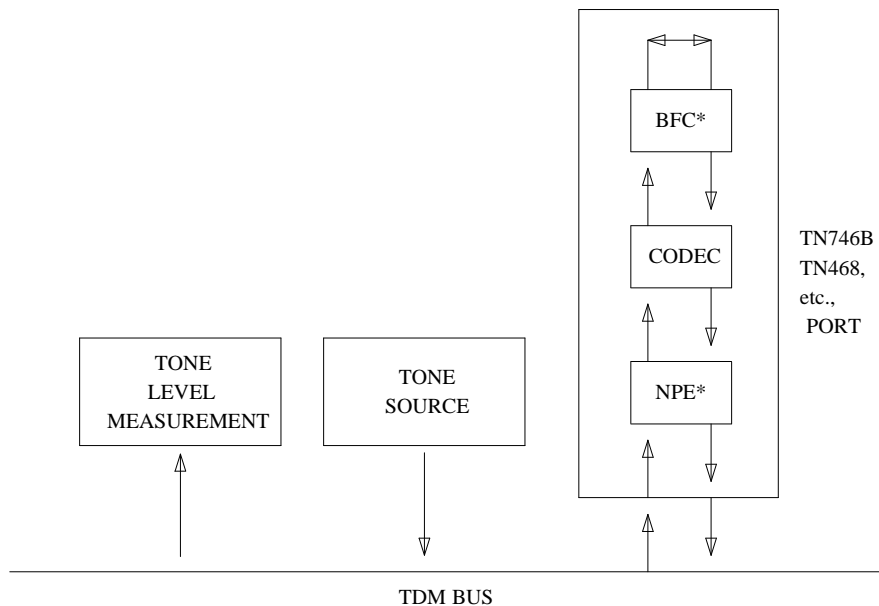
Figure 10-2. Analog Loop Around Test

This test is designed to check the on-board transmission capabilities of the NPE, the codec, and the battery feed chip of the analog port. A Tone Detector and a Tone Generator talk and listen on the same pair of time slots as the Analog Port. The Analog Port is then instructed to go into loop around mode (see the following below). The test passes if the signal measured by the Tone Detector is within acceptable limits.

* BFC - BATTERY FEED CHIP
NPE - NETWORK PROCESSING ELEMENT

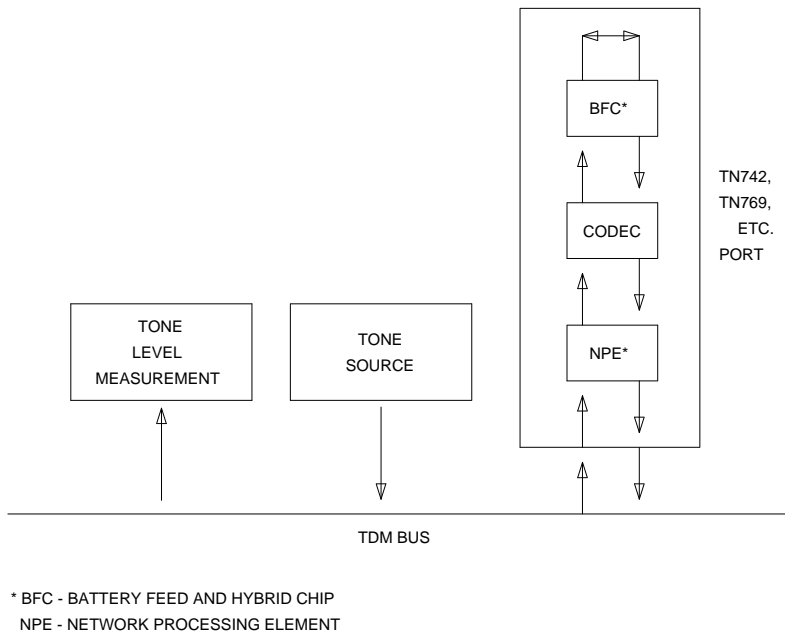
Figure 10-3. Analog Loop Around and Conference Test

This Loop Around Test is sensitive to the length of the loop, the equipment in the loop, or the equipment terminating the loop, such as off-premises stations. If this test is causing a false alarm, then disable the test by changing the `Tests` field to `n` using the **change station** command for this station.

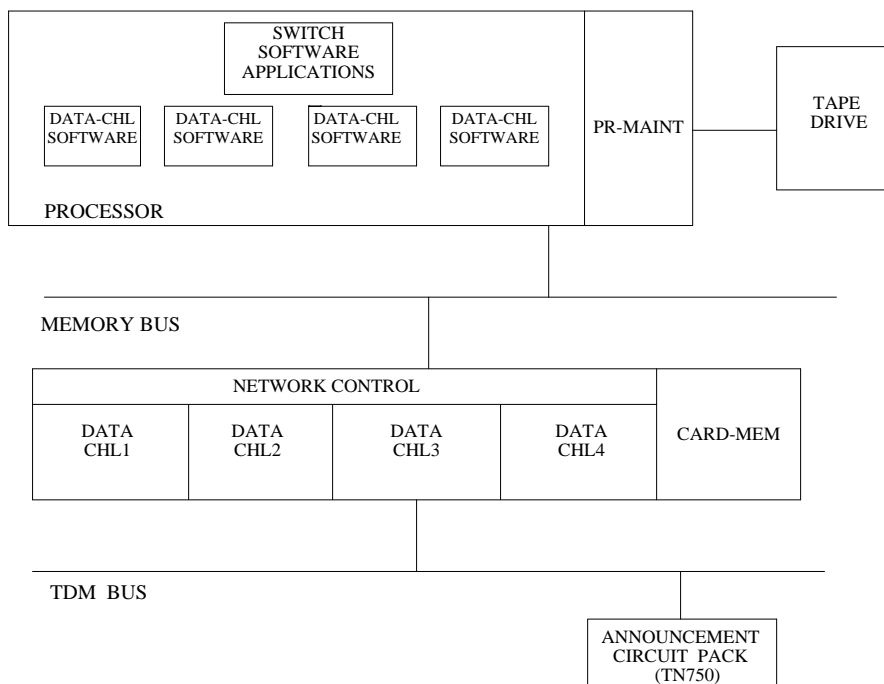
Figure 10-4 shows the connection of the Announcement Circuit Pack to the system. To save or restore announcements, an ANNOUNCEMENT Data Extension must be administered, and at least one DATA-CHL (Network Control Data Channel) must be in the in-service/idle state.

Figure 10-4. Connection of Announcement Circuit Pack to the System

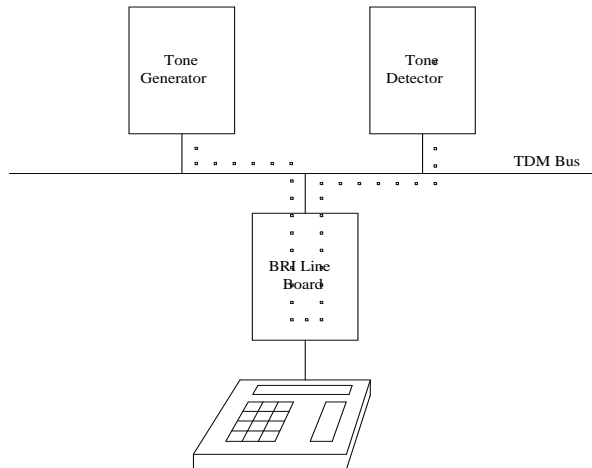
The dotted lines in Figure 10-8 show how a Loop Around Test is performed for the B-channels. The figure shows a terminal connected to a BRI line board using a TN556. If a TN2198 is used, the terminal would be connected to a NT1, and the NT1 to the BRI board.

Figure 10-8. Path of the BRI Port Local TDM Loop Around

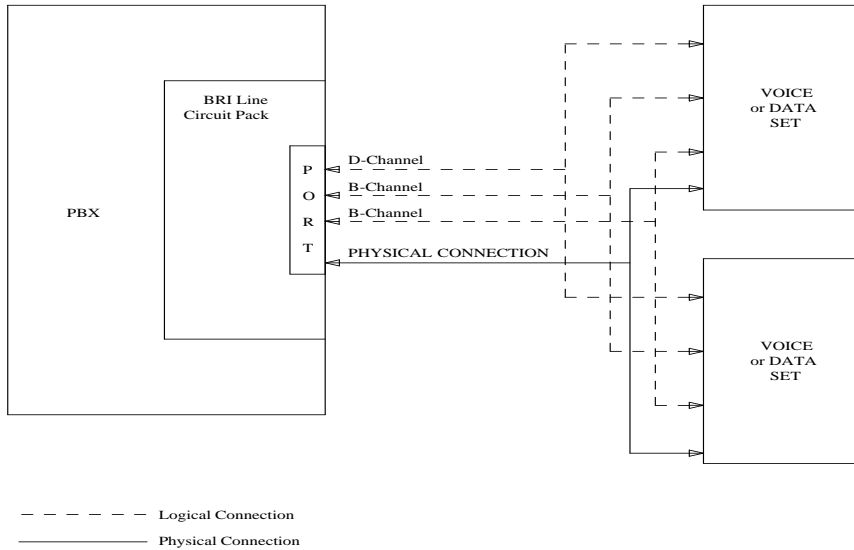
Figure 10-9 illustrates the physical connection (solid line) between an ISDN-BRI Circuit Pack and a voice or voice/data set. Each physical connection allows for two B-channels, as stated above, plus one D-channel. Each ISDN-BRI circuit pack can support up to 12 of these PHYSICAL connections to different voice and voice/data sets or ASAI and Lucent adjuncts.

Figure 10-9. ISDN-BRI Set Interactions

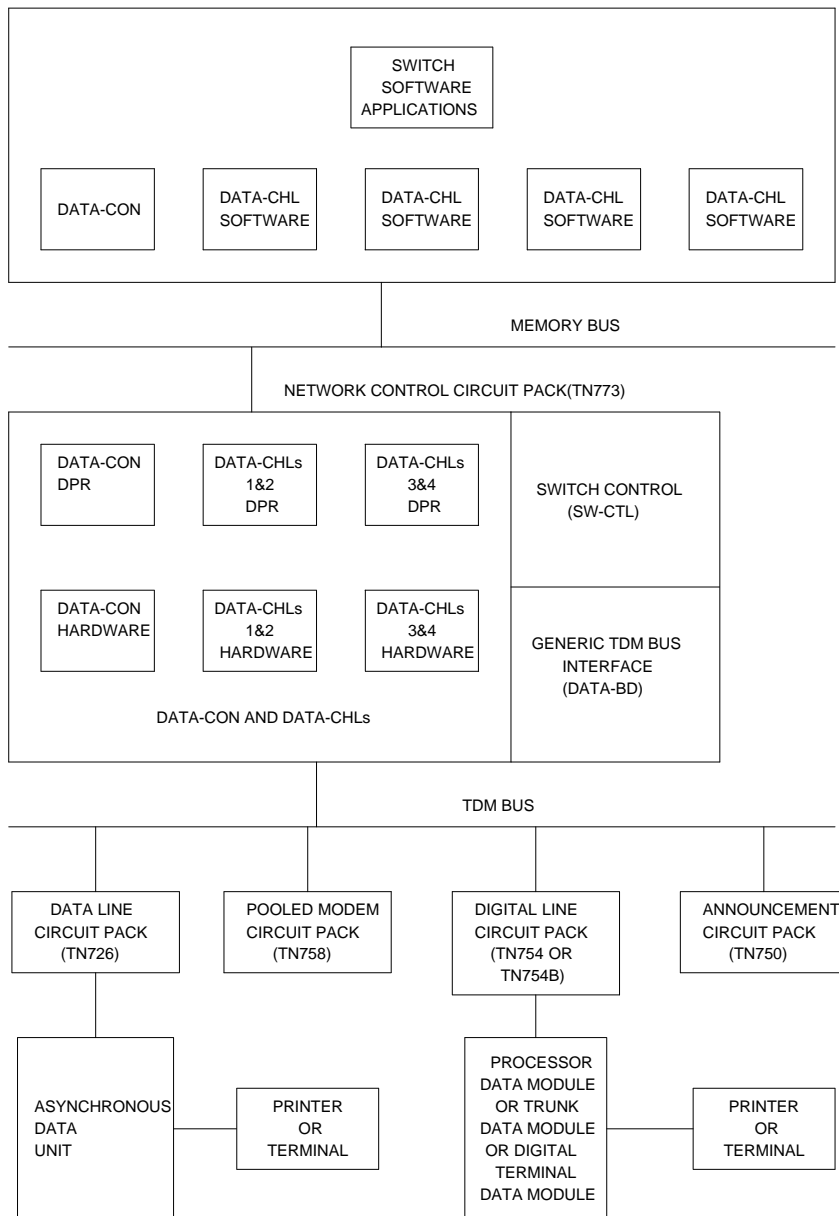
Figure 10-24. DATA-CON (Network Control Driver)

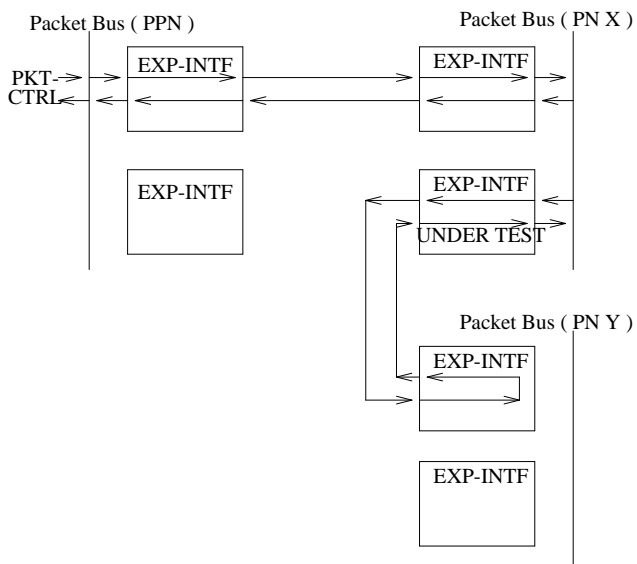
If the Expansion Interface circuit pack to be tested is part of a link from EPN to EPN, the path shown in Figure 10-33 is used.

Figure 10-33. Expansion Interface Packet Interface Test—EPN to EPN

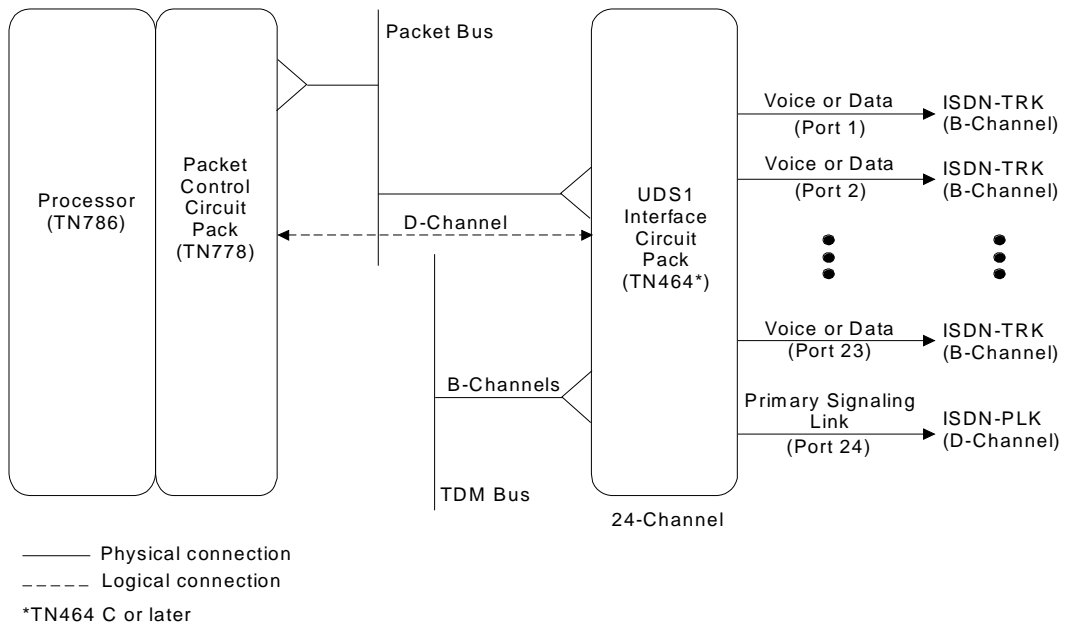
Figure 10-38. FAS ISDN-PRI Over PACCON Signaling Group (24 Channel)

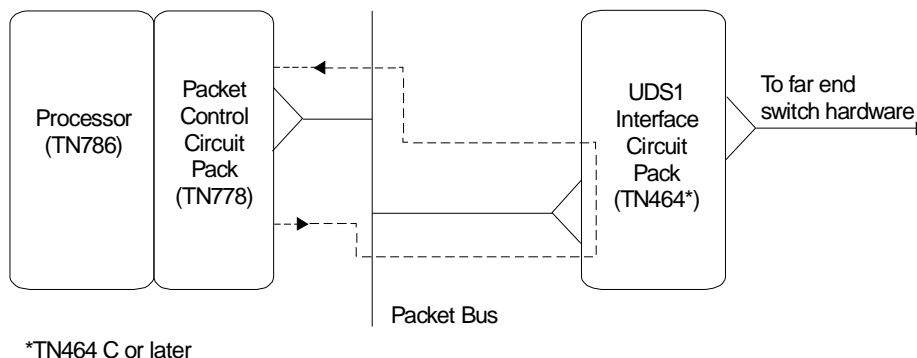
This test verifies the connectivity of an ISDN-PRI Signaling Port (D-channel) across the Packet Bus, also known as the LAN bus. It will execute only if the port is busied out. Failure of this test indicates a fault associated with the port hardware on the circuit pack.

Figure 10-39. Signaling Port Packet Bus (LAN) Loopback

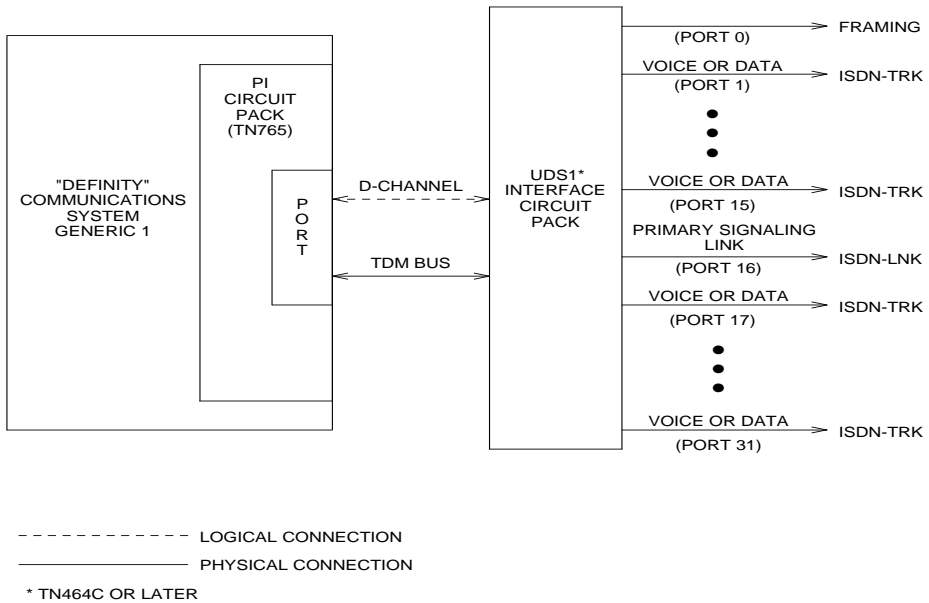
Figure 10-41. FAS ISDN-PRI Signaling Group (32 Channel) over Processor Interface

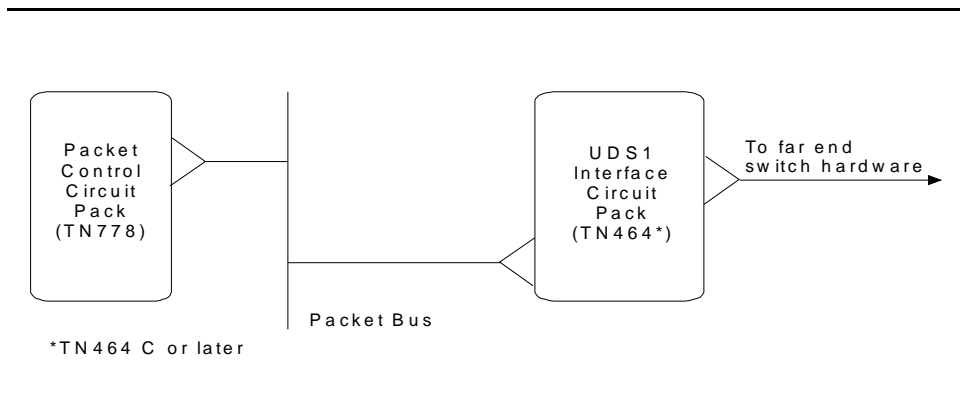
Figure 10-53. PRI over PACCON Primary Signaling Link Hardware Check (Test #636)

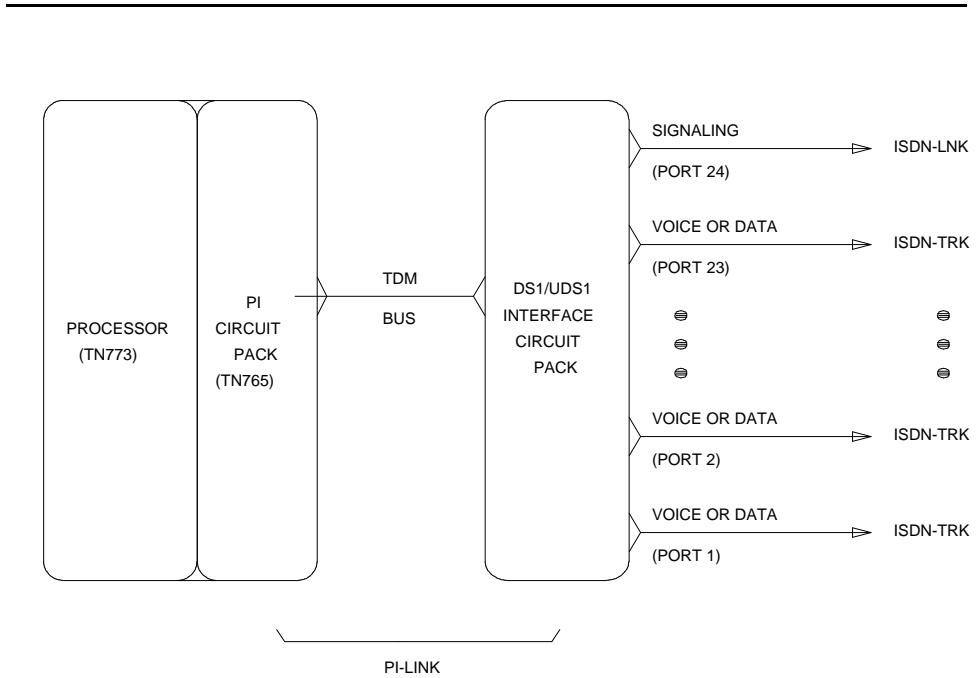
As a port on a DS1 circuit pack (DS1-BD or UDS1-BD), and as part of a signaling group dependent on a D-channel (ISDN-LNK/ISDN-PLK) for signaling, operation of the ISDN-TRK is dependent on the health of these other maintenance objects. The ISDN D-channel in turn depends on the Packet Bus (PKT-BUS)/Processor Interface Link (PI-LINK) (dependent on setup) for transmission through the system. Keep this hierarchy of dependencies in mind when diagnosing problems.

Figure 10-58. DS1 ISDN Trunk Interactions (24-channel interface)

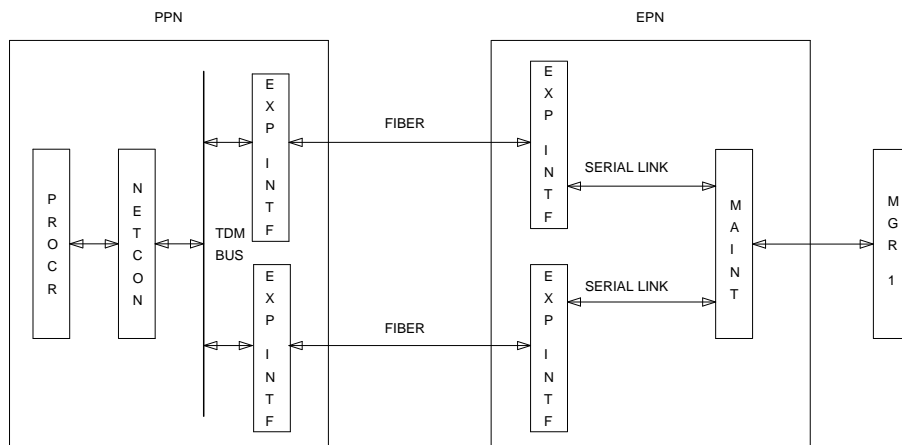
In [Figure 10-62](#), PROCR means a TN790 for a RISC Processor circuit pack, NETCON is the Network Control circuit pack (TN777B) (the Active NETCON circuit pack in a high or critical reliability system), and MB stands for the EPN Maintenance circuit pack. [Figure 10-62](#) shows the connectivity for a system with duplicated Expansion Interface Links.

Figure 10-62. EPN Maintenance Circuit Pack Message Flow

The PPN communicates with the EPN Maintenance circuit pack using the following path (messages from the EPN Maintenance circuit pack to the PPN take exactly the reverse path). From the PPN, TN773 Processor circuit pack, EPN Maintenance circuit pack messages are passed to the Switch Control on the Network Control circuit pack over the Memory Bus (MBUS) and then over the TDM Bus to the Active PPN Expansion Interface circuit pack. The Active PPN Expansion Interface circuit pack passes the message across the fiber to the Active EPN Expansion Interface circuit pack. The Active EPN Expansion Interface circuit pack then passes the message over a serial link to the EPN Maintenance circuit pack. [Figure 10-62](#) illustrates this path.

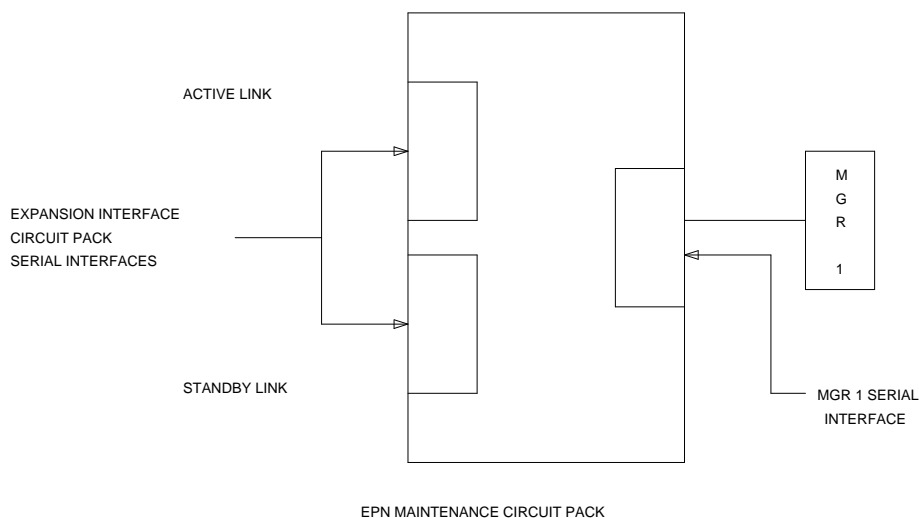
This test checks the on-board circuitry of the EPN Maintenance circuit pack associated with the serial links to the Expansion Interface circuit pack. [Figure 10-64](#) shows the three serial interfaces on the EPN Maintenance circuit pack and is meant to clarify that the two dealing with the Expansion Links are being tested. A request is sent to the EPN Maintenance circuit pack over the Active link via the Active Expansion Interface circuit pack serial interface circuitry to test the serial interface circuitry of the standby Expansion Interface circuit pack link. If a response is received, then by definition the serial interface circuitry associated with the Active link is good.

Figure 10-64. EPN Expansion Links Connections

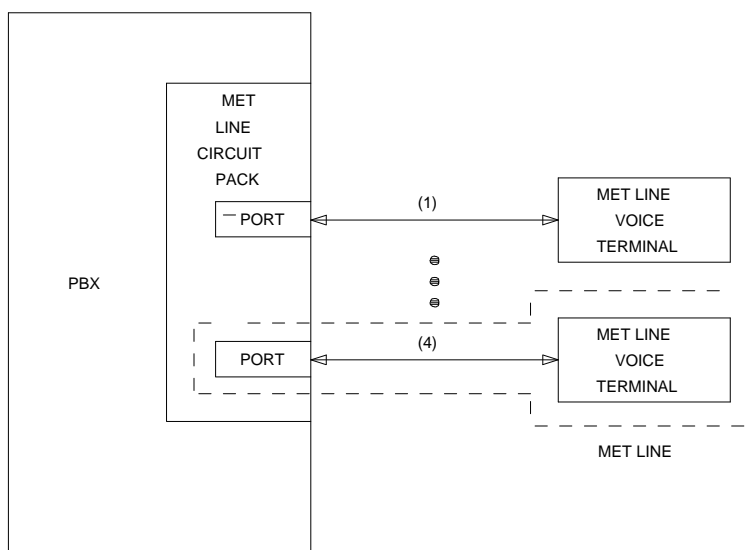
MET Line interactions are shown in [Figure 10-65](#).

Figure 10-65. MET Line Interactions

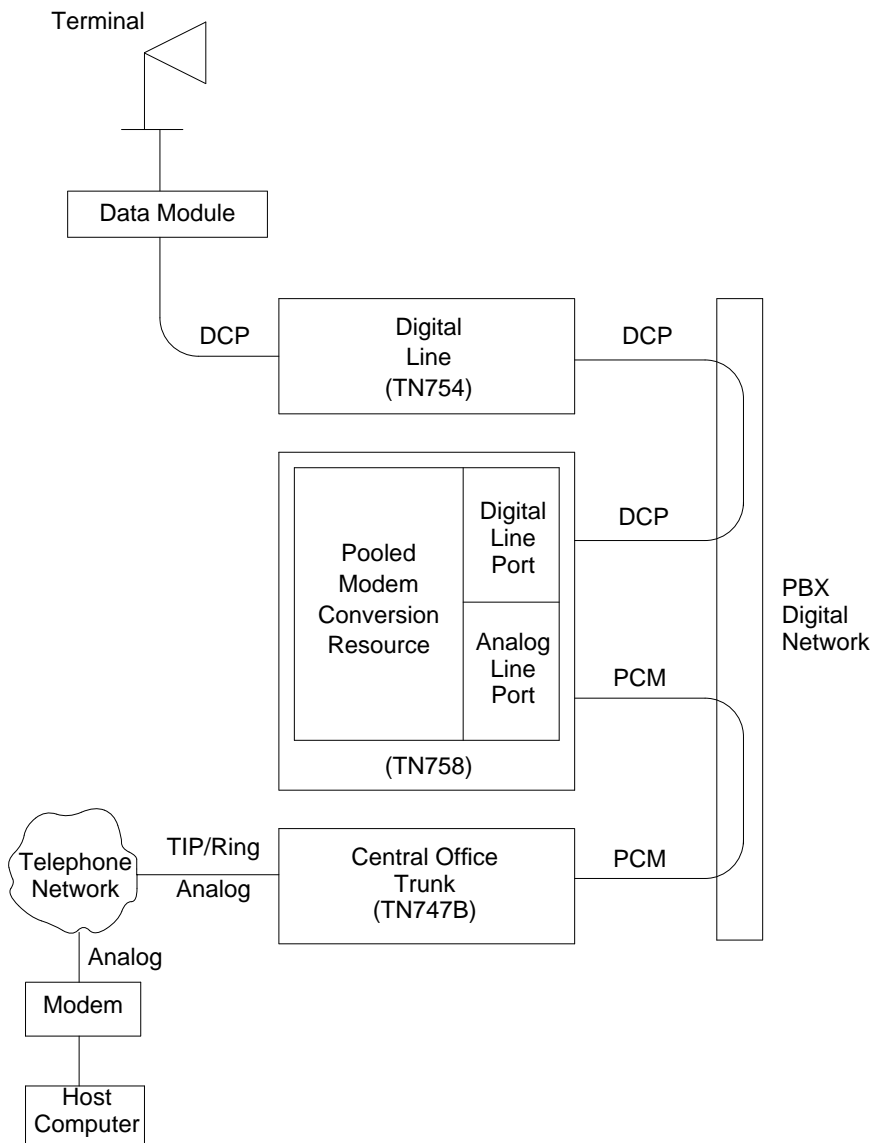
connected through the PBX network to the analog line or trunk port containing the analog modem signals. The digital port connects through the PBX network to the digital line or trunk port in the call. [Figure 10-66](#) shows a typical end-to-end connection using a conversion resource on the integrated Pooled Modem circuit pack.

Figure 10-66. Typical Modem Pool Switched Connection with Integrated Pooled Modem

Refer to [Figure 10-66 on page 10-831](#) while reading the following paragraph.

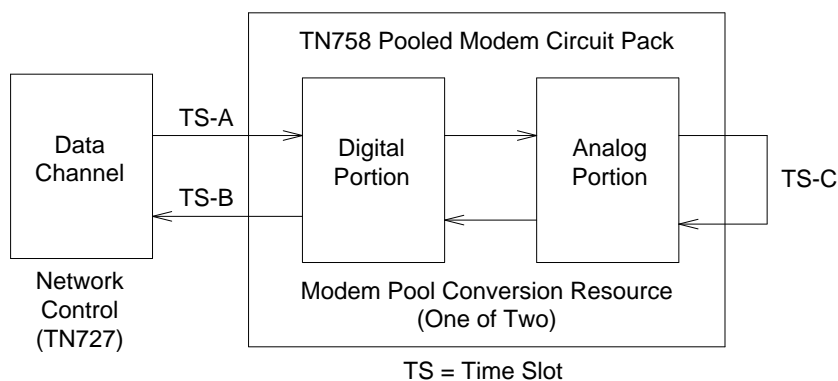
Figure 10-68. Modem Pool Conversion Resource Loop Around Test Set-up

The Modem Pool Conversion Resource Loop Around Test is set up as follows:

Test data patterns are transmitted from the Network Control Channels 1 or 3 over network time slot A through the digital port, looped around through the analog port via time slot C back to the Network Control Channel circuit via time slot B where the patterns are checked for accuracy. Finally, the test forces a disconnect by breaking the connection between the Data Channel and Modem Pool Port (time slot A) and verifying that the Data Channel and Modem Pool Port go on-hook within the proper time.

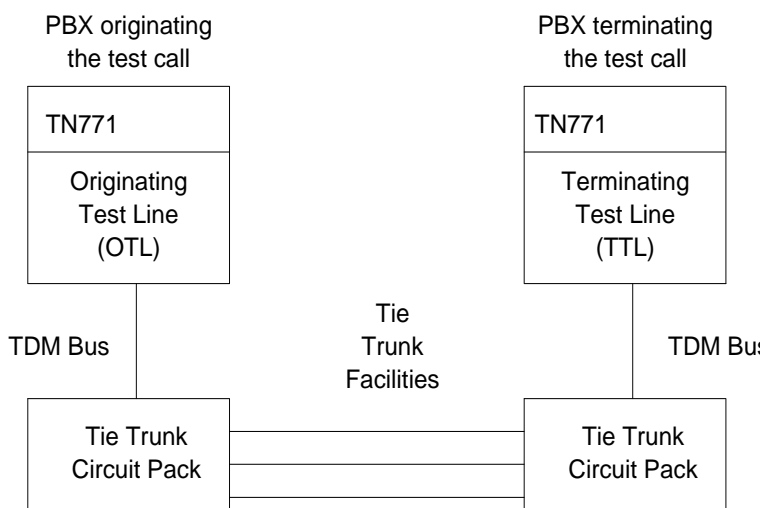
Figure 10-72. ATMS Tie Trunk Test Call

The Maintenance/Test Analog Port is port number 1 on the TN771 Maintenance/Test circuit pack. This port is used by the Automatic Transmission Measurement System (ATMS) as an Originating Test Line (OTL) or Terminating Test Line (TTL) for test calls over analog trunks. [Figure 10-72](#) shows a typical ATMS configuration.

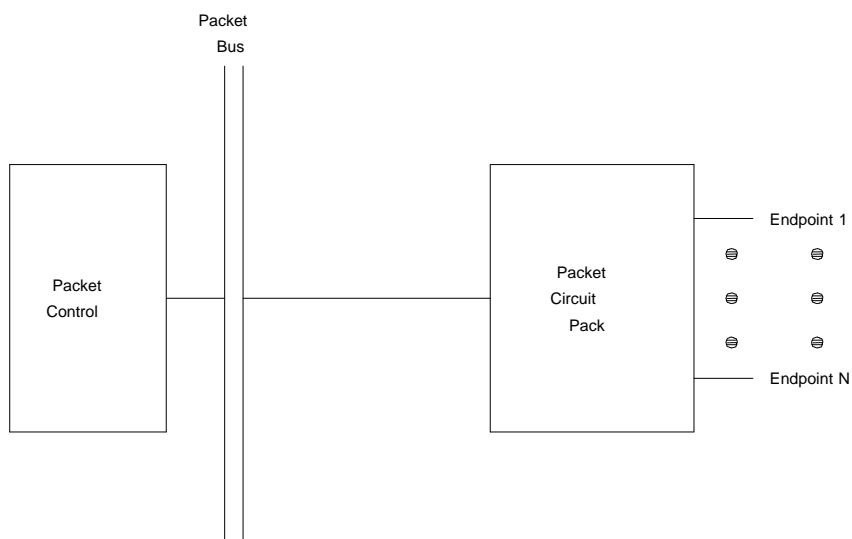
Figure 10-80. Hardware Configuration

The TN778 Packet Control circuit pack is the hardware component that serves as the interface between the SPE and the Packet Bus. It terminates the Link Access Procedure D (LAPD) protocol and provides support for thousands of signaling links. As shown in [Figure 10-80](#), a Packet Control link generally terminates on the Packet Control circuit pack and a packet endpoint which is connected to a Packet circuit pack. An ASAI adjunct is an example of a packet endpoint, and a TN556 is an example of a Packet circuit pack. In G3iV1.1-286 or G3iV2-386, the following Packet circuit packs (packs that can connect to the Packet Bus) are available:

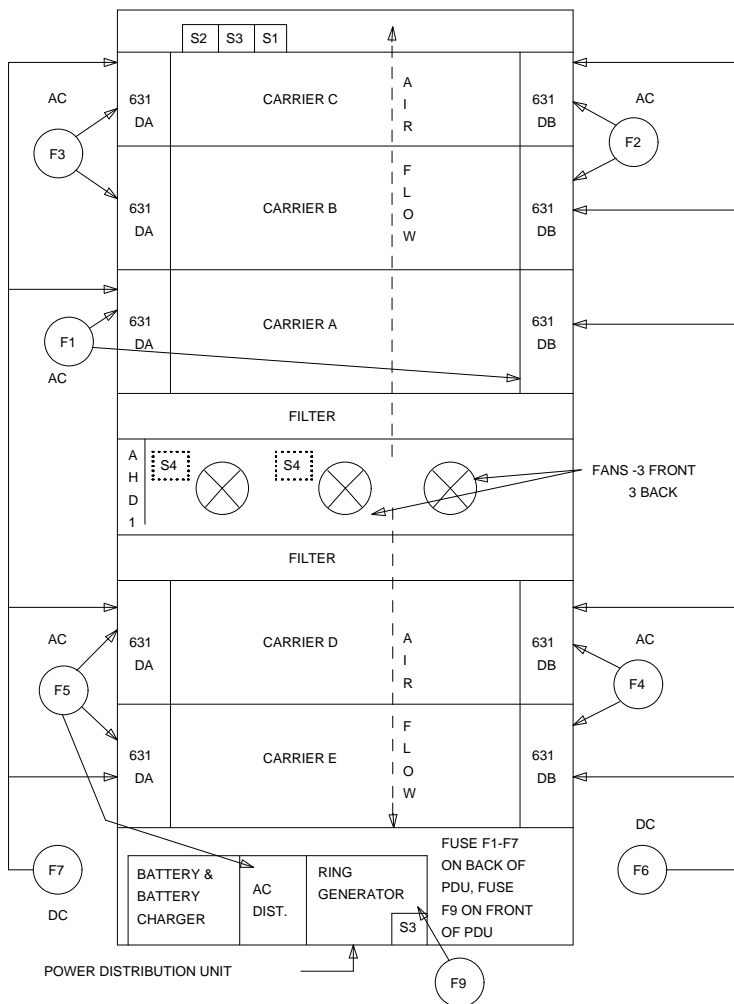
Figure 10-82. Multicarrier Cabinet Environment Components

All analog phones in DEFINITY Generic 1 cabinets must be provided with a voltage that allows them to ring. The Analog Ring Generator MO represents the device that provides the ringing voltage for analog phones in a multicarrier or single carrier cabinet system. In a multicarrier cabinet system, the Analog Ring Generator resides in the PDU. [Figure 10-82](#) shows the position of the PDU and illustrates that fuse F9 is used for the Analog Ring Generator. [Figure 10-83](#) shows the position of the fuses on the PDU and describes how to replace a fuse. In a single carrier cabinet system, the Analog Ring Generator is part of the WP-91153 power unit, and each carrier in the single carrier cabinet contains its own Analog Ring Generator. A ringing voltage generator failure means that no ringing will occur on analog phones; however, ringing on digital and hybrid phones will still occur.

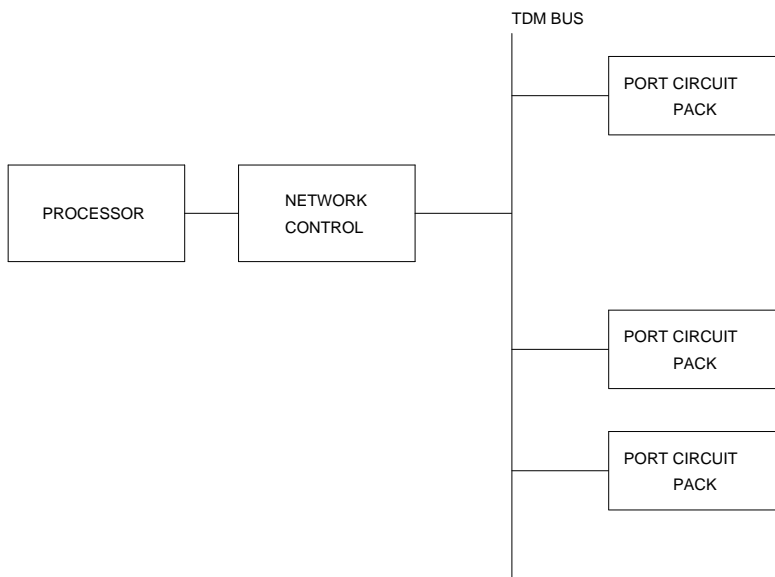
Figure 10-87. Switch Control Connectivity

The Switch Control is used to send control information between port circuit packs and the processor (see [Figure 10-87](#)). This control information is sent via the PPN cabinet's Time Division Multiplex (TDM) Bus. The portion of the TDM Bus used to transmit control messages is called the control channel. The control channel can be on either TDM Bus A or TDM Bus B, but only one bus is used for the control channel at any given time.

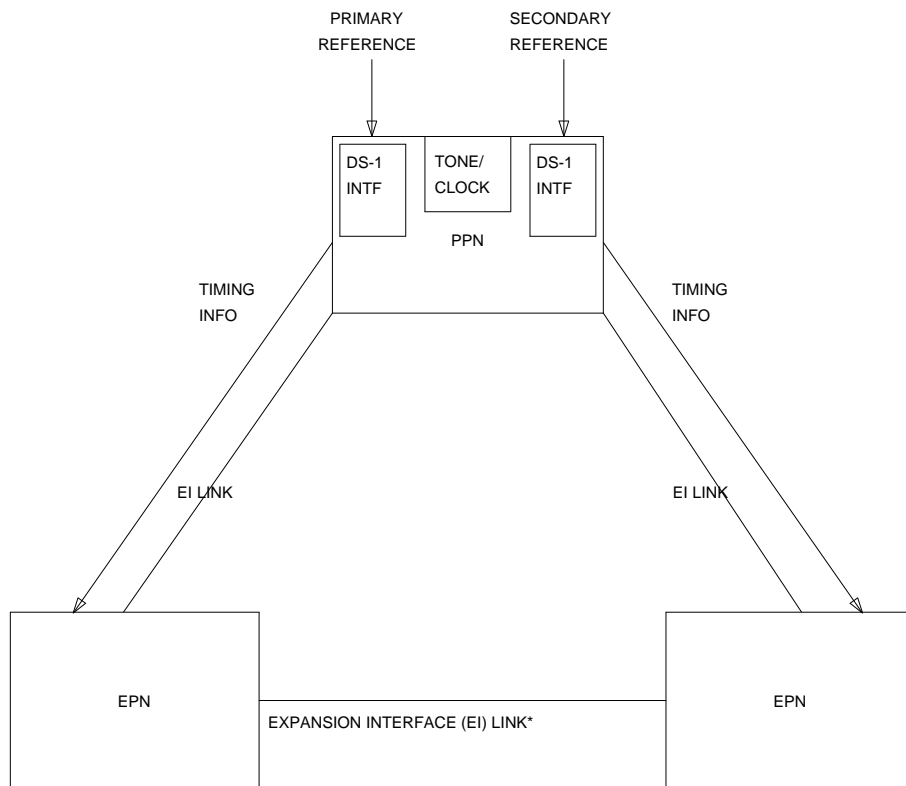
Figure 10-88. Typical Stratum 4 Synchronization Configuration

The system can be configured with primary and secondary synchronization references (DS1 interface circuit packs) when using Stratum 4 synchronization. Both references are optional (since the local oscillator can be used), and the secondary reference is optional if a primary is provided. If this system is the master for the network, then its local oscillator would be used and no DS1s would be used as references.

* EPN-TO-EPN LINKS ARE NOT USED TO CARRY TIMING

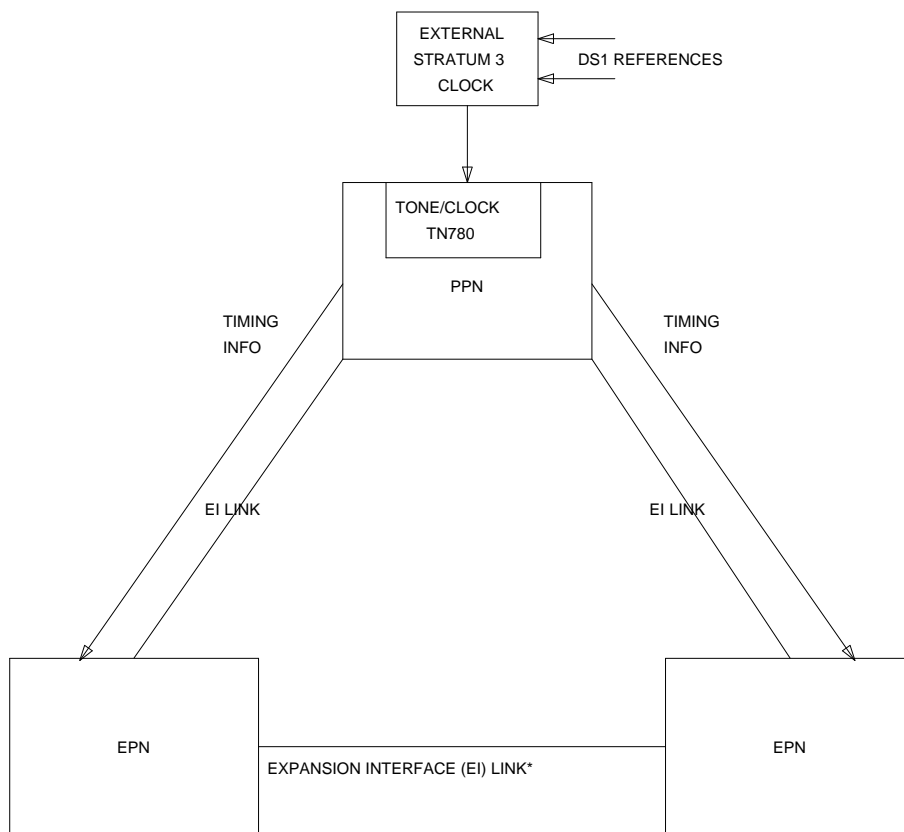
Figure 10-89. Example Stratum 3 Synchronization Configuration

This is only one possible configuration.

* EPN-TO-EPN LINKS ARE NOT USED TO CARRY TIMING

The external Stratum 3 clock may be connected to the TN780 Tone-Clock in any port network. However, it is recommended that it be connected to the PPN.

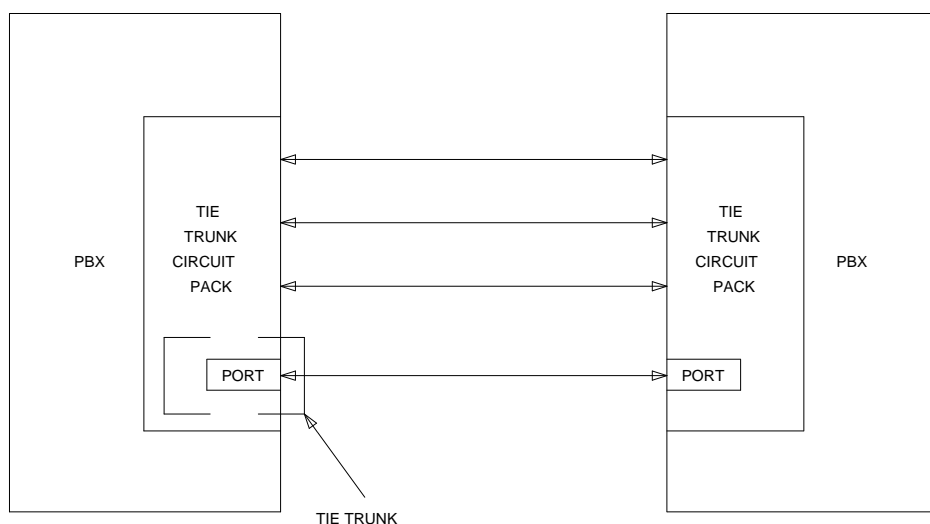
Figure 10-94. Tie Trunk Interactions

The Tie Trunk circuit pack fits into a port slot and contains four trunk circuits (see [Figure 10-94](#)). Each of these circuits interface a digital PBX to an analog tie trunk going to another PBX across one-way dedicated circuits (except for the TN497 circuit pack) or across two-way dedicated circuits. Except for the TN439 and TN497 circuit packs, each tie trunk has a 4-wire audio connection and may have two signaling leads (E and M). Each tie trunk for the TN439 and TN497 circuit packs has 2-wire audio connection/signal leads (A and B).
