DEFINITY[®]

Enterprise Communications Server

Release 8.2

Maintenance for R8r

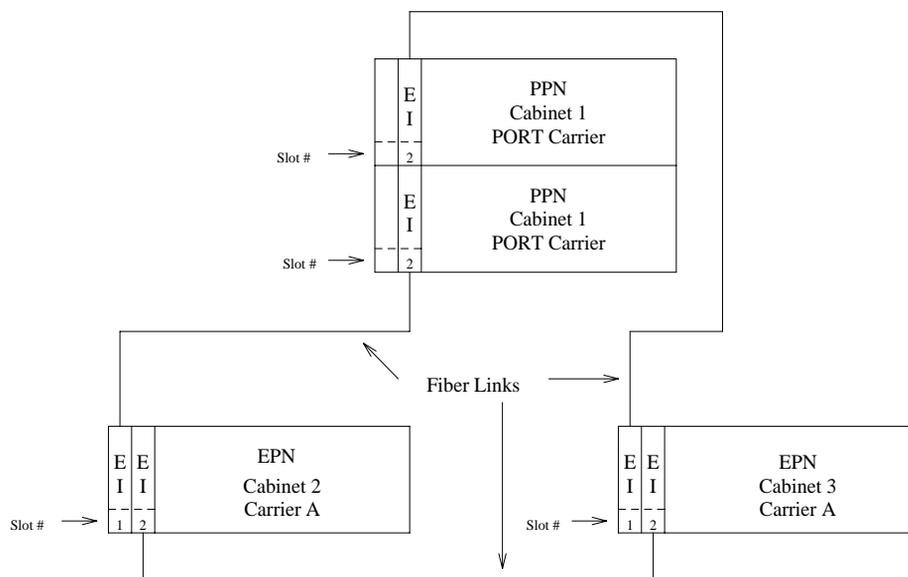
Figure 1-1. Direct Connect PNC

The PNC is provided in one of two different configurations: Direct Connect and Center Stage Switch (CSS). In either configuration the TN570 Expansion Interface (EI) board provides the interface to the data on the TDM/PKT busses. In the direct connect configuration up to three PNs connect by hardware between each pair of PN EIs. See [Figure 1-1](#).

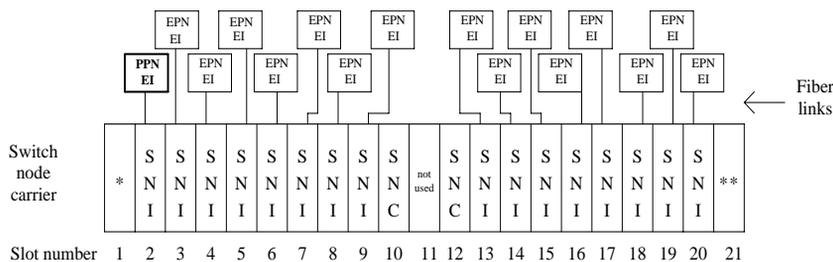
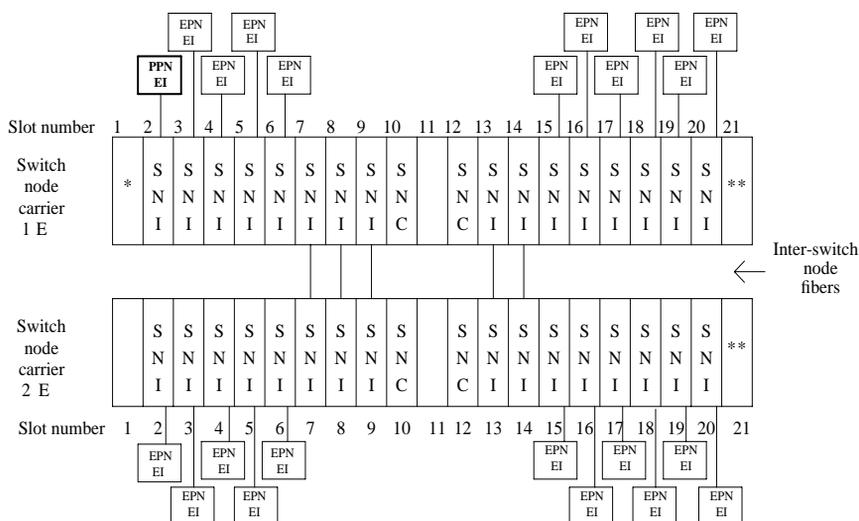
Figure 1-2. Center Stage Switch Configurations (Simplex Examples)

[Figure 1-2](#) shows two examples of CSS configurations. Illustrations of the switch node carrier hardware appear in Chapter 2.

CSS with one switch node

CSS with two switch nodes

* The PPN EI or a DSIC circuit pack may reside in this slot

** A DSIC circuit pack may reside in this slot

In the CSS configuration, up to 16 PNs (including the PPN) can connect to one switch node (SN). With two SNs, up to 22 PNs can be connected. Each SN consists of a carrier containing the following components (in critical reliability systems, each SN is duplicated on a second, identically configured carrier):

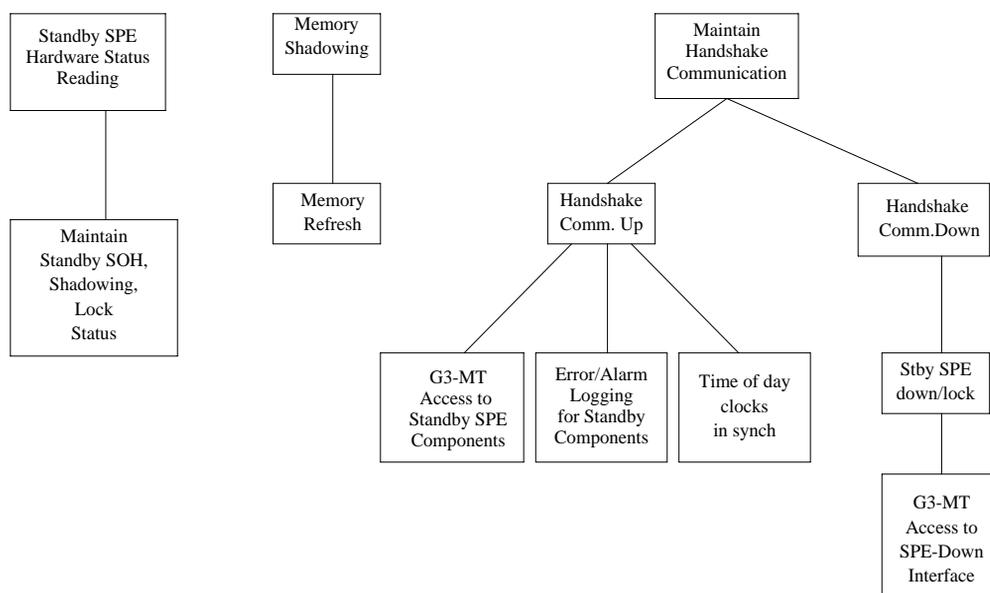
Figure 1-4. Components of Standby Maintenance

As shown in [Figure 1-4](#), all maintenance capabilities for the standby SPE are built upon these three strategies.

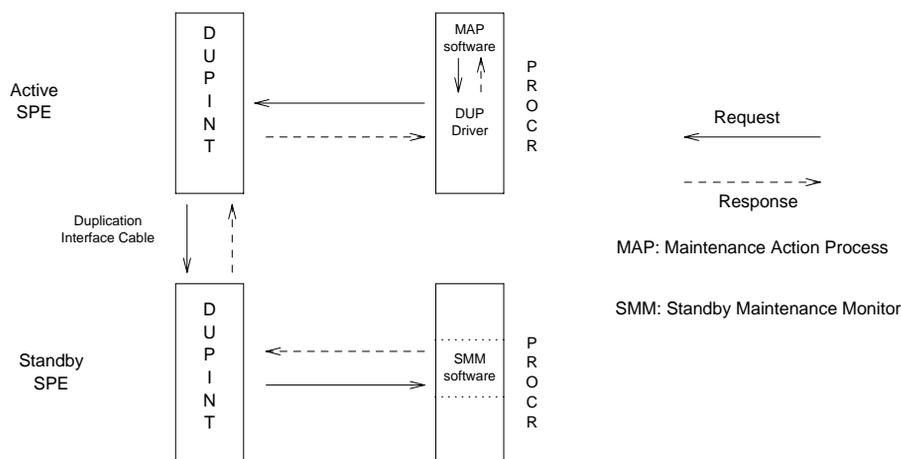
Figure 1-5. Handshake Communication Path

The physical path of handshake communication is illustrated below. Hardware problems at any point in this route could interfere with handshake communication. If the standby SPE fails to respond to four successive handshake requests, handshake communication is considered down. A major alarm is logged against STBY-SPE with error type 1 logged. The **status spe** screen will indicate that handshake is down. It is then no longer possible to communicate with the standby SPE. Maintenance testing of the standby by the active SPE (or by command) is discontinued, and the error and alarm logs become outdated for standby components.

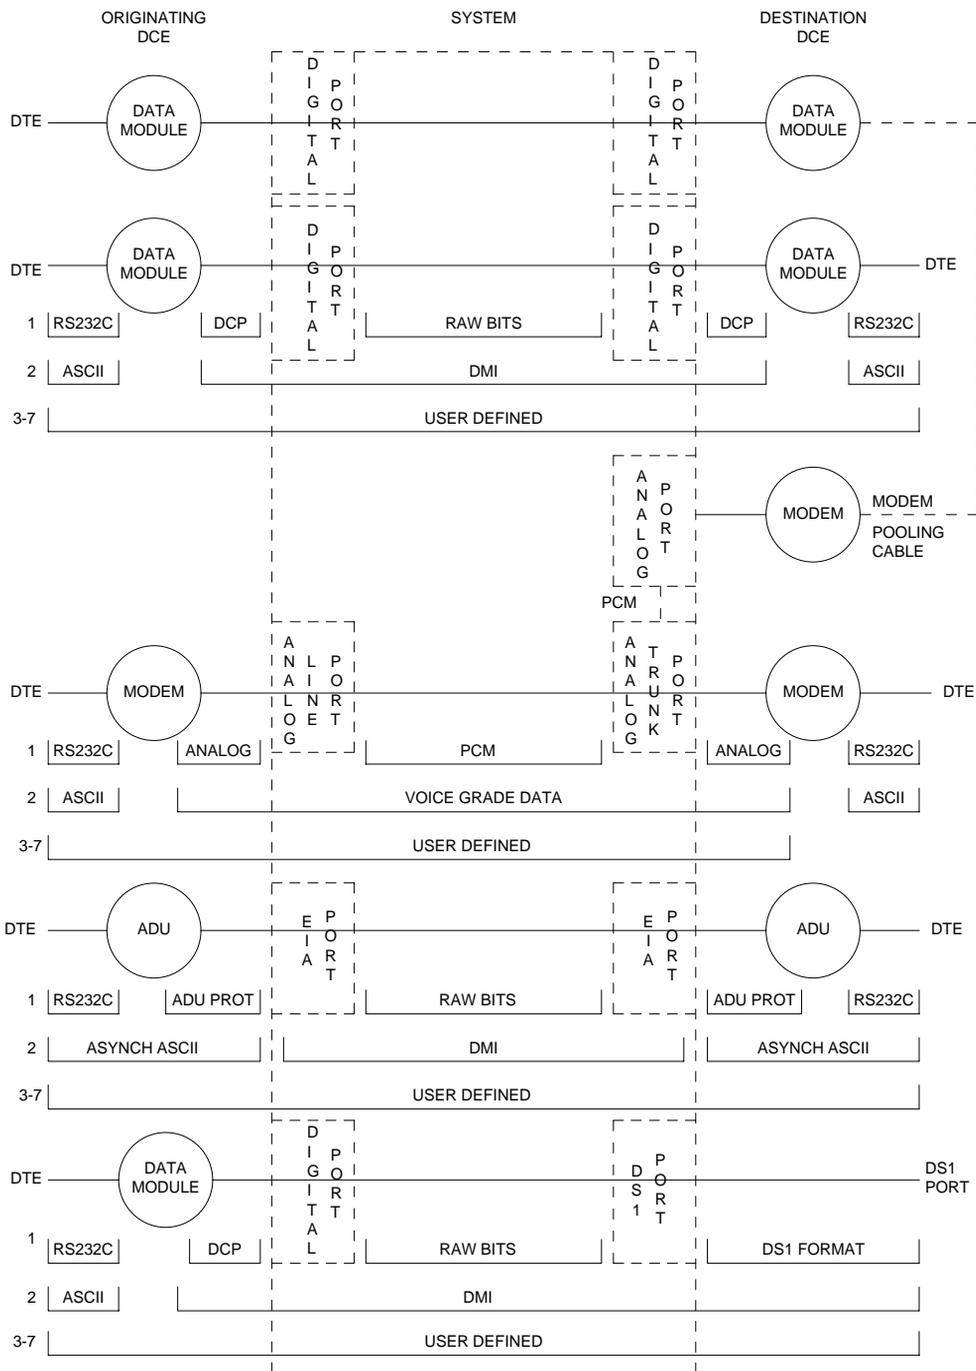
Figure 1-6. Data Transmission States

This section describes the protocols handled by the system and the points where these protocols change. [Figure 1-6](#) is a pictorial guide through data-transmission state changes. [Figure 1-6](#) illustrates the flow of data from DTE equipment, like a terminal or host, through DCE equipment, like a modem or data module, into a communications port on the system. The data flow is shown by solid lines. Below these lines are the protocols used at particular points in the data stream.

Layers 3 to 7 (and the DTE-created layer 2) are embedded in the transmission stream and are meaningful only at the destination DTE equipment. Therefore, they are shown in the figure as “user-defined,” with no state changes until the transmission stream reaches its destination.

Not shown in the [Figure 1-6](#) is the treatment of D-channels in ISDN-PRI and ISDN-BRI transmissions. PRI and BRI D-channels transport information elements that contain call-signaling and caller information. These elements conform to ISDN level-3 protocol. In the case of BRI, the elements are created by the terminal or data module; for the PRI, the elements are created by the system, which inserts them into the D-channel at the DS1 port.

The following is a list of the protocols when data is transmitted to and through the system. The list is organized by protocol layers. Refer to [Figure 1-6](#).

[Table 1-8](#) summarizes the protocols used at various points in the data transmission stream. See [Figure 1-6](#).

[Figure 1-6](#) implies the following connectivity rules:

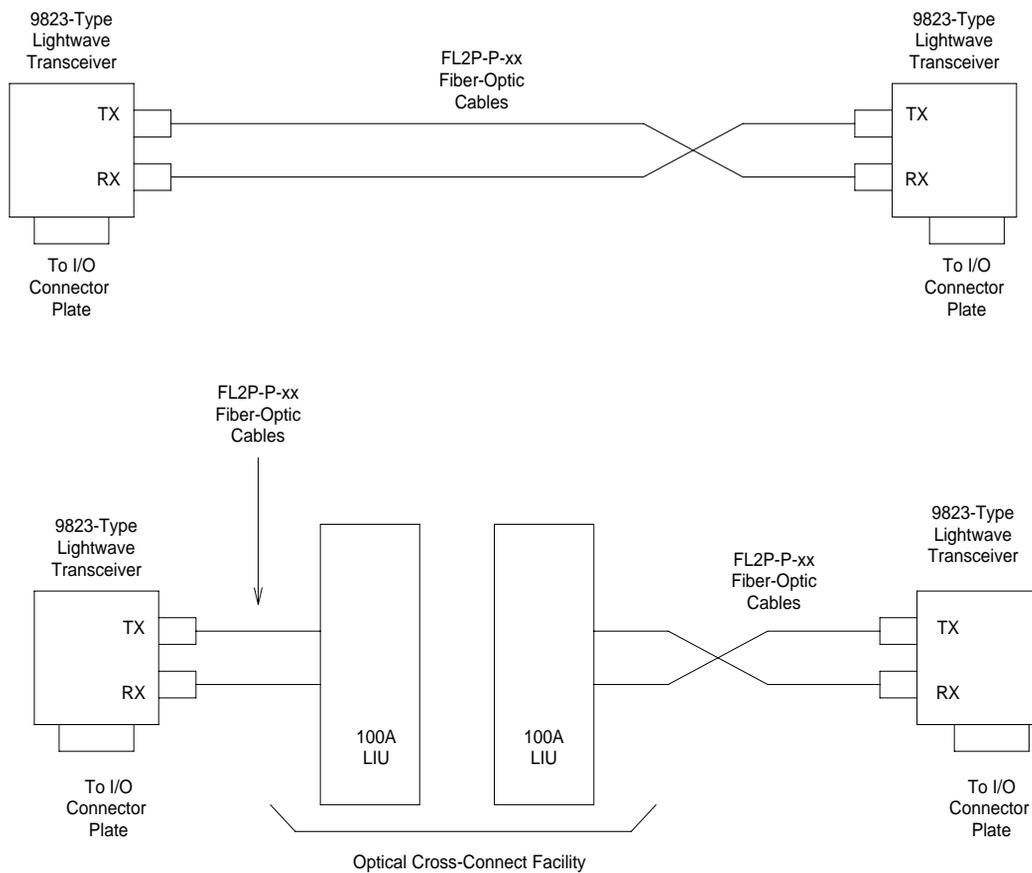
**Figure 2-2. Fiber Link Connection Hardware**

The lightwave transceivers are powered from I/O connector plate leads attached to TN570 Expansion Interface circuit pack or a TN573 Switch Node Interface circuit pack. The transceivers include loop-around capabilities to support fiber fault isolation. Either of two different 9823-type multi-mode transceivers may be used, depending upon the length of the fiber (table below), or the 300A single mode fiber transceiver. The transceivers at each end of a given fiber should match. [Figure 2-2](#) illustrates the interconnection of fiber optic hardware.

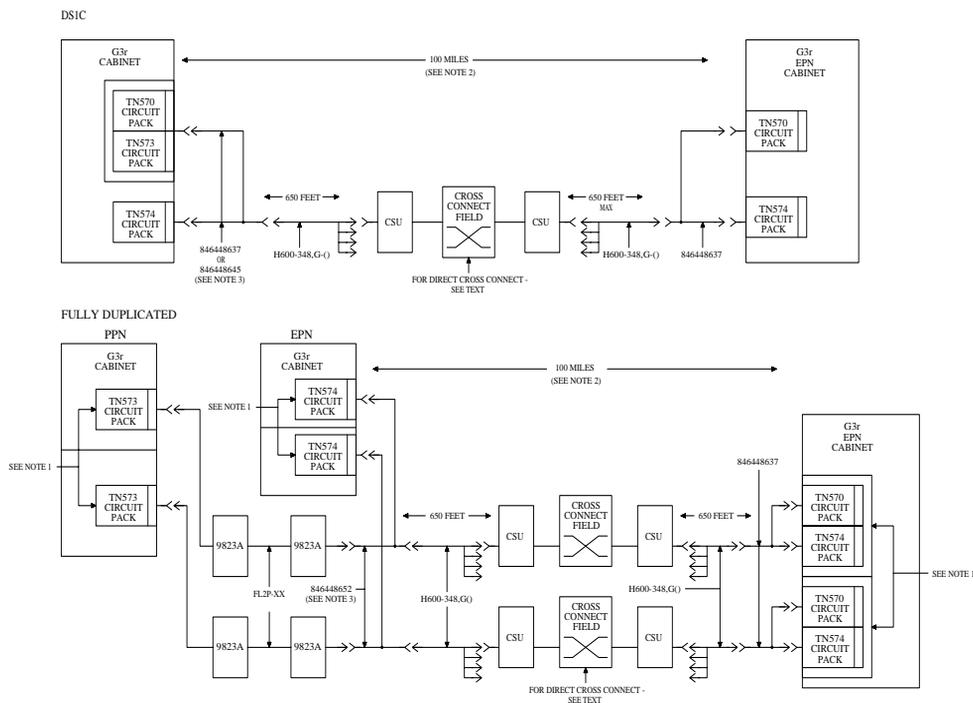
Figure 2-3. Typical DS1 CONV Connections to Remote EPNs

An H600-348 cable connects the DS1 CONV cable to a Channel Service Unit (CSU), which connects to a wall field. (Alternatively, connection is sometimes made directly from the Y-cable to the wall field. See the pinout for the 50-pin connector at the end of the Fiber Fault Isolation Procedure in [Chapter 5, “Alarms, Errors, and Troubleshooting”](#).) This cable provides from one to four DS1 connections. One end of the H600-348 cable is plugged into the 50-pin amphenol piggy-back connector on the 8464486xx cable connected to the DS1CONV port connector. The other end of the H600-348 cable has four 15-pin sub-miniature D-type connectors that plug into the CSU. A pinout of this cable appears the end of the Fiber Fault Isolation Procedure in Chapter 5. H600-348 cables come in the following lengths:

1. Place duplicate pairs in different carriers.
2. When removing two or more, the maximum cable distance between any two remoted end points is 100 miles (161 km). For example, if the EPN is 75 miles (121 km) from the PPN, then EPN 2 can only be 25 miles (40.2 km) from the PPN.
3. 846447637 is used within a carrier for a TN574, for TN1654 within a carrier use a 847245750.

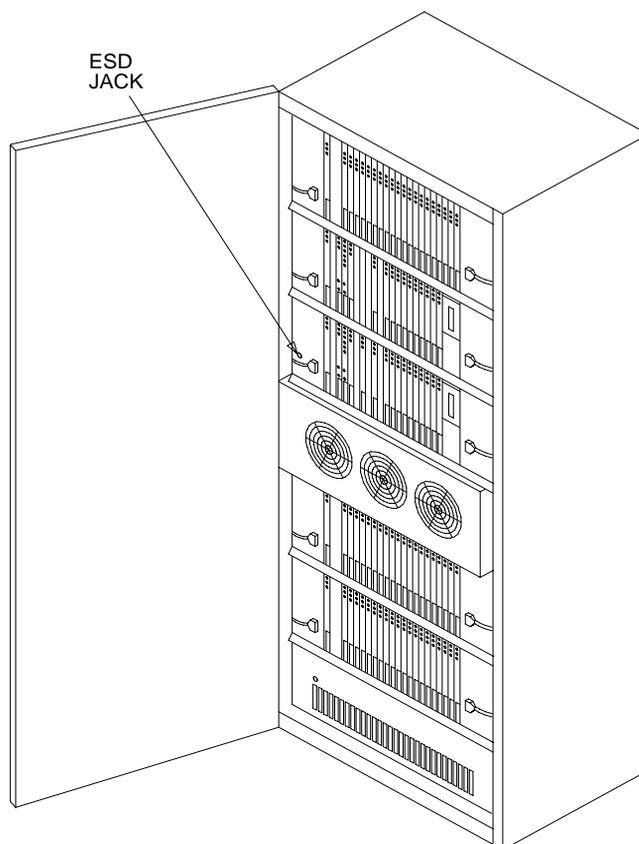
Figure 5-1. Multi-Carrier Cabinet ESD Grounding Wrist Strap Jack

[Figure 5-1](#) shows the location of the grounding jack.

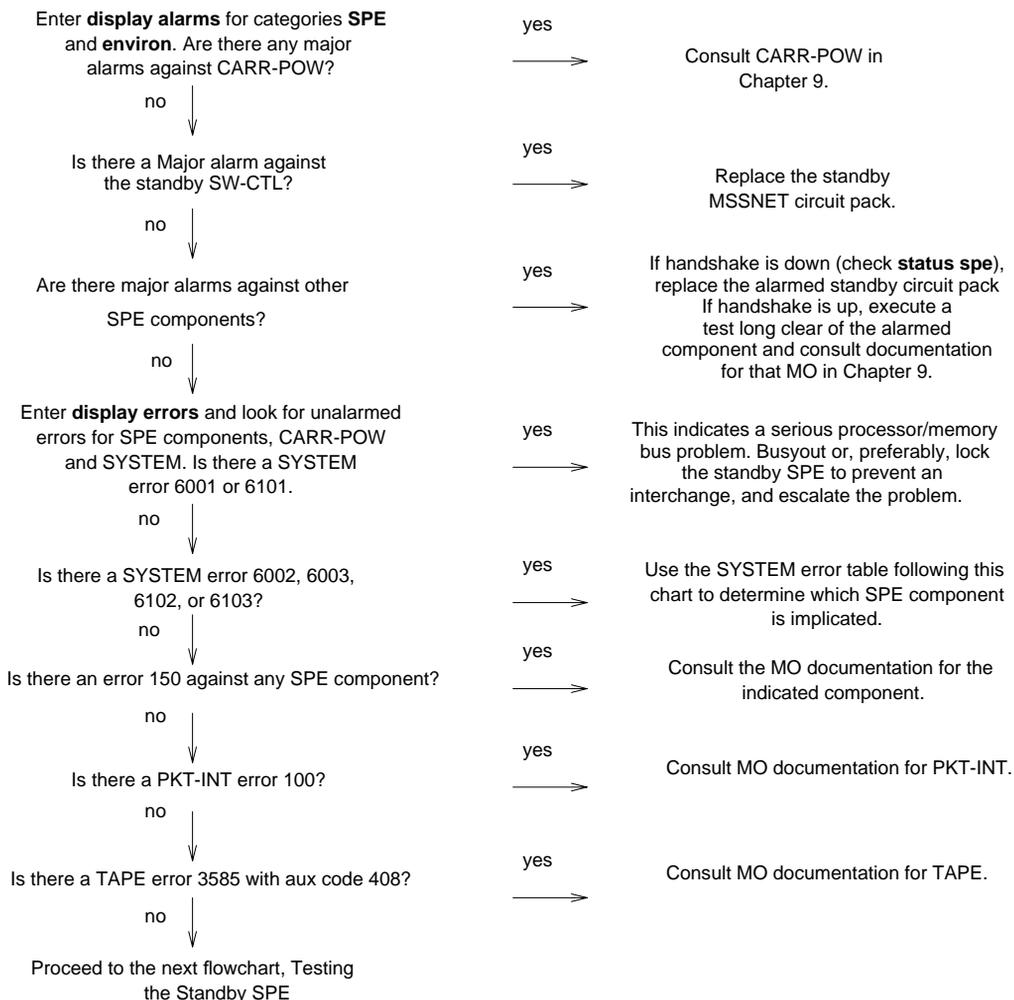
Figure 5-2. Determining the Cause of an SPE Interchange

The system may have had time to log alarms or errors against the fault the caused the interchange. Proceed through the steps summarized in [Figure 5-2](#). Examine only major alarms with a timestamp near the time of interchange, and whose carrier designation is the current standby SPE (the SPE interchanged out of). Include any resolved alarms meeting this description.

The following table shows which components are indicted by the auxiliary error codes found by using the preceding flowchart ([Figure 5-2](#)). Once you have identified the faulted component, consult the section for that MO.

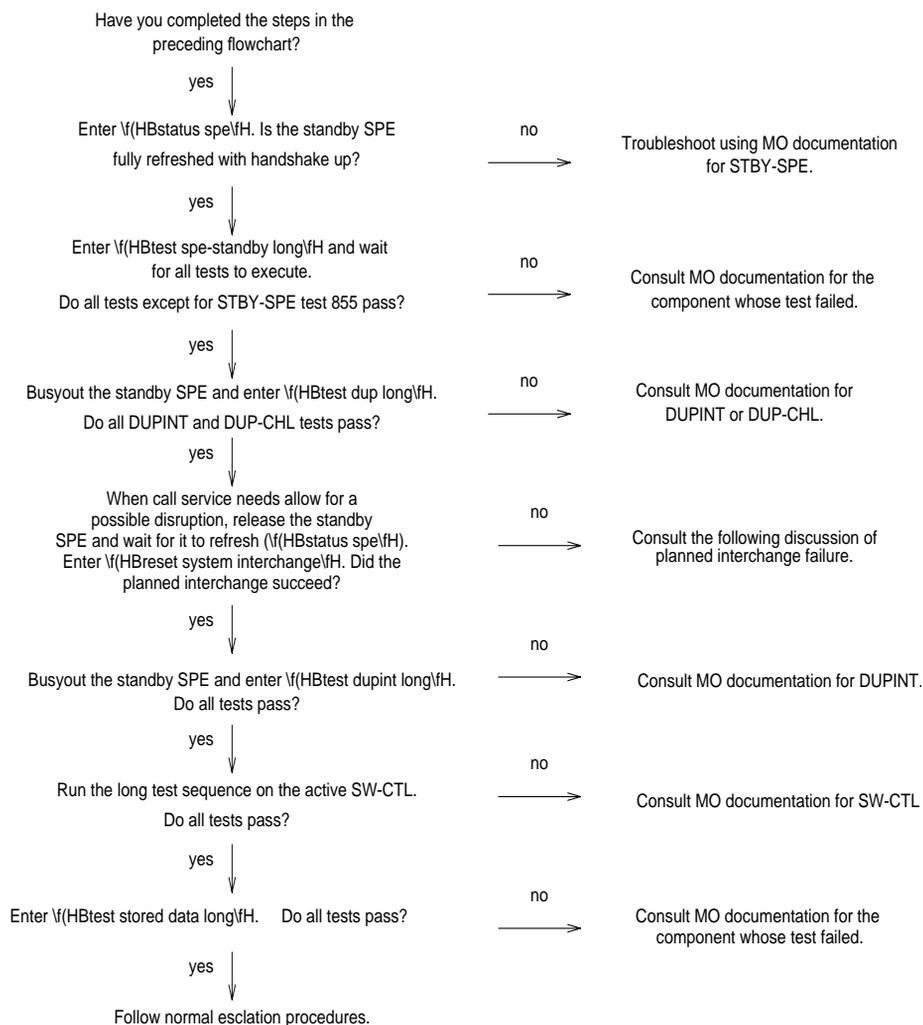
Figure 5-3. Testing the Standby SPE

The system may not have had time to log errors against the failed component that caused the spontaneous interchange. If you have progressed through the preceding flowchart without determining the cause of interchange, test the standby for faults by proceeding through the following steps shown in [Figure 5-3](#).

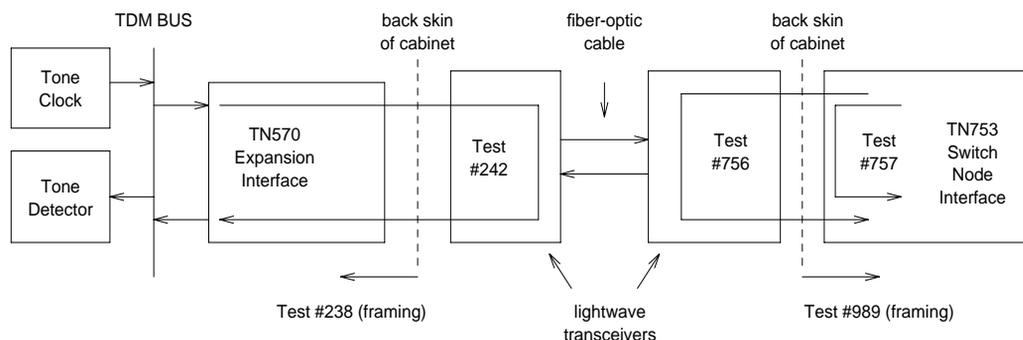
Figure 5-4. Fiber fault isolation tests

Test 242 can be run as part of the **test board UUCSS long** command for an Expansion Interface circuit pack. Besides testing on-board components, this test is helpful for isolating problems between a circuit pack and the lightwave transceiver. The loopback shown in this diagram shows only part what test 242 does. If no lightwave transceiver is connected to the Expansion Interface circuit pack, an on-board loopback is performed on the Expansion Interface circuit pack. For more information about test 242, see [“EXP-INTF \(Expansion Interface Circuit Pack\)”](#).

Did test 788 pass and test 789 fail? If yes, replace the DS1C and lightwave transceiver (if present) at the other end of the DS1C complex. See [Figure 5-4](#) and [Figure 5-5](#). Go back to Step 4.

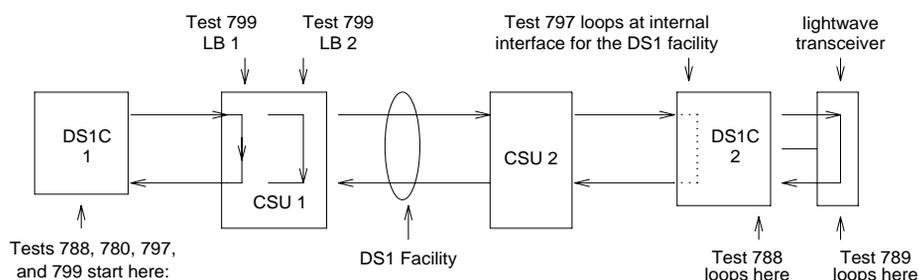
Figure 5-5. DS1 CONV Loopbacks

[Figure 5-5](#) shows the loopbacks performed on the SNI circuit pack for test 756 and test 757. Test 756 reports the result of the off-board loopback; test 757 reports the result of the on-board loopback. Test 756 and test 757 can run individually or as part of the **test board UUCSS long** command for an SNI circuit pack.

If DS1Cs exist on the fiber link (check with **list fiber-link**), then additional DS1CONV loopback tests can be run to further isolate the problem. The loopback tests are shown in [Figure 5-5](#). For more information about loopback tests 788 and 789, see the [“DS1 CONV-BD”](#) section in. For more information about DS1 facility loopback tests 797 and 799, see the [“DS1-FAC \(DS1 Facility\)”](#) section.

This test requires manually altering the external connections of the DS1 facility. Place the loopbacks at as many points as your CSU capabilities will allow (see [Figure 5-5](#)).

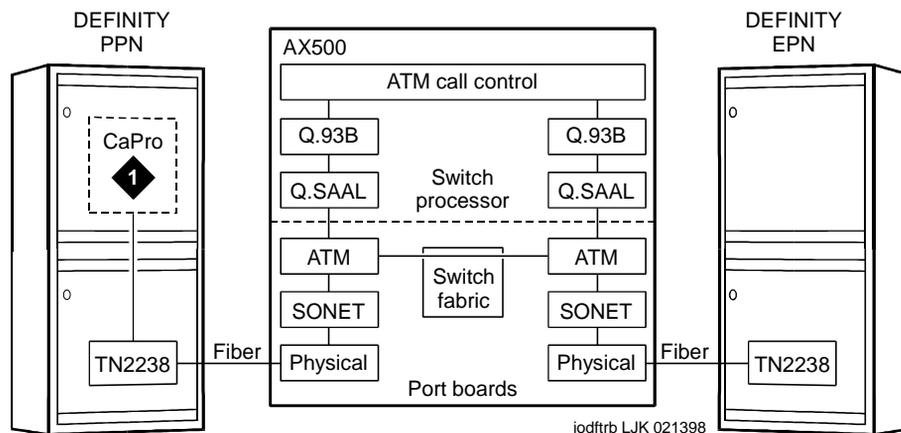
Figure 5-6. ATM troubleshooting schematic

This section provides tips for DEFINITY ATM PNC when interfacing with the ATM switch. Throughout this section, refer to [Figure 5-6](#).

The CaPro element (Note 1 in [Figure 5-6](#)) is a software module within the DEFINITY PPN.

In the ATM PNC configuration, the proprietary Center Stage Switch (CSS) is replaced by the ATM network. Since the CSS switch nodes are replaced by the ATM network in the ATM PNC configuration, the SNI boards are no longer needed. In place of SNI board, the ATM EI boards are connected to an ATM switch port over a fiber optic cable. The port on the ATM switch is under the control of ATM switch maintenance software. Refer to [Figure 5-6](#) in the “[ATM Tips](#)” section in Chapter 5 for a schematic of these connections.

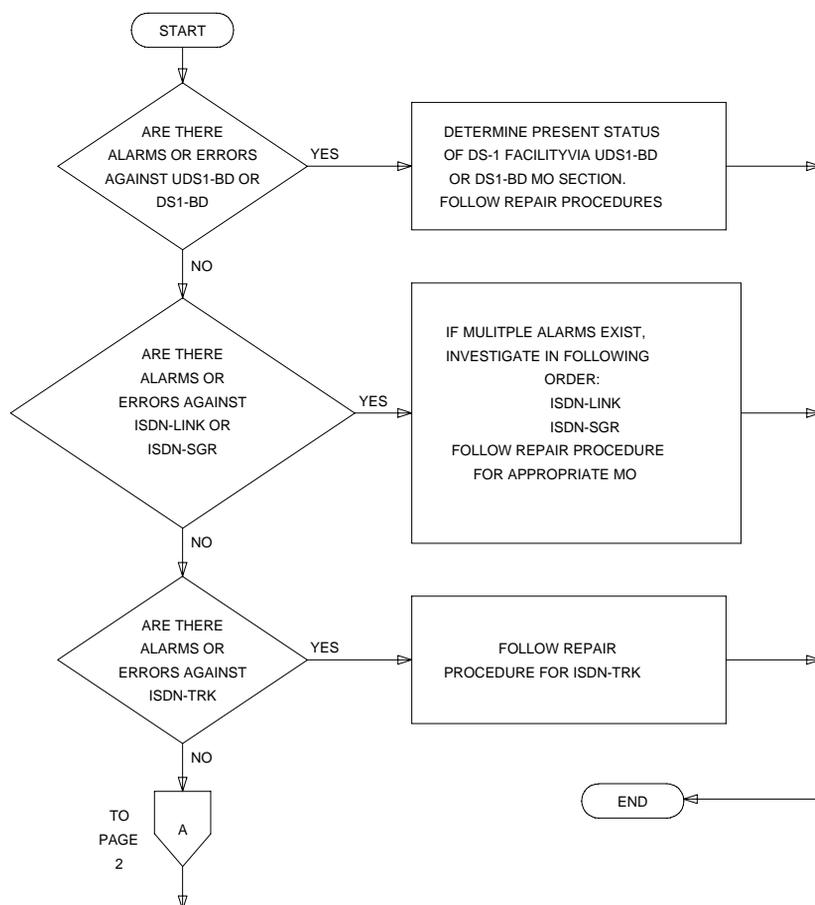
Figure 5-38. Troubleshooting ISDN-PRI (Page 1 of 2)

The following flow chart defines a layered approach when troubleshooting ISDN-PRI problems. Since a problem at a lower layer affects upper layers, layers are investigated from low to high. In the flowchart, the DS1 facility is layer 1, the ISDN-PRI D-channel is layer 2, and the ISDN trunks are layer 3. Transient problems are diagnosed on Page 2 of the flowchart. For problems with PRI endpoints (wideband), see the following section.

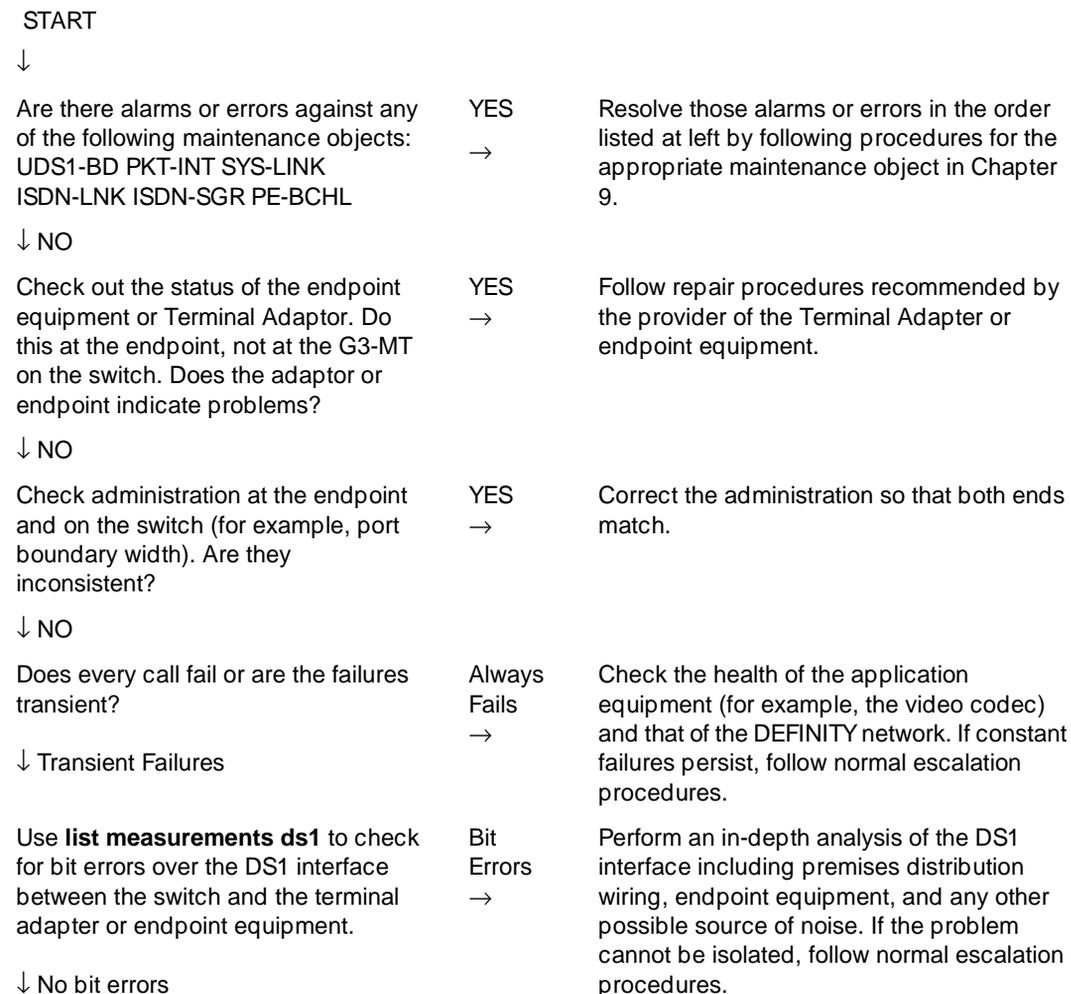
The following flow chart defines a layered approach when troubleshooting PRI endpoint problems. Because problems at lower layers affect upper layers, layers are investigated from low to high. In this procedure, the DS1 facility is layer 1, the TN1655 Packet Interface is layer 2, and the PRI endpoint ports are layer 3.

Check for alarms and errors against SYNC. Has a synchronization source been unstable? Has the system switched synch sources?

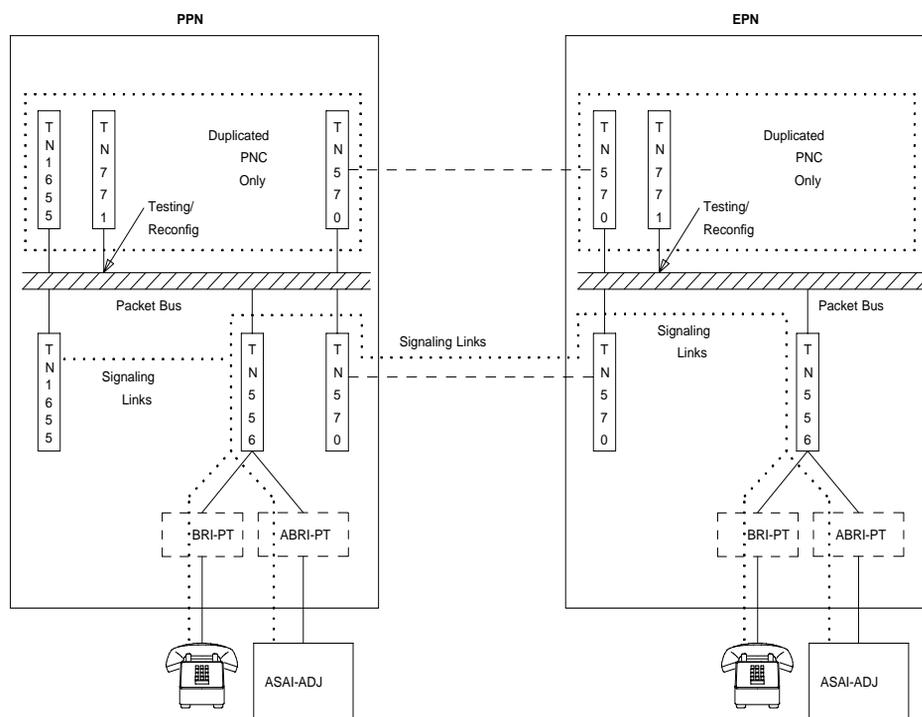
Figure 5-40. ISDN-BRI/ASAI Packet Bus Connectivity

Troubleshooting ISDN-BRI/ASAI problems can be a complex and involved procedure. The reason for this is that ISDN-BRI devices communicate with the SPE over the Packet Bus, as opposed to the TDM Bus. Therefore, it is possible for failures of other Packet Bus-related system components to cause problems with ISDN-BRI devices. [Figure 5-40](#) shows the connectivity of the Packet Bus as it applies to ISDN-BRI signaling.

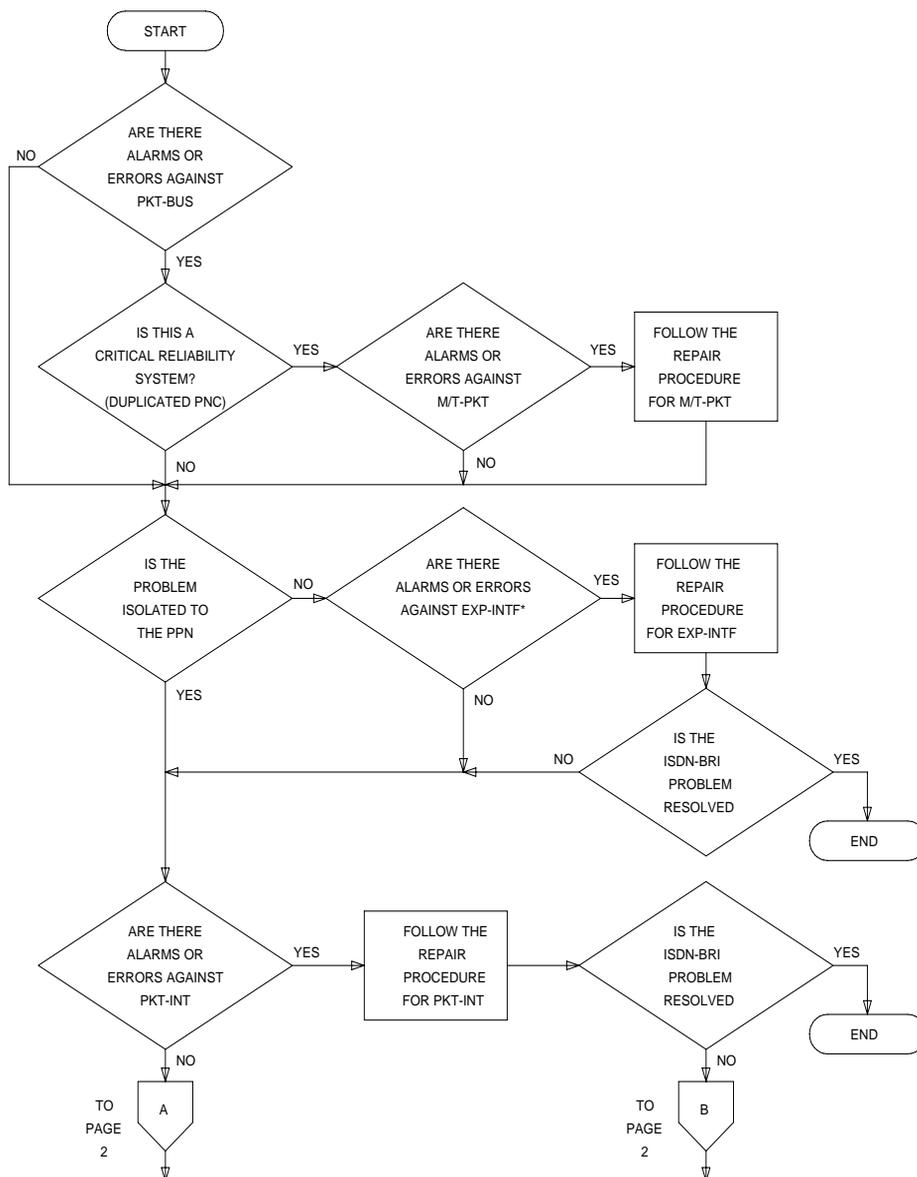
Figure 5-41. Troubleshooting ISDN-BRI Problems (Page 1 of 2)

The flowchart in [Figure 5-41](#) describes the steps needed to isolate and resolve ISDN-BRI problems. The order in which you should examine the maintenance objects is determined by looking at how widespread the failure is. For example, since all ISDN-BRI devices communicate with the TN1655 Packet Interface circuit pack, this MO should be examined early in the sequence. On the other hand, a failure of an Expansion Interface (TN570) circuit pack may cause ISDN-BRI failure in an EPN, but could not be the cause of a failure in the PPN.

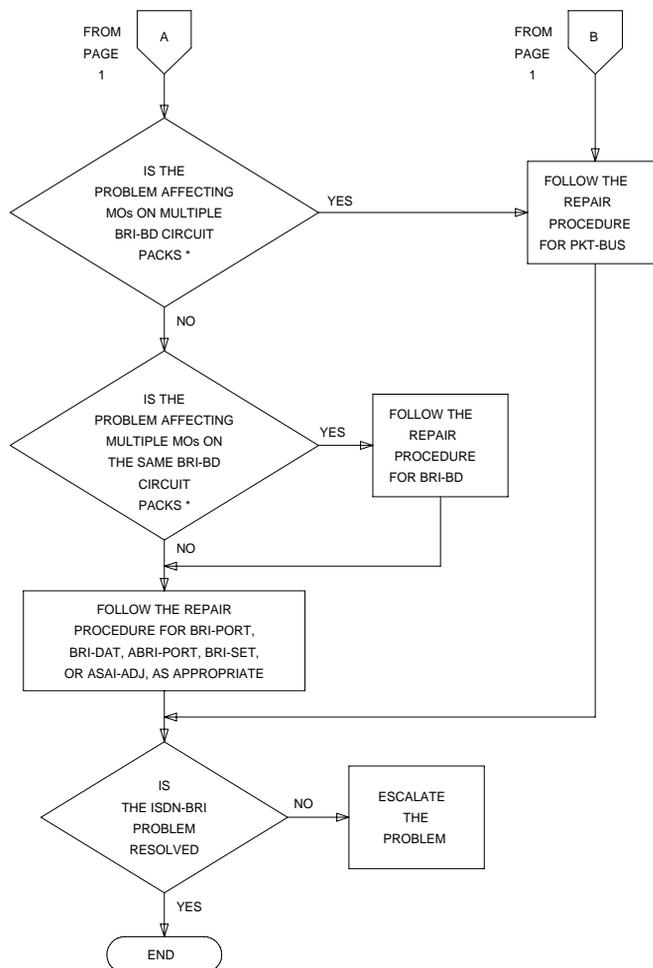
Figure 5-42. Troubleshooting ISDN-BRI Problems (Page 2 of 2)

* THESE MOs WOULD BE BRI-PORT,
ABRI-PORT, BRI-DAT,
BRI-SET, OR ASAI-ADJ

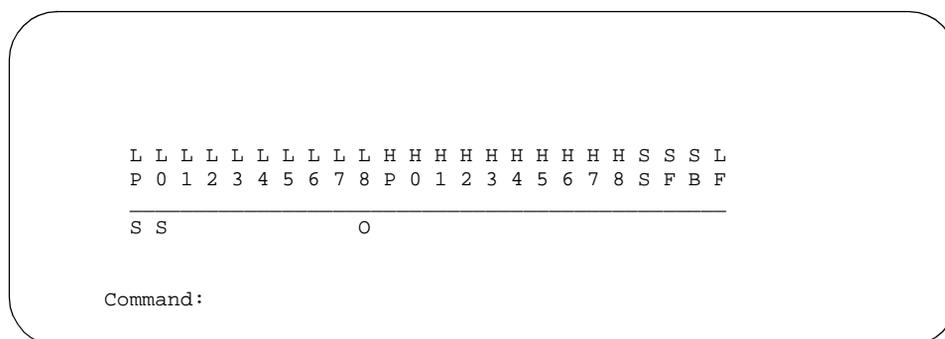
Below is an example of a standalone mode display. The symbols above the line represent specific leads on the backplane. The bottom line indicates the following:

- O Open lead
- S Shorted lead
- blank No fault

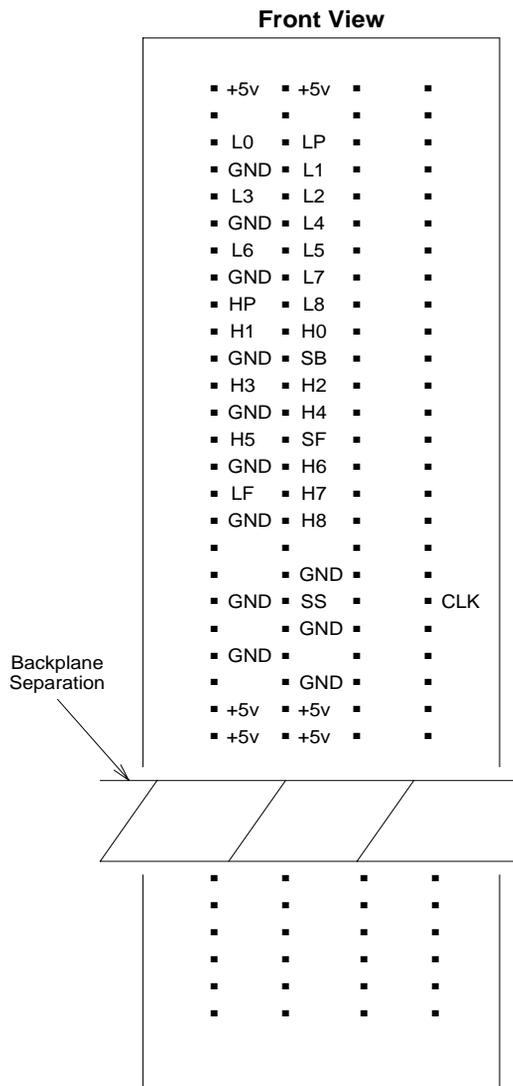
Figure 5-43. Packet Bus Leads on the Backplane

[Figure 5-43](#) shows the location of the packet bus leads for a given slot as seen from the front and back of the carrier.

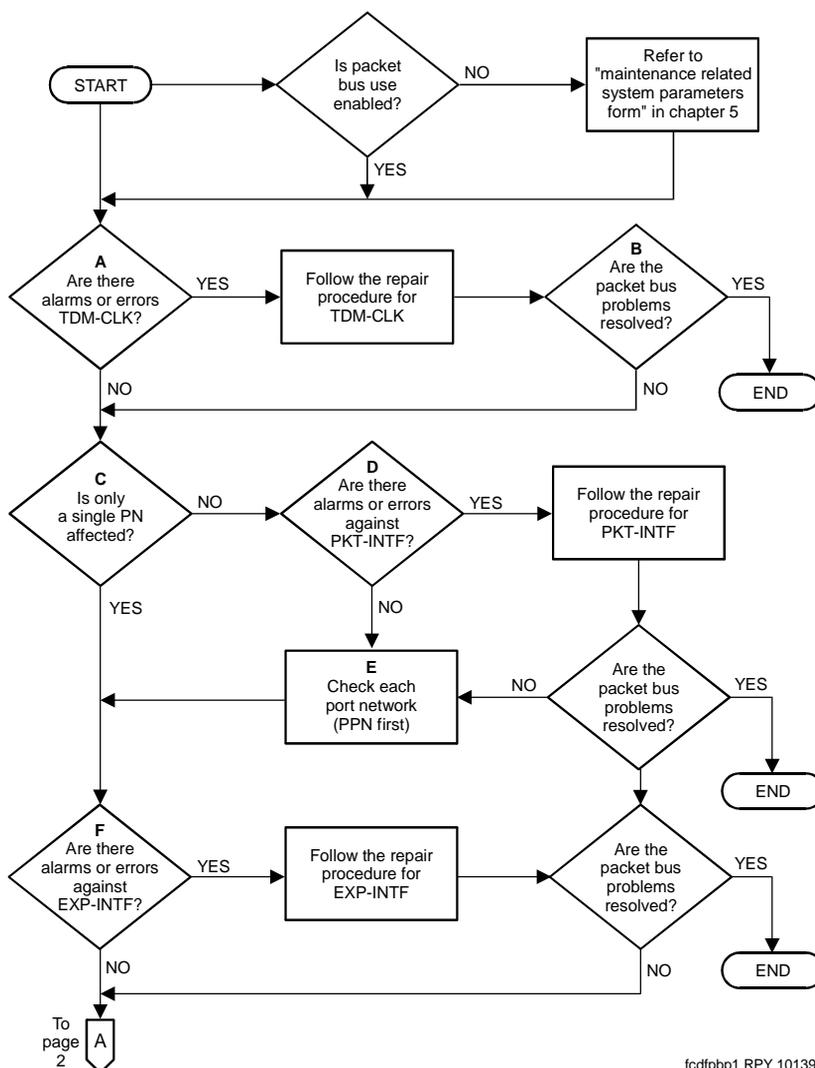
Figure 5-45. Troubleshooting Packet Bus Problems (Page 1 of 2)

Boldface letters in the flowchart refer to paragraphs in the explanatory section that follows.

Whenever the flowchart refers to MO documentation, keep in mind that the repair procedure for that MO may in turn refer to another MO's repair procedure. The flowchart tries to coordinate these procedures so that a logical flow is maintained if the packet bus problems are not resolved via the first set of repair procedures. However, a packet bus failure can lead to a somewhat haphazard referencing of various MO procedures that may result in taking steps that are repetitive or unnecessary. If this occurs, return to the flowchart at the step that follows the reference to [Chapter 9, "Maintenance Object Repair Procedures"](#), and continue from there. The following **status** commands can also help diagnose packet bus problems, especially when logged in remotely.

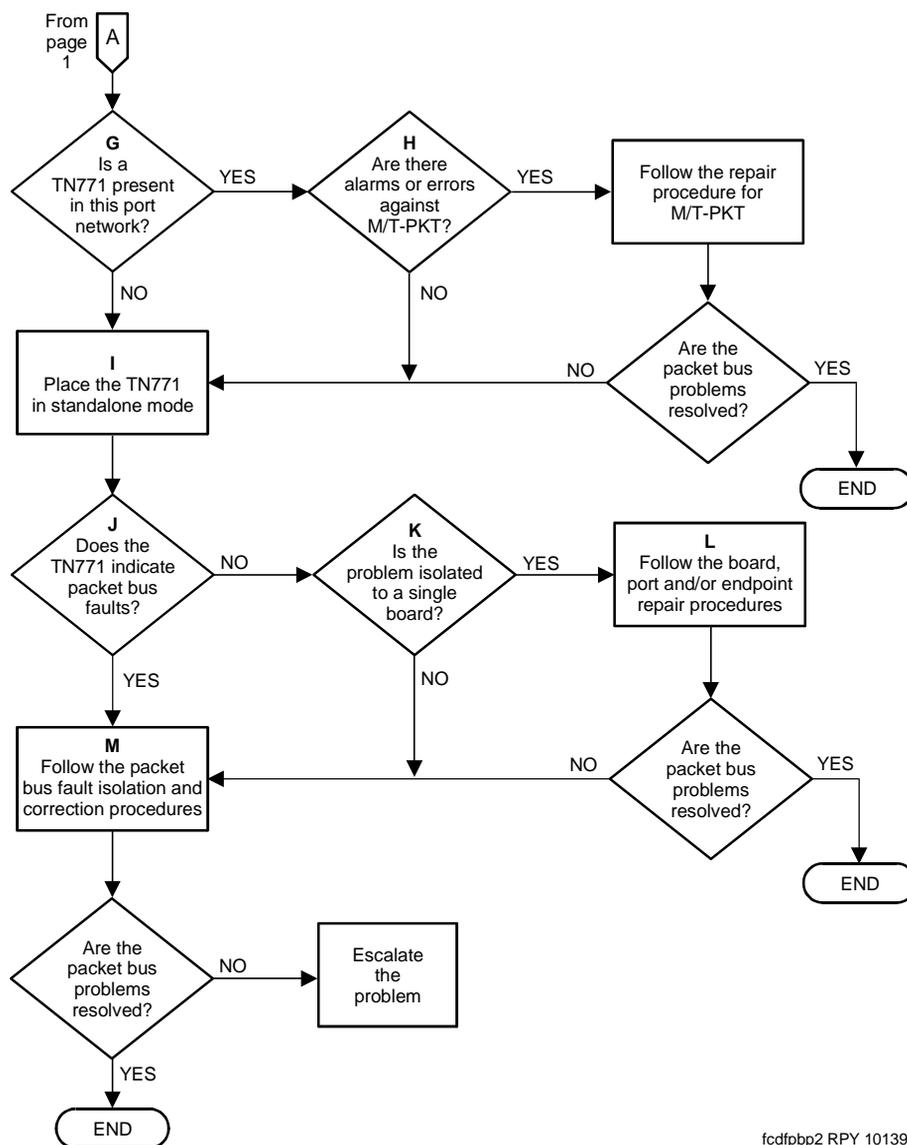
Figure 5-46. Troubleshooting Packet Bus Problems (Page 2 of 2)

Boldface letters in the flowchart refer to paragraphs in the explanatory section that follows.

The following paragraphs refer by letter to corresponding entries in the preceding flowchart. Individual errors and alarms are not detailed in the flowchart. When referring to explanations of these in [Chapter 9, "Maintenance Object Repair Procedures"](#), any that do not refer explicitly to the TDM bus (except TDM-CLK) should be considered a possible cause of packet bus problems.

- a. Problems with the system clock (TDM-CLK) can cause service disruptions on the packet bus. All alarms active against TDM-CLK should be resolved first, even if the explanation refers only to TDM bus. A packet bus problem cannot cause a TDM-CLK problem, but a TDM-CLK problem can cause a packet bus problem.

- d. A packet problem that affects more than one port network is probably caused by either a Packet Interface failure or a PPN packet bus failure. The Packet Interface is checked before the packet bus.

- h. If a TN771D is present, it can fail in such a way that it eventually disrupts the packet bus or misinterprets a packet bus problem.
- i. If work is being done on-site, follow the procedures described earlier in this discussion on standalone mode. If work is not being done on-site, go to the next step.

- j. The answer is yes if any of the following apply:
 - The TN771D in standalone mode indicates any faulty leads.
 - Test #572 in the PKT-BUS test sequence fails.

- k. If the non-functional endpoints are isolated to a single circuit pack, that circuit pack is probably the cause of the problem.
- l. Investigate errors and alarms in the following order:

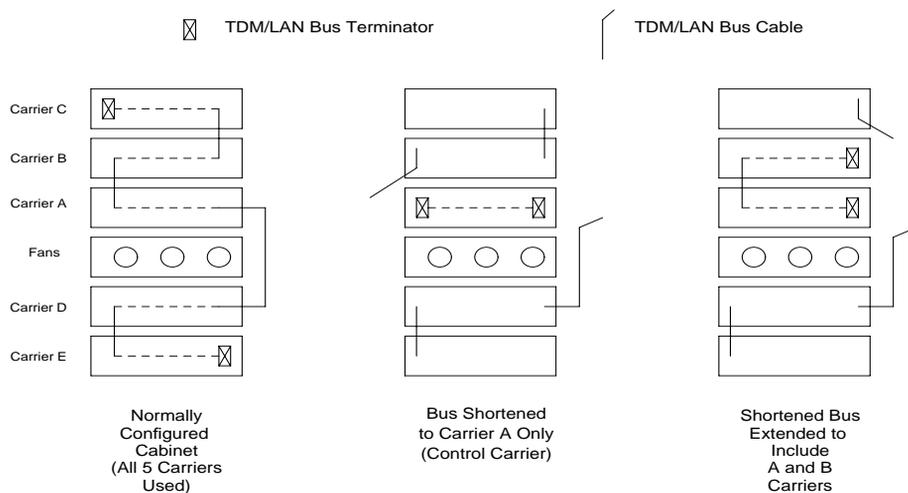
Figure 5-47. Carrier Rewiring Example—Rear View of Multicarrier Cabinet

Procedure 4 consists of two parts. Part 1 attempts to clear the packet bus fault by replacing all the bus cabling and terminators within a port-network. Part 2 attempts to isolate the fault to a particular carrier by extending the packet bus from the control carrier to additional carriers one at a time.

In Procedure 4, the TDM/LAN Cable Assemblies and TDM/LAN termination resistor packs are replaced. If this action does not resolve the packet bus fault, the carriers are reconfigured by moving the termination resistor packs on the carrier backplanes in such a manner that certain carriers are disconnected from the bus. To terminate the packet bus at the end of a particular carrier, unplug the cable that connects the carrier to the next carrier and replace the cable with a TDM/LAN terminator resistor pack (see [Figure 5-47](#)). When the length of the packet bus is modified with this procedure, circuit packs that are essential to system operation (and the TN771D Maintenance/Test in standalone mode) must still be connected to the new 'shortened' packet and TDM busses.

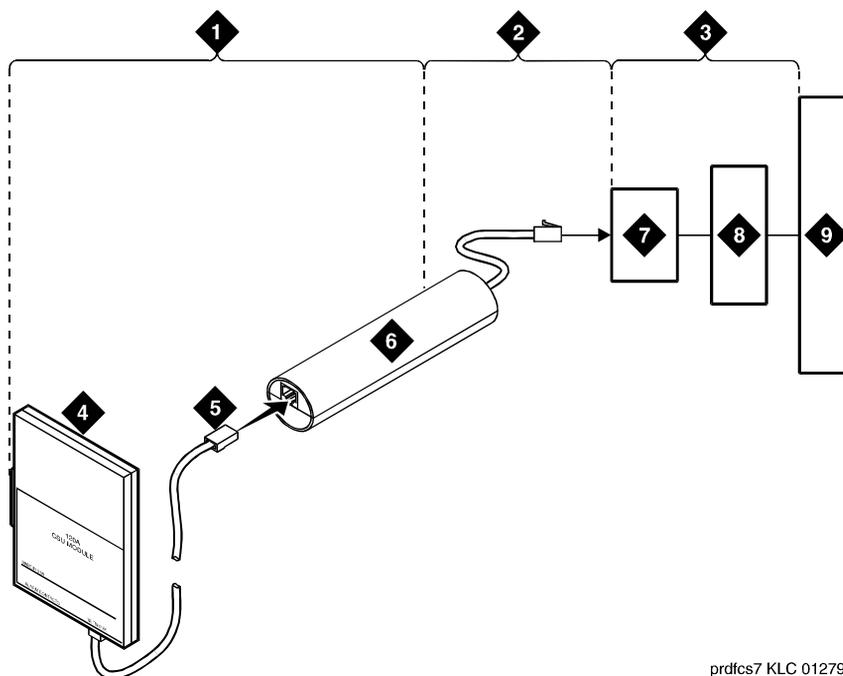
Figure 6-1. Network Interface at Smart Jack

prdfcs7 KLC 012797

1. If there is no extended demarcation point, install the loopback jack directly at the network interface point as shown in [Figure 6-1](#).
2. If there is an extended demarcation point and the Smart Jack is not accessible, install the loopback jack as shown in [Figure 6-2](#).
3. If there is an extended demarcation point, but the Smart Jack is accessible, install the loopback jack as shown in [Figure 6-3](#).

The addition of the loopback jack and the presence of a Smart Jack divides the DS1 span into 3 separate sections for fault isolation. These sections are shown in [Figure 6-1](#) through [Figure 6-3](#) for the different span configurations. They are:

- Test customer premises wiring (section 1 in the following 3 figures) from the ICSU to the loopback jack as described in “DS1 Span Test.”
- Test the CO-to-network interface wiring (section 3 in [Figure 6-1](#)) using the Smart Jack loopback (CO responsibility). Coordinate this test with the DS1 provider.

Fiber MUXes can take the place of Interface termination feeds as shown in [Figure 6-1](#), [Figure 6-2](#), [Figure 6-3](#), and [Figure 6-4](#). Test these spans using the same procedures as metallic spans. Note the following points:

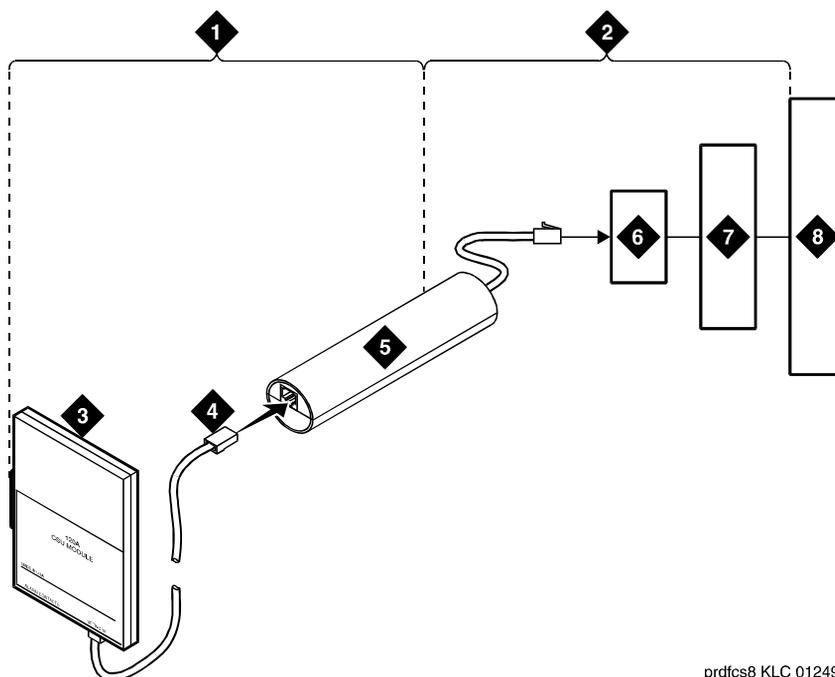
Figure 6-4. Network Interface at "Dumb" Block

When the loopback jack is added to a span that does not contain a Smart Jack, the span is divided into 2 sections. See [Figure 6-4](#) and [Figure 6-5](#).

1. ICSU to the loopback jack.
2. Loopback jack to the Central Office (CO).

1. Install the loopback jack at the point where the cabling from the ICSU plugs into the “dumb” block. If there is more than one “dumb” block, choose the one that is closest to the Interface Termination feed or the fiber MUX. This provides maximum coverage for loopback jack tests. Refer to [Figure 6-4](#) and [Figure 6-5](#).

1. Test customer premises wiring (section 1 in [Figure 6-4](#)) from the ICSU to the loopback jack as described in the "DS1 Span Test" section.

2. Test the loopback jack-to-"dumb" block and "dumb" block-to-CO wiring (section 2 in [Figure 6-4](#)). This can be done using a loopback that "overlaps" the section of the span. Any of the following loopbacks can do this:

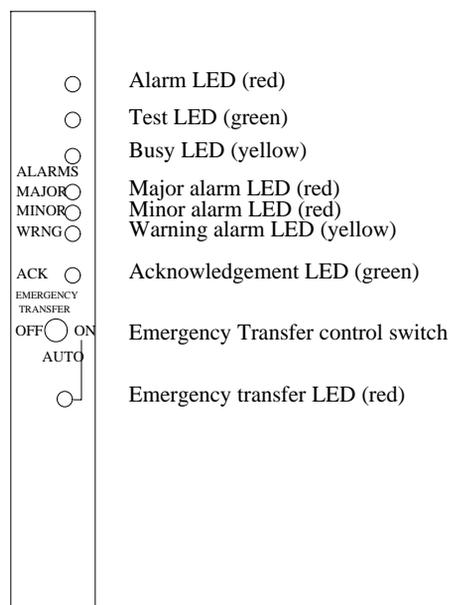
Figure 7-1. SYSAM and EPN Maintenance Circuit Pack LEDs

LED color	State	Level/Function	Interpretation
Red	flashing	MAJOR	Major alarm against a component in the same cabinet, (PPN for SYSAM, and EPN for MAINT).
	solid	MAJOR	Major alarm against a component in another cabinet.
	flashing	MINOR	Minor alarm against a component in the same cabinet.
Red	solid	MINOR	Minor alarm against a component in another cabinet.
Yellow	flashing	WARNING	Warning alarm against a component in the same cabinet.
	solid	WARNING	Warning alarm against a component in another cabinet.
Green	on	ACK	Acknowledged; alarm has been reported to INADS.
Red	on	EMERGENCY TRANSFER	Emergency transfer has been invoked. This occurs upon power-up as well as during disabling failures.

These LEDs are illustrated [Figure 7-1](#).
