DEFINITY[®]

Enterprise Communications Server

Release 8.2

Maintenance for R8r

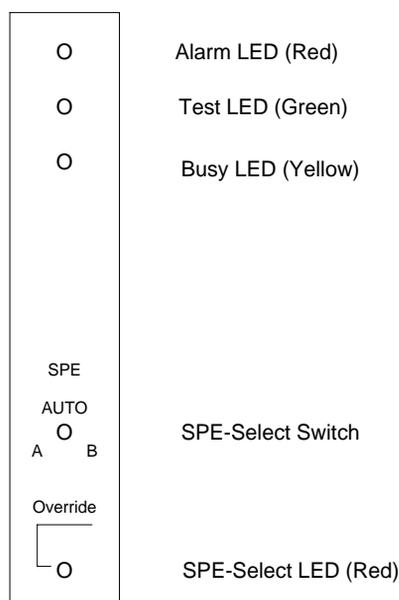
Figure 7-2. Duplication Interface Circuit Pack LEDs

In systems with duplicated SPEs, (High Reliability and Critical Reliability), there are two Duplication Interface UN330B circuit packs. One is located in carrier A and one in carrier B of the PPN. Each circuit pack has four LEDs. The top three have the traditional function of indicating the status of the pack.

The LED located at the bottom of the faceplate directly beneath the SPE Select switch is labeled OVERRIDE. Under normal operating conditions, the SPE Select switch is in the AUTO (center) position, and the OVERRIDE LED remains unlit. This means that the system controls which SPE is active. System selection of the active SPE can be manually overridden by moving the SPE Select switches from the AUTO position to either the "A" position or the "B" position on both Duplication Interface circuit packs. At this time, the red OVERRIDE LEDs on both Duplication Interface circuit packs will light steadily to indicate that one SPE is locked Active and the system is not duplicated. If both SPE Select switches are not in the same position, the system software retains control of Active SPE selection, and the OVERRIDE LED remains unlit. When control of the SPE selection is returned to the system by returning the SPE Select switches on both Duplication Interface circuit packs to the AUTO position, the OVERRIDE LED will go dark. Forced SPE selection should be undertaken only after consulting the appropriate sections in [Chapter 9, "Maintenance Object Repair Procedures"](#).

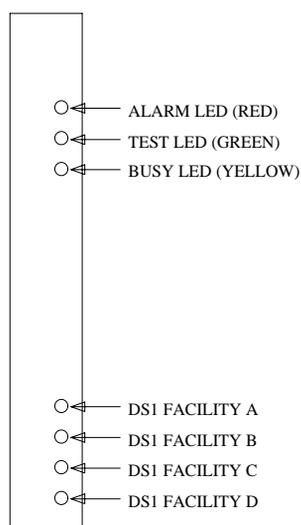
Figure 7-3. TN574 DS1C Circuit Pack LEDs

Below the three standard LEDs on the DS1C circuit pack are four green LEDs used to indicate whether a receive signal is present for each of the four DS1 facilities. [Figure 7-3](#) shows which facility (A, B, C, or D) corresponds to each LED. If a green LED is off, there is a Loss of Signal condition on the DS1 facility associated with that LED. The presence of a signal does not guarantee that the signal is using the correct framing format or line coding; an Alarm Indication Signal indicating that the opposite end of the DS1C complex is out of service may be present.

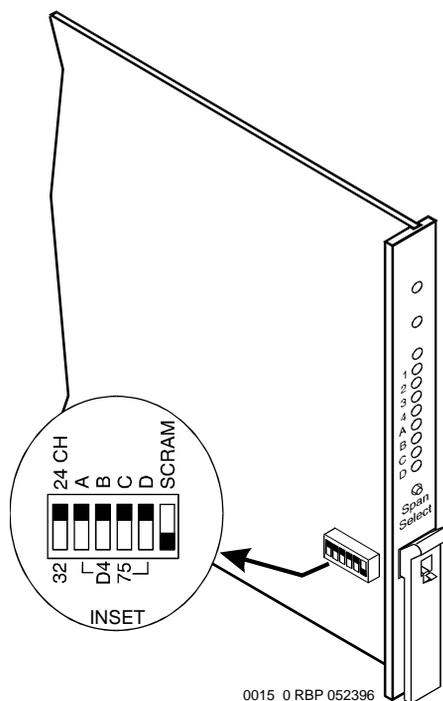
Figure 7-4. TN1654 DS1CONV Circuit Pack

The next four LEDs on the TN1654 DS1CONV board are labeled STATUS LEDs and are for future use. These LEDs will not be lit.

The bottom four LEDs on the TN1654 board are labeled SPAN LEDs. These LEDs are under firmware control. If the facility is not administered, then the LED is not lit. The LED is lit amber if the facility is running alarm free. If the facility is detecting either a red alarm (loss-of-signal or loss-of-frame), a yellow alarm (remote frame alarm) or a blue alarm (AIS signal) then the LED is lit red. The SPAN SELECT Switch on the TN1654 faceplate is for future use. Pushing the switch will have no effect on the board. See [Figure 7-4](#) for a view of the face plate on the TN1654 DS1CONV circuit pack.

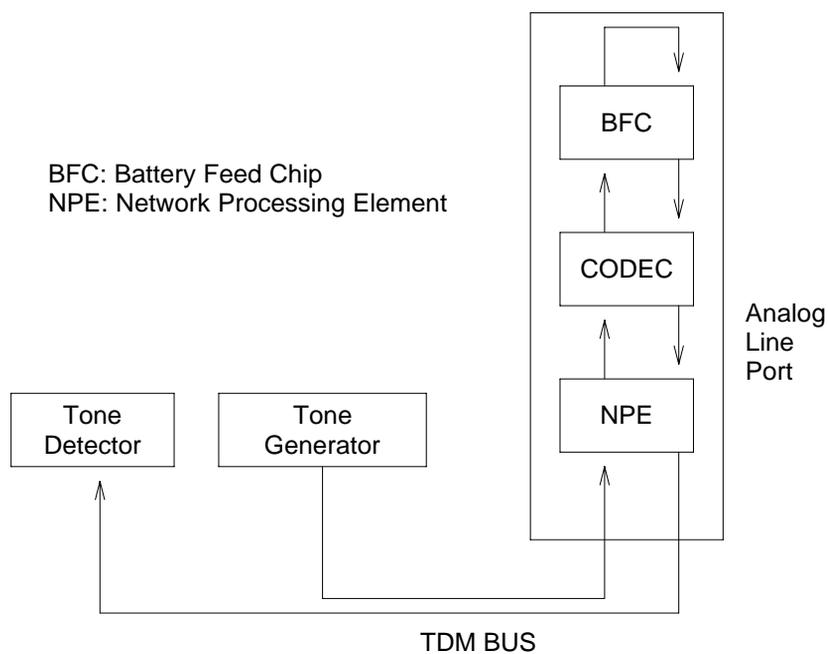
Figure 9-1. Analog Looparound and Conference Test

This test is designed to check the on-board transmission capabilities of the NPE, the codec, and the battery feed chip of the Analog Port. A Tone Detector and a Tone Generator talk and listen on the same pair of time slots as the Analog Port. The Analog Port is then instructed to go into loop around mode (see [Figure 9-1](#)). The test passes if the signal measured by the Tone Detector is within acceptable limits.

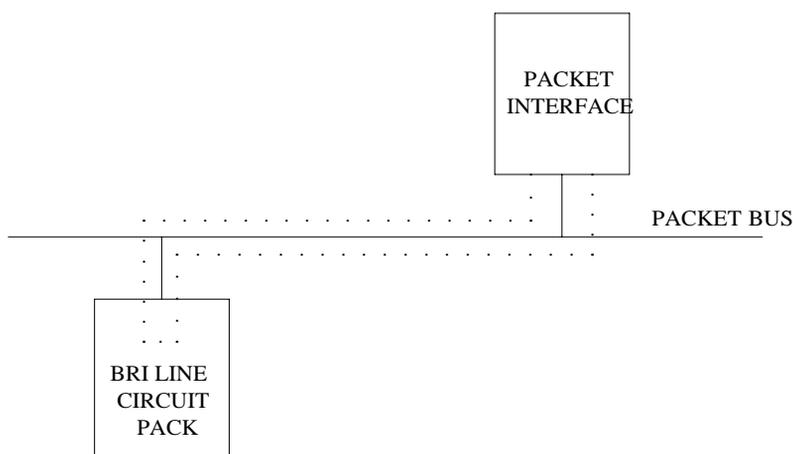
Figure 9-2. BRI Port Local LAN Looparound Path

This test verifies the connectivity of a BRI port across the LAN Bus and executes only if the port is out-of-service. The test aborts if calls associated with the port are in-progress. Failures of this test indicate either on-board faults associated with the ASAI-PT hardware on the circuit pack or problems with the LAN Bus, which is used to form connectivity between the switch and the ASAI-PT.

The dotted lines in [Figure 9-2](#) show how a Looparound Test is performed across the Packet Bus for the D-channel.

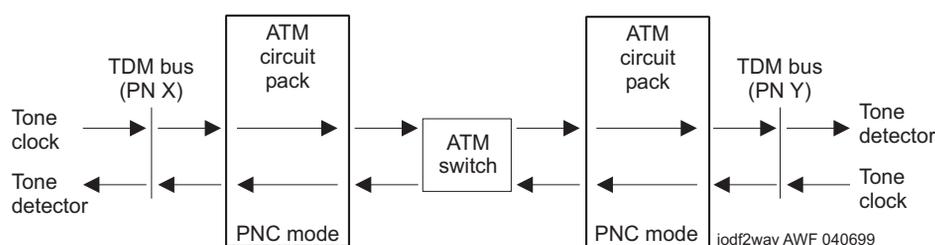
The test results indicate if the test failed in one or both directions. The test aborts if the ATM-EIs do not exist on both ends (for example, the EIs are not administered correctly). If the test passes, the TDM and ATM framer interfaces of both ATM-EIs are functioning properly. If the test fails, a series of tests are run on the board. [Figure 9-3](#) shows a schematic of this test.

Figure 9-3. Expansion Interface 2-Way Transmit Test #241
PN X and PN Y represent any of 43 possible port networks.

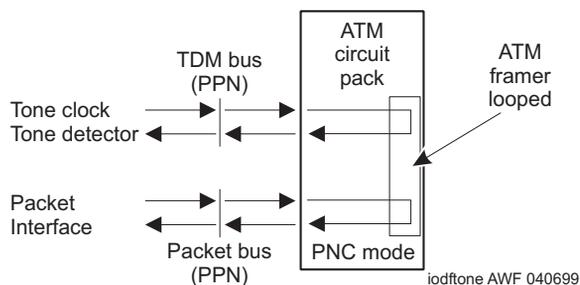
Figure 9-5. ATM Board Framer Looparound Test (#1260)

- **The circuit (TDM) path:** one of the tone generators sends a bit pattern through a TDM bus time slot to the ATM framer. The pattern is converted into ATM cells and looped back to the ATM-EI board, which converts the cell back into the bit pattern and puts it on a pre-determined time slot. A tone detector tests for the bit pattern and reports the test result. This test verifies that a large portion of the ATM-EIs circuit paths are functioning correctly. [Figure 9-5](#) shows a diagram of the test.

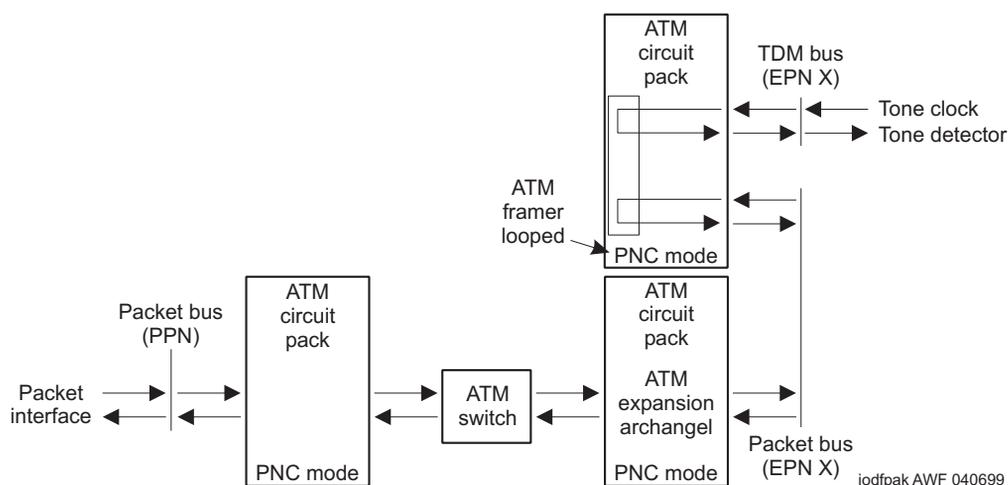
**Figure 9-6. ATM Board Framer Looparound Test (#1260)
(non-EAA, Packet Path)**

- **Packet path:** the Packet Interface circuit pack sends packet data to the ATM framer interface, where it is mapped into ATM cells and then looped around internally. The cells are converted back to packet data after it has been looped. This portion of the test verifies correct operation of the ATM-EI's Packet bus interface and a large portion of the ATM-EI's packet paths. [Figure 9-6](#) shows the packet switched signal path for the ATM circuit pack.

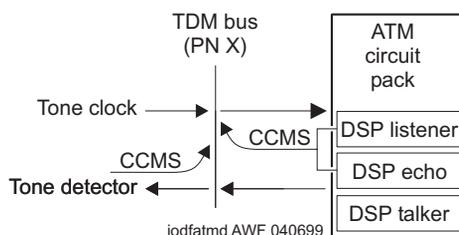
Figure 9-8. ATM Board DSP Test (#1293)

If the test fails for all DSPs, a MAJOR alarm is raised against the board. If the test fails for one or more DSPs, a MINOR alarm is raised. If a DSP is "busy," the test for that particular DSP is considered passed. The test aborts if the system resources (for example, the TDM time slots, tone generator, and others) are not available.

This test applies to TN2305 and TN2306 ATM-EIs, both active and standby, and is run as part of craft short and long testing, periodic, scheduled, initialization, and error analysis testing. Refer to [Figure 9-8](#) for a diagram of this looparound test.

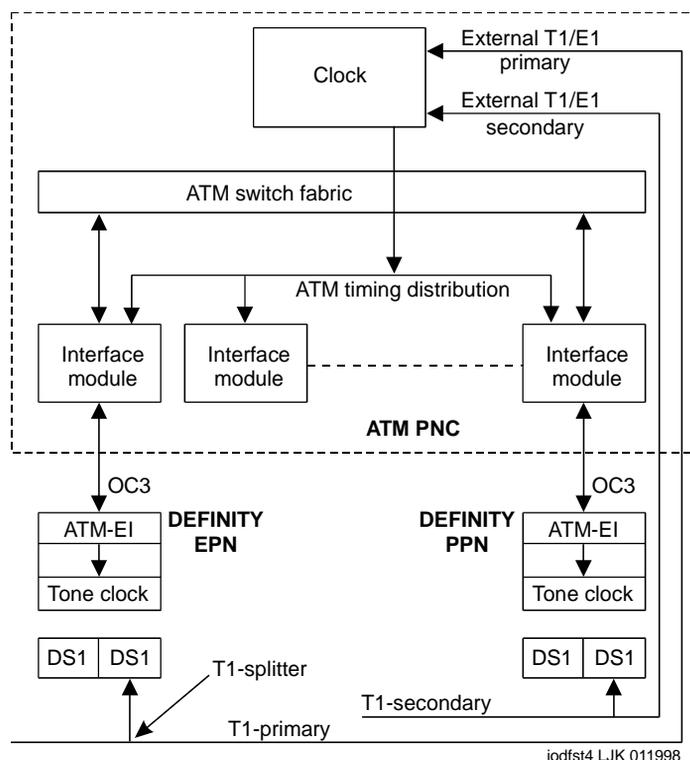
Figure 9-10. Stratum 4 synchronization with simple ATM PNC

If the primary synchronization reference in [Figure 9-10](#) is providing a valid timing signal, then the flow of system synchronization would travel from the DS1 interface circuit pack in the EPN to the ATM switch. The primary DS1 interface circuit pack provides a timing signal for the ATM switch clock circuitry. This synchronization source is then distributed to all of its OC3 Interface Modules. Each ATM Expansion Interface circuit pack uses the received data stream from the ATM switch to generate a timing signal. The Tone-Clock circuit packs in the EPNs use this signal to generate timing for all the circuit packs in their respective EPNs. All PN, in the above mentioned scenario are designated the *slave* port networks. The ATM switch is the *master* that contains the system synchronization source. If the primary synchronization reference does not provide a valid timing signal, ATM synchronization maintenance infers a switch to the secondary reference.

If the primary synchronization reference is not providing a valid timing signal, the system automatically switches to the secondary synchronization reference. If the primary synchronization reference is invalid, and if the secondary reference does not provide a valid timing signal or is not administered as a synchronization reference, the switch infers that the local oscillator of the ATM switch provides the system timing source. If the system is using the local oscillator of the ATM switch as the system timing source because the primary and secondary references are providing invalid timing signals, when either the primary or secondary reference becomes valid again, the system switches back to the primary or secondary source. When both the primary and secondary source become valid, the system switches to the primary source, since the primary source is always preferred over the secondary source when both sources are equally healthy.

[Figure 9-10](#) depicts a simplex ATM PNC with T1/OC3 synchronization reference into the ATM switch.

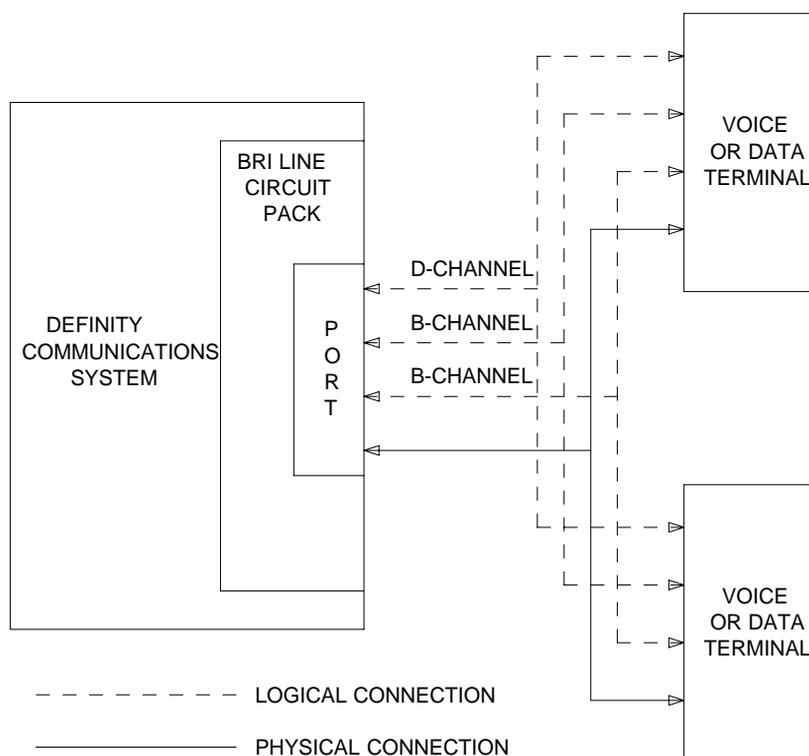
Figure 9-11. ISDN-BRI Port Interactions

[Figure 9-11](#) illustrates the physical connection (solid line) between an ISDN-BRI Port and its associated ISDN-BRI set(s). Each physical connection allows for two B-channels and one D-channel. Each ISDN-BRI circuit pack can support up to 12 of these *physical* connections to different voice and voice/data sets or ASAI or Lucent adjuncts. On a TN2198 each ISDN-BRI circuit pack can support up to 12 *physical* connections to a NT1 which in turn connects to 2 terminals.

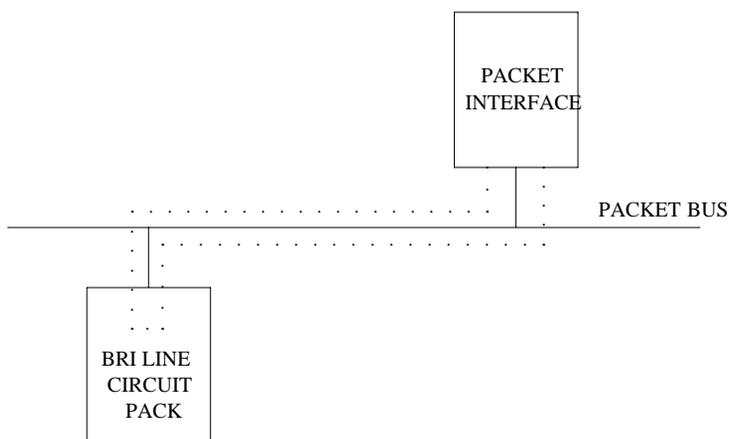
Figure 9-12. Path of the BRI Port Local LAN Loop Around

This test, which verifies the connectivity of a BRI port across the LAN Bus, executes only if the port is out-of-service. The test aborts if calls associated with the port are in-progress. Failures of this test indicate either on-board faults associated with the BRI-PORT hardware on the circuit pack, or problems with the LAN Bus, which is used to form connectivity between the switch and the BRI-PORT.

The dotted lines in [Figure 9-12](#) show how a Loop Around Test is performed across the Packet Bus for the D-channel.

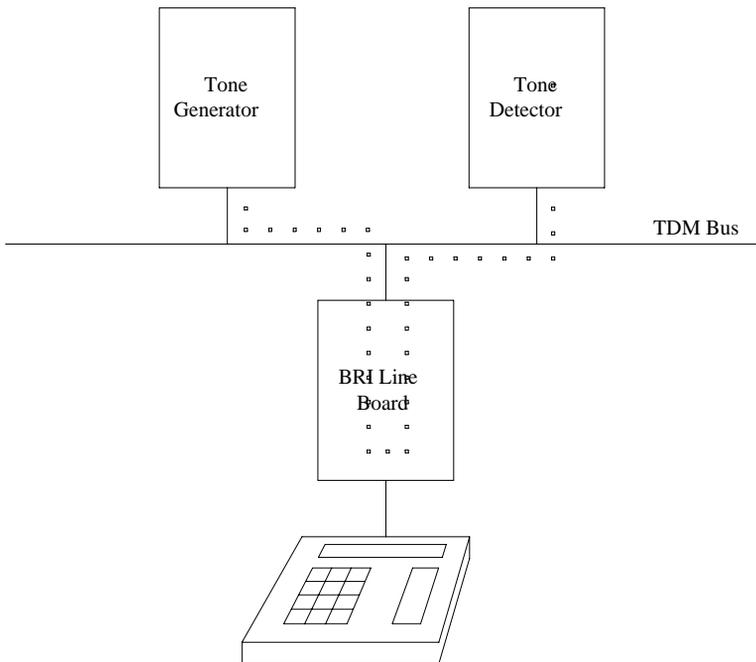
Figure 9-13. Path of the BRI Port Local TDM Loop Around

The dotted lines in [Figure 9-13](#) show how a Loop Around Test is performed for the B-channels. The figure shows a terminal connected to a BRI line board using a TN556. If a TN2198 is used the terminal would be connected to a NT1, and the NT1 to the BRI board.

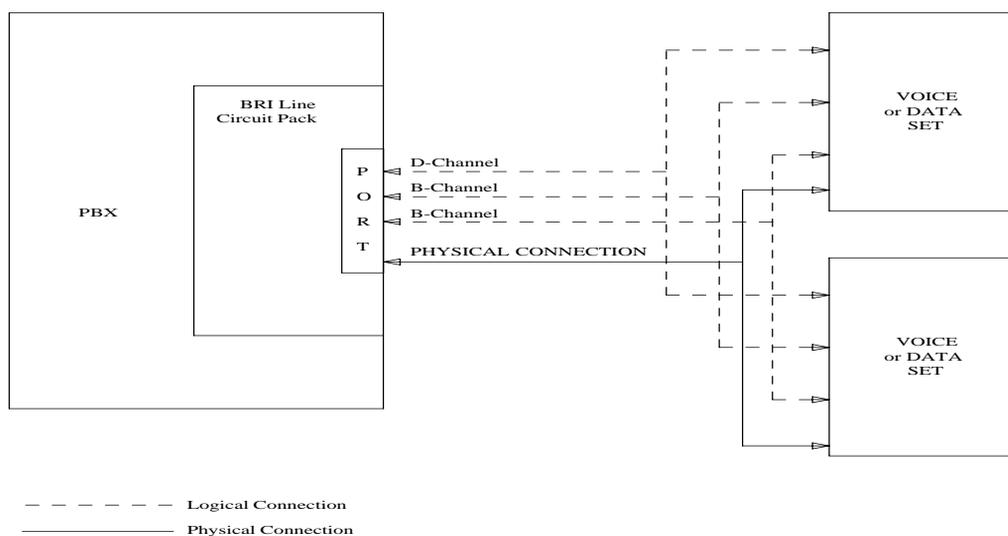
Figure 9-14. ISDN-BRI Set Interactions

[Figure 9-14](#) illustrates the physical connection (solid line) between an ISDN-BRI Circuit Pack and a voice or voice/data set. Each physical connection allows for two B-channels, as stated above, plus one D-channel. Each ISDN-BRI circuit pack can support up to 12 of these PHYSICAL connections to different voice and voice/data sets or ASAI and Lucent adjuncts.

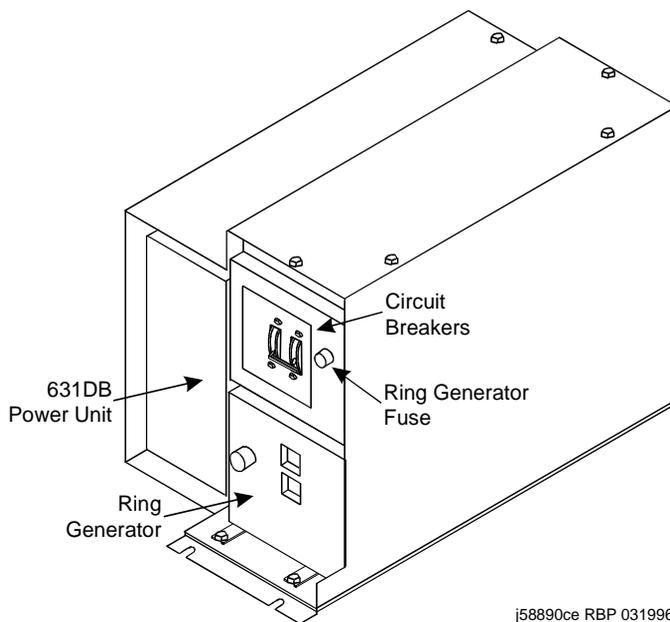
Figure 9-15. AC Power Distribution Unit (J58890CE-2) — Front

[Figure 9-15](#) shows an AC Power Distribution Unit (List 9 or List 10). This unit sits at the bottom of some Multi-Carrier Cabinets.

The AC Power Distribution Unit contains the following components:

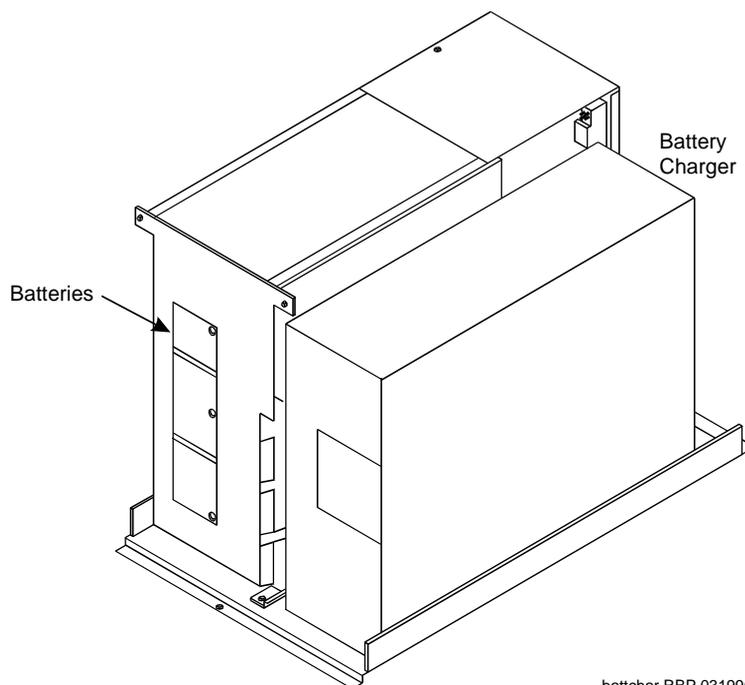
battchar RBP 031996

The optional battery charger (List 11) sits at the bottom of some Multi-Carrier Cabinets. See [Figure 9-16](#).

Figure 9-16. Battery Charger (Optional Part of J58890CE-2) — Front

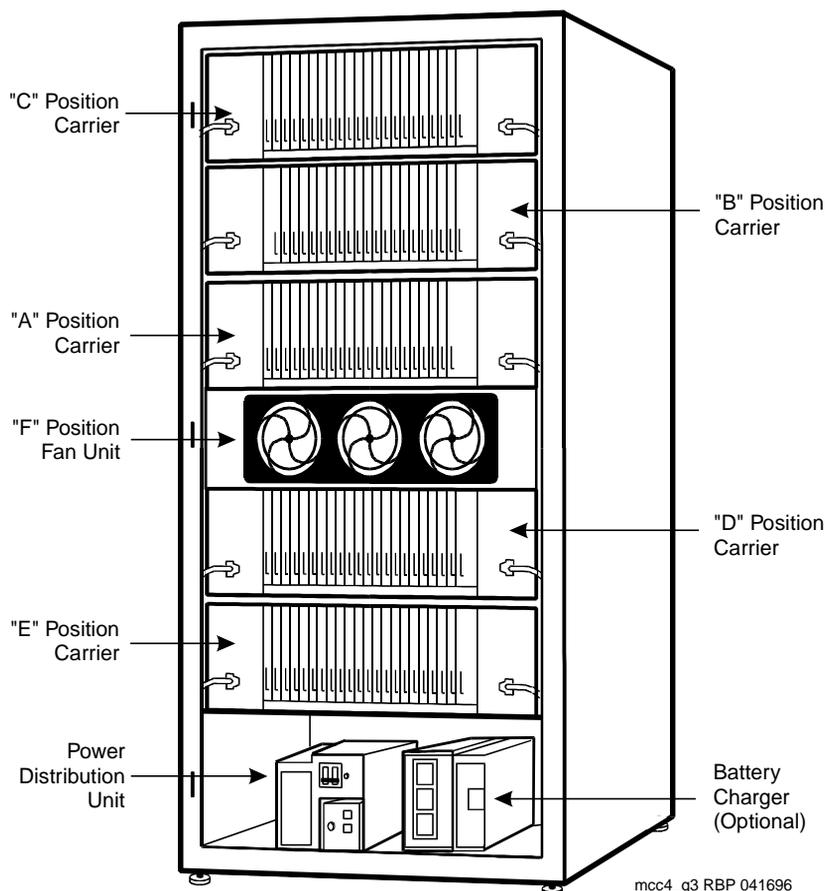
Figure 9-17 shows AC power distribution in some Multi-Carrier Cabinets. The DC power distribution cables are on both sides of the cabinet. These cables supply power to each of the carriers. The optional battery charger is at the right side of the power distribution unit.

Figure 9-17. AC Power Distribution in Multi-Carrier Cabinets

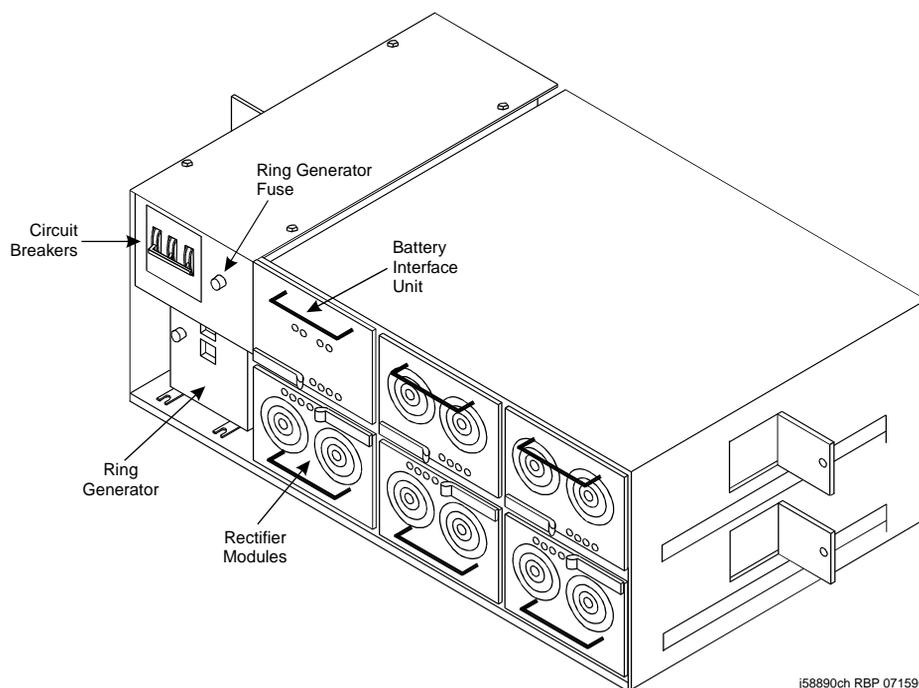
In AC powered cabinets, the power distribution unit (J58890CH-1), distributes 170 to 264 VAC from a wall outlet to a set of BU3200A Battery Interface Units (BIU). See [Figure 9-18](#) and [Figure 9-19](#).

Figure 9-18. AC Power Distribution Unit (J58890CH-1) — Front

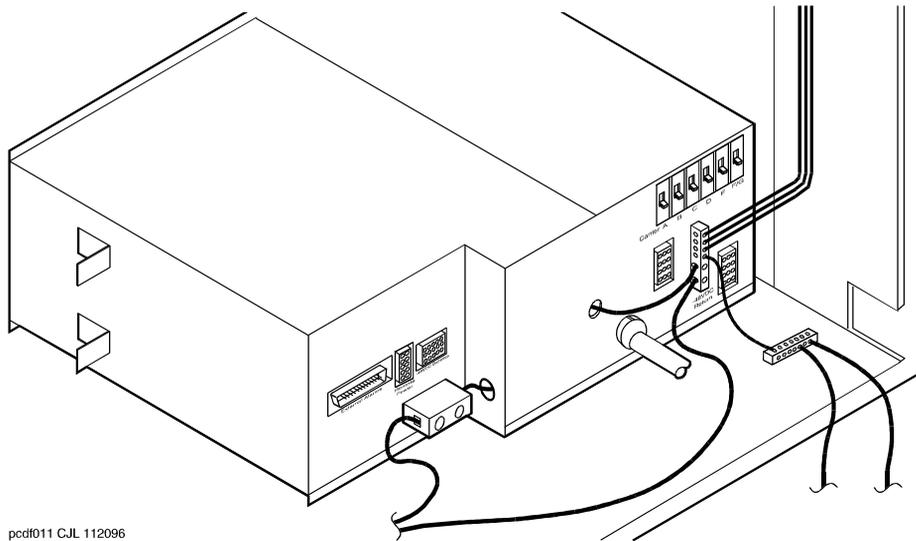
pcdf011 C.JL 112096

Figure 9-19. Power Distribution Unit (J58890CH-1)

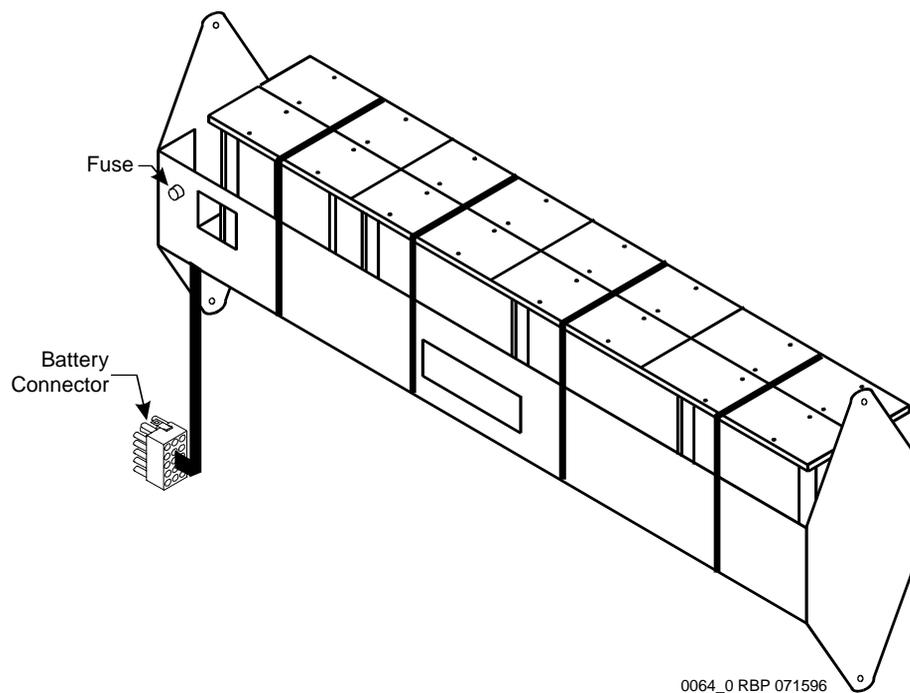
[Figure 9-20](#) shows the small battery assembly.

Figure 9-20. Small Battery Assembly

The small batteries provide short-term battery holdover. If AC power fails, 48 VDC batteries power the system for 10 seconds in a PPN cabinet, for 15 seconds in an EPN cabinet, and for 10 minutes in the control carrier in a standard reliability system. The batteries also provide system power for five minutes in the control carrier in high and critical reliability systems, and for 10 minutes in the expansion control carrier in the "A" position of an EPN cabinet (Release 5r only).

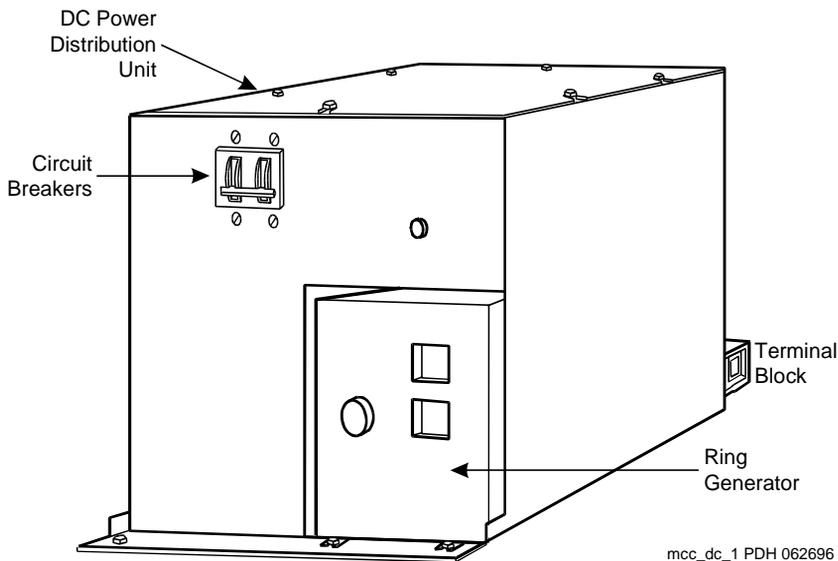
[Figure 9-21](#) shows a power distribution unit in some DC-powered Multi-Carrier Cabinets. The unit sits at the bottom of the cabinet and contains the ring generator, 20 Amp circuit breakers, terminal blocks, and system fan power.

Figure 9-21. DC Power Distribution Unit (J58890CF-2) — Front

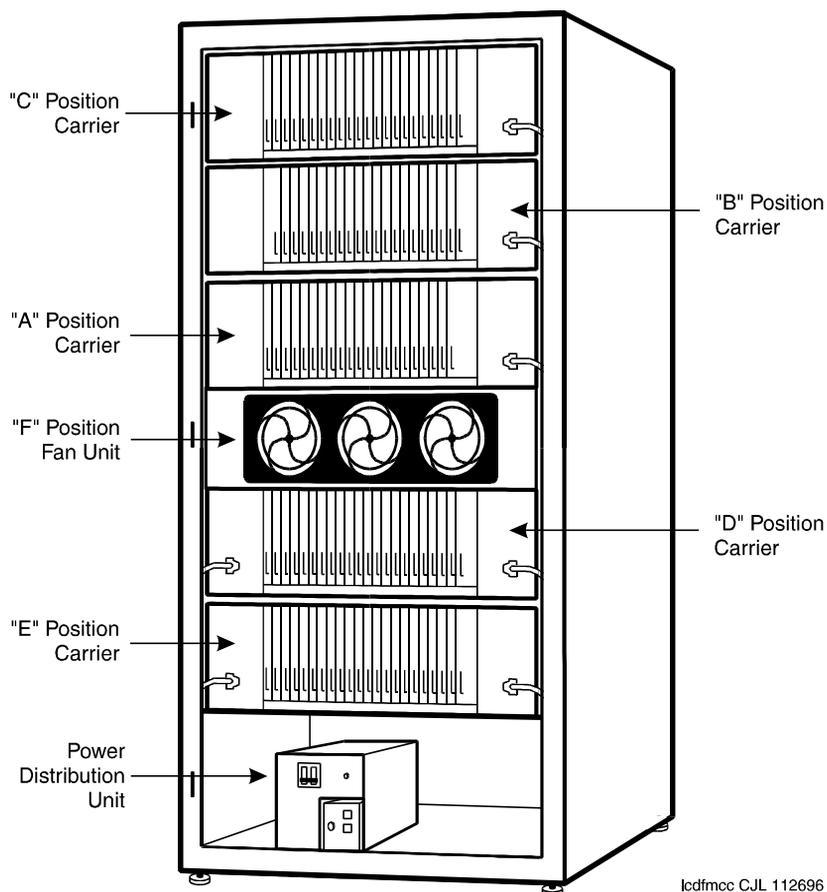
[Figure 9-22](#) shows a typical AC powered Multi-Carrier Cabinet.

Figure 9-22. Typical Multi-Carrier Cabinet with 649A Power Units

Some carriers may contain two power supplies, the 644A and the 645B, which together supply the required voltages to the carrier. Other carriers may contain one 649A power supply located on the right side of the carrier. In these systems, an additional 649A is located on the right of the optional switch node carriers.

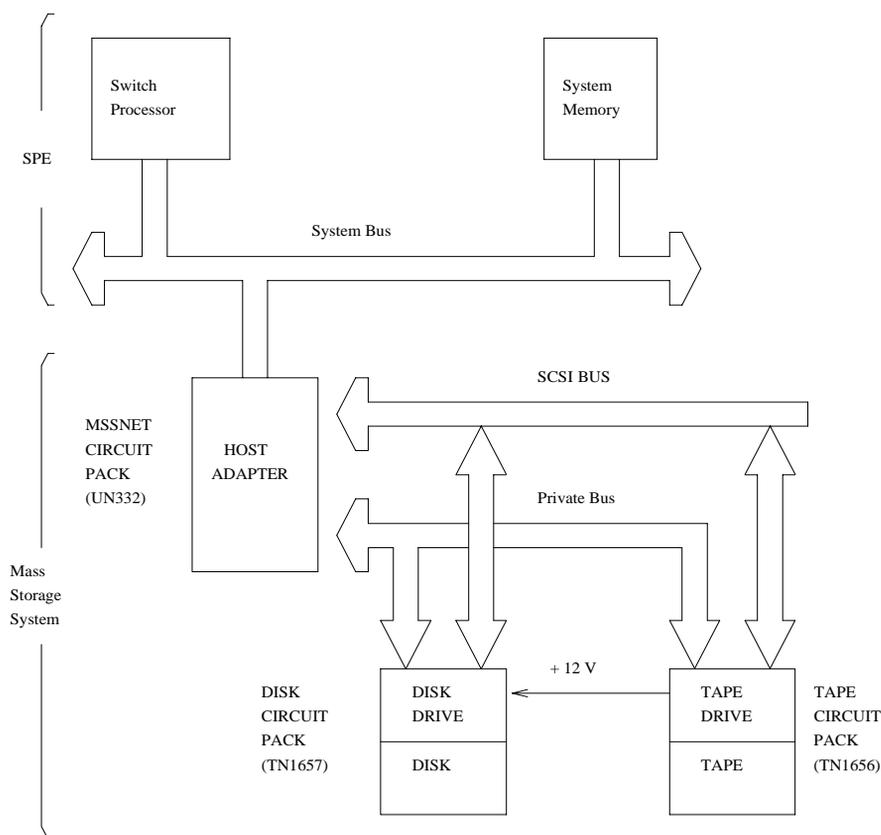
Figure 9-23. Mass Storage System Interactions

The TN1657 Disk circuit pack is part of the Generic 3r Mass Storage System (MSS). The MSS provides non-volatile storage for system software, translation data, announcement data and program update data. As shown in [Figure 9-23](#), the MSS consists of a Host Adapter circuit on the UN332 MSS-Network Control circuit pack (MSSNET), a Small Computer System Interface (SCSI) bus, a TN1656 Tape circuit pack or a TN2211 Optical Disk circuit pack, and the TN1657 Disk Drive circuit pack. The Disk Drive acts as the primary storage device and the Optical Disk or Tape Drive serves as a backup device (also known as removable media device).

A -48V to +12V converter circuit on the Removable Media circuit pack provides power for both the Removable Media Drive and the Disk Drive. The presence of +12V on these circuit packs is monitored separately by maintenance software so that a failure of the +12V converter on the Removable Media circuit pack can be identified or ruled out as the source of the problem when the Disk Drive loses +12V power.

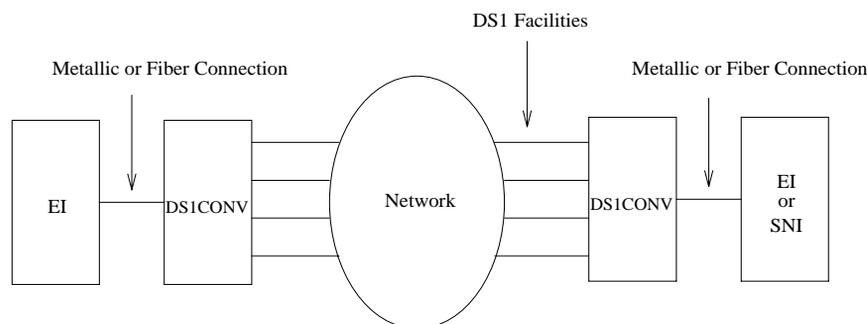
DS1 CONV circuit packs are connected to the Expansion Interface (EI) circuit packs (TN570) and the Switch Node Interface (SNI) circuit packs (TN573) as shown in [Figure 9-25](#).

Figure 9-25. DS1 CONV Complex and the DS1 Facilities

The DS1 CONV Complex can replace fiber links between two EIs and fiber links between an EPN EI and an SNI. Fiber links between two SNIs and fiber links between the Processor Port Network (PPN) and the Center Stage Switch (CSS) cannot be replaced by a DS1 CONV Complex.

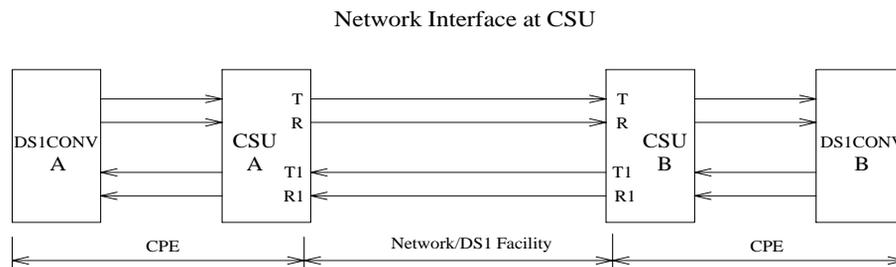
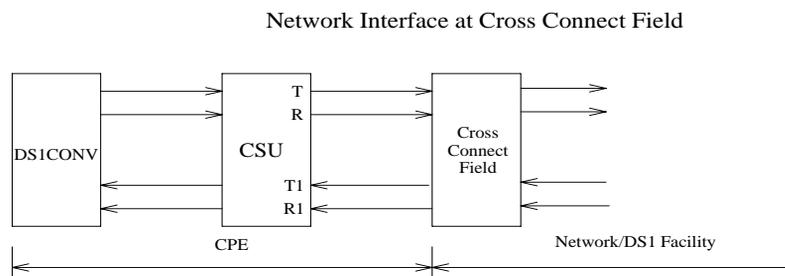
Figure 9-26. DS1 Facility Connections

The DS1 facility line signal is pre-equalized at the transmitter on the DS1 CONV circuit pack so that DS1 line pulses have correct amplitude and shape when they reach the Network Interface (see [Figure 9-26](#)). The amount of equalization necessary is determined by the distance to the Network Interface and also by the type of wiring used to connect to the Network Interface. If the equalization is not set to the correct value, potentially high error rates (errored seconds) will be observed on the DS1 facility. Equalization values are determined as follows:

For the following repair procedure, refer to [Figure 9-26](#) and the diagrams in the related test descriptions.

- 1. Check the loopback LEDs on both CSU A and CSU B as shown in [Figure 9-26](#) to see if a CSU is in a loopback mode. Also check to see if the CSUs have been manually hard-wired into a loopback mode. Remove detected loopbacks.

To isolate a problem, set the loopback first at the loopback point **LB 1**, and then at the loopback point **LB 2**, see [Figure 9-29](#) and [Figure 9-26](#). Place the loopbacks at as many points as your CSU capabilities will allow. Hard-wired loopbacks at the far end are not desirable, because the equalization level adjustments may cause problems.

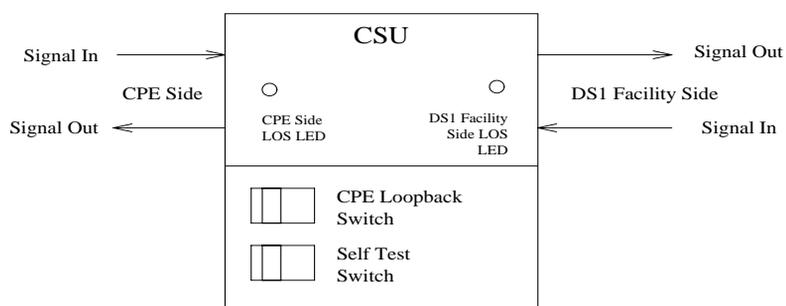
Figure 9-27. Typical CSU Maintenance Capabilities

Fault isolation for this problem may be different depending on the capabilities of the CSU device that is being used. Typically, CSUs provides an LED that is useful for fault isolation (see [Figure 9-27](#)). This is the "16 Zeros" LED. This LED is momentarily lit when a string of 16 consecutive zeros is detected in the DS1 signal from the DS1 CONV. Zeros on a DS1 link are represented by an absence of a pulse. Thus, an active 16 Zeros LED indicates a LOS alarm from the DS1 CONV.

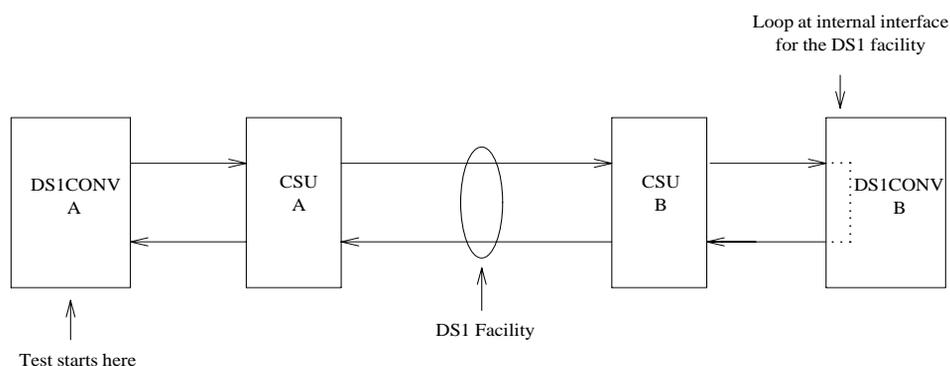
Figure 9-28. Far-End Internal Loopback Test (#797)

On a Standard Reliability and High Reliability System (no PNC duplication), if there is only one DS1 facility available, then this test can only be executed at the end-point which is closer to the SPE relative to the neighbor DS1 CONV circuit pack because of its impacts on the system control links. For TN574 DS1 CONV boards, the completion of the test will be delayed in this configuration to wait for the recovery of the system control links. On a Critical Reliability System (PNC Duplication), or when there are multiple DS1 facilities, the test can be executed at any DS1 CONV circuit pack.

If the test passes on a TN1654 DS1 facility, the *round trip delay time* will be displayed in milliseconds in the *Error Code* field. The round trip delay time is defined as the length of time in milliseconds it takes for the firmware to receive the test pattern after it has been sent.

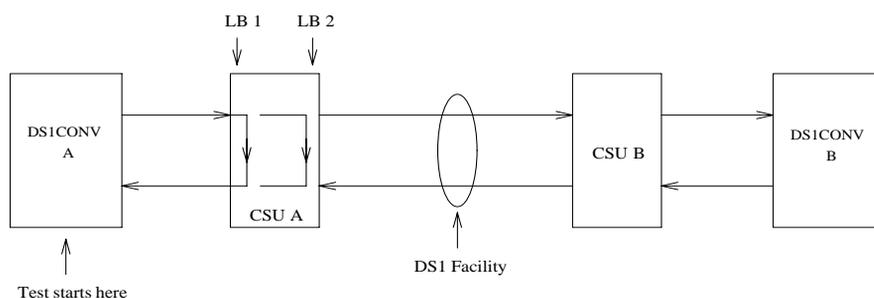
Figure 9-29. Loopback Points for Test #799

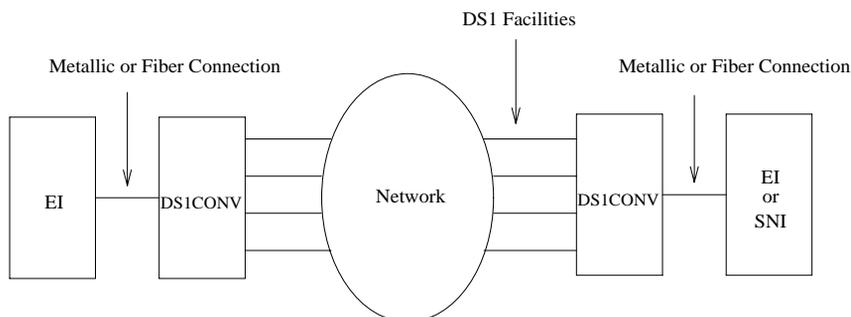
Figure 9-30. DS1 CONV connection to EIs and SNIs

DS1 CONV circuit packs connect to TN570 Expansion Interface (EI) circuit packs and TN573 Switch Node Interface (SNI) circuit packs via metallic cables as shown in [Figure 9-30](#). A fiber link cable can be used instead of the metallic cable if it is necessary to locate the DS1 CONV far from the connected EI or SNI circuit pack, for example, in an adjacent cabinet.

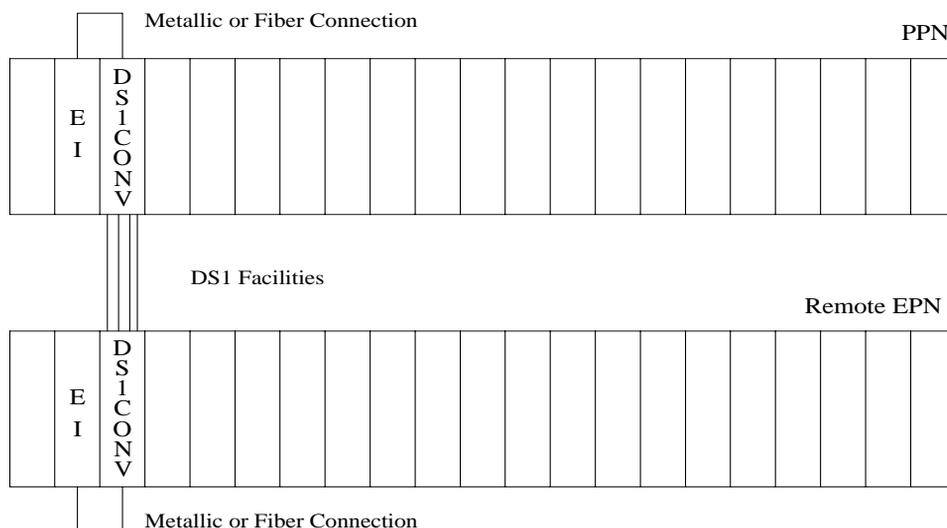
Figure 9-31. DS1 CONV Complex in Direct Connect PNC

[Figure 9-31](#) and [Figure 9-32](#) show DS1 CONV connections in a direct connect PNC configuration and between the CSS and an EPN in a Critical Reliability System configuration (duplicated PNC).

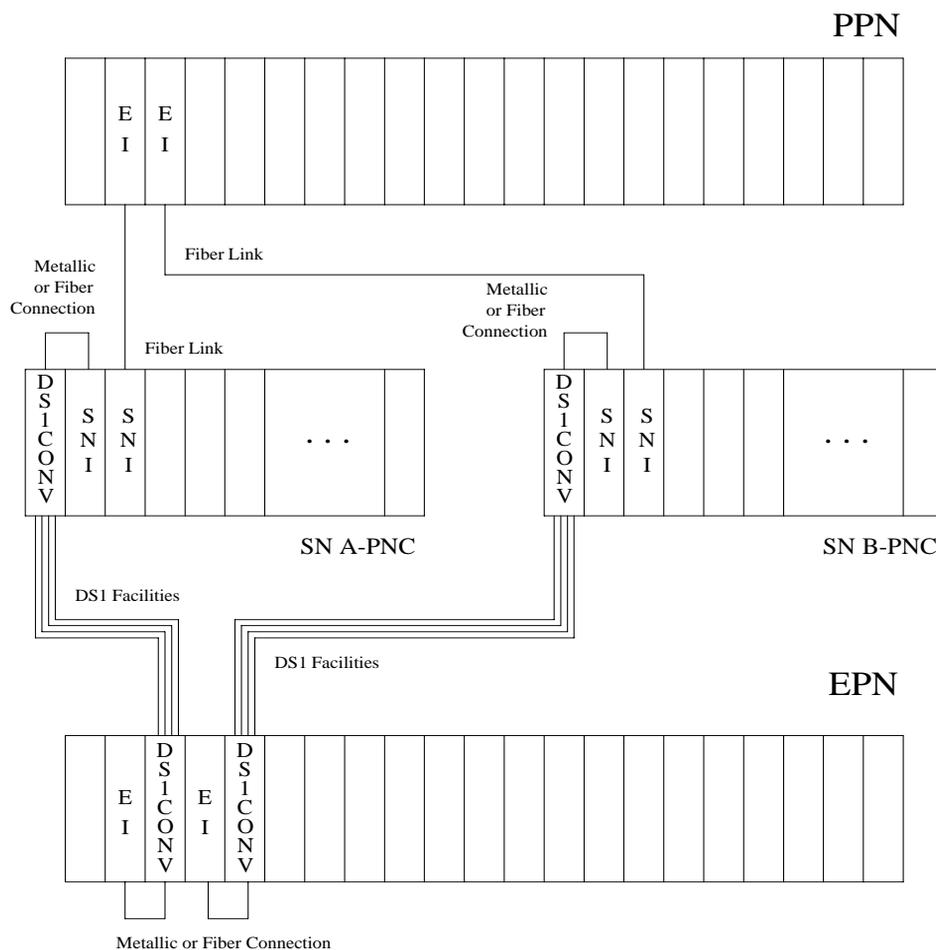
Figure 9-32. DS1 CONV Complex in Duplicated PNC with 1 SN

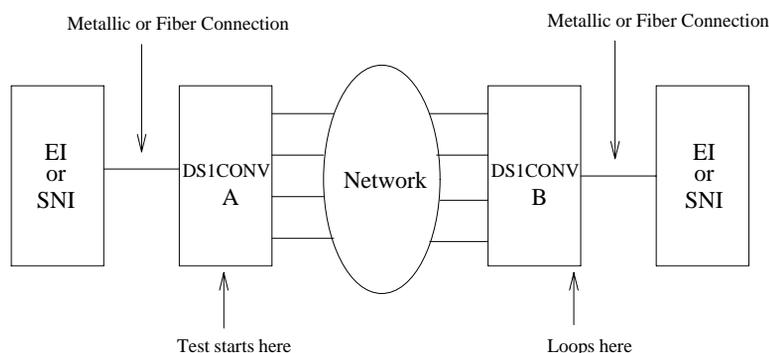
Every part of this test is executed under firmware control and the result is sent back to the maintenance software. Test is executed by sending digital data through every administered DS1 facility channel. Two different test patterns are used, these are hexadecimal values 55 and AA.

Figure 9-33. Far-end DS1 CONV Loopback Test (#788)

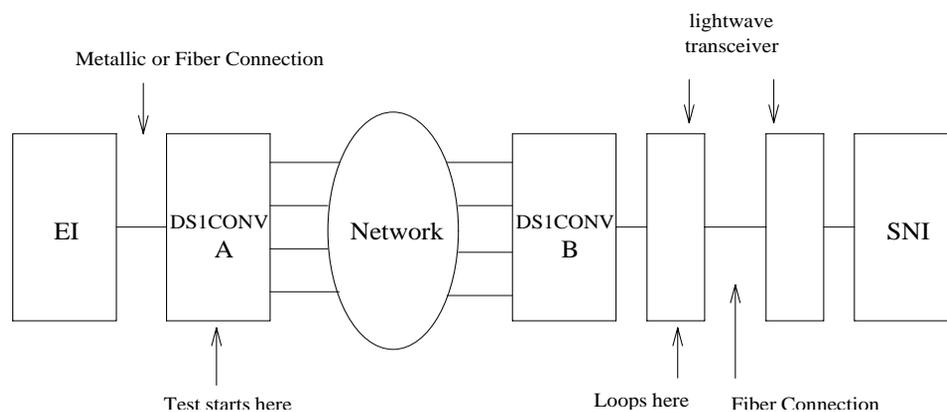
Every part of this test is executed under firmware control and the result is sent back to the maintenance software. Test is executed by sending digital data through every DS1 facility channel. Two different test patterns are used, these are hexadecimal values 55 and AA.

Figure 9-34. Far-end Lightwave Transceiver Loopback Test

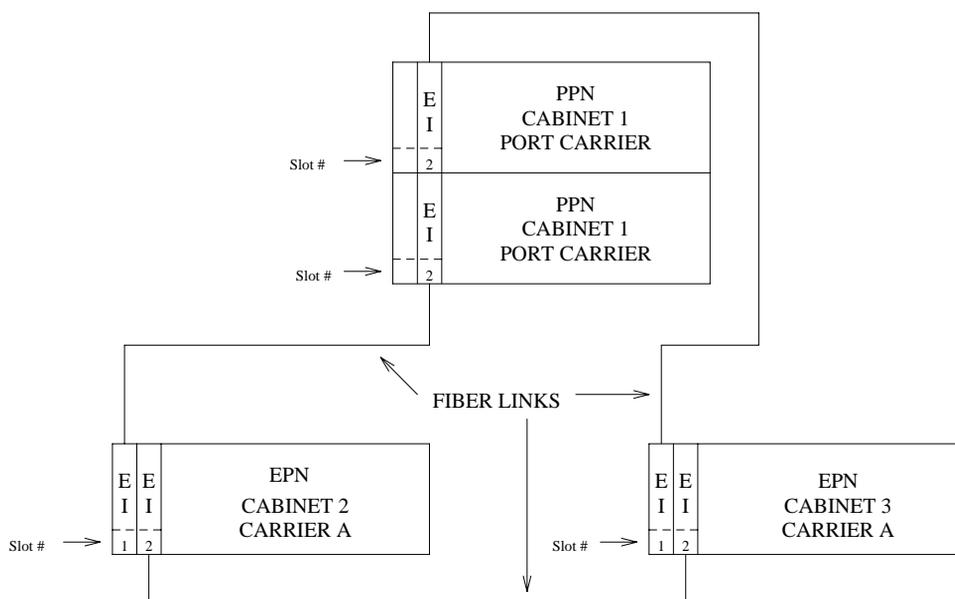
[Figure 9-35](#) shows the location of the EI circuit packs in a typical simplex PNC, direct connect configuration.

Figure 9-35. Direct Connect Configuration with Simplex PNC

Each Port Network in direct connect configurations must be connected to each other port network through a fiber link. Each EPN has one EI that functions as an archangel. This EI must be connected with fiber to an EI located in the PPN. If an EI is functioning as an archangel (bus master), its yellow led will be flashing at a rate of 2 seconds on and 200 ms off.

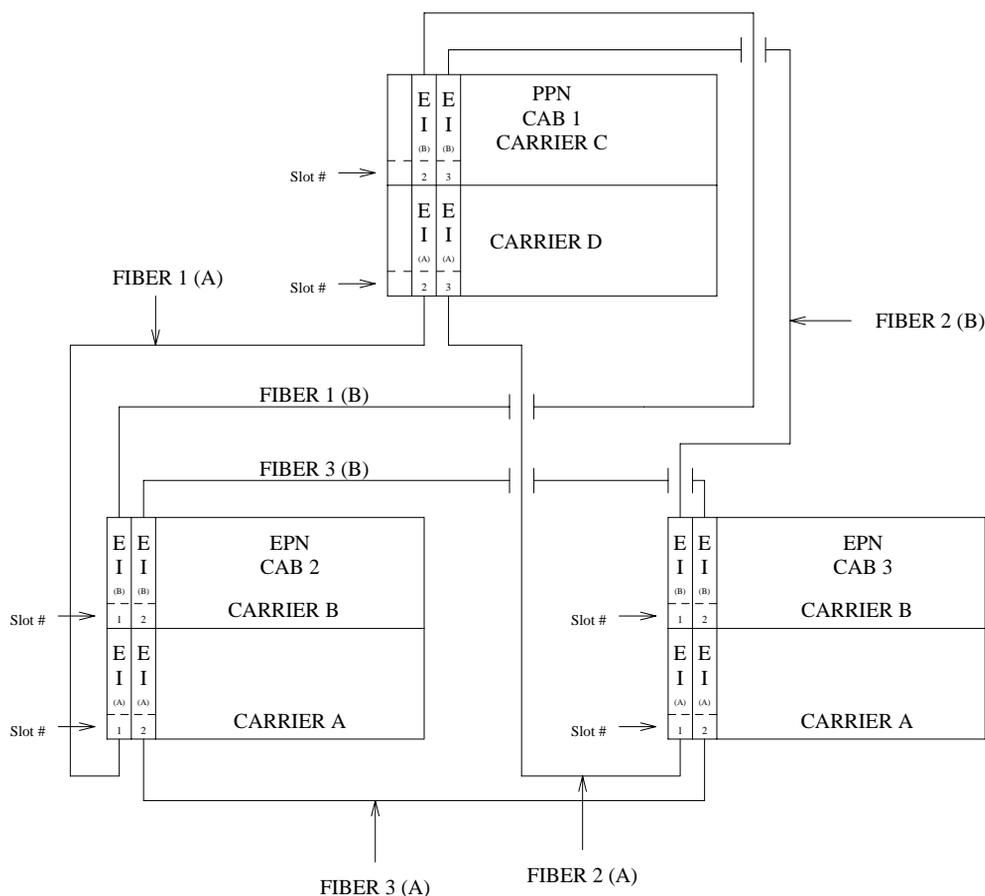
[Figure 9-36](#) shows the location of EI circuit packs in a typical duplicated PNC, direct-connect configuration.

Figure 9-36. Direct Connect Configuration with Duplicated PNC

In a duplicated PNC there is an A-side PNC and a B-side PNC. All EIs in this diagram are labeled with an A or a B to designate which PNC they are a part of. Note that the PNC designation (A or B) does not relate directly to carrier location. Again, only one of the EIs in an EPN can function as an archangel (TDM Bus Master). The EI that is on the active PNC and that is connected to the PPN is the only one that can function in this mode. In normal operation, its yellow LED should be blinking at a rate of 2 seconds on and 200 ms. off.

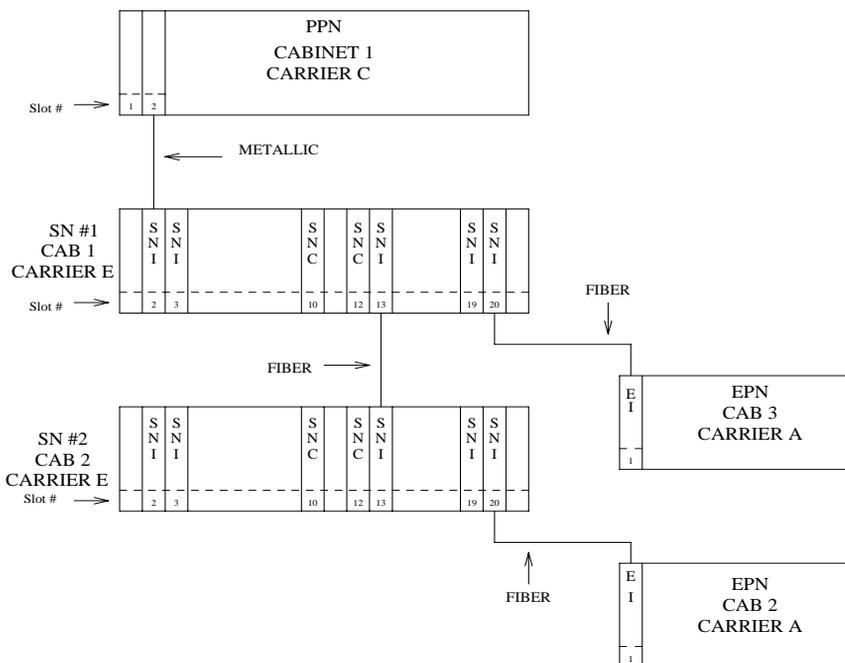
[Figure 9-37](#) shows the location of EIs in a typical center stage switch configuration with simplex PNC.

Figure 9-37. Center Stage Switch Configuration with Simplex PNC

In a simplex stage switch configuration, only one EI is needed in each port network. Notice that there is no direct connection between the EPNs, rather all inter-EPN connections are made through the stage switch. Each SNI in the switch node carriers can be connected to an EPN through an EI circuit pack.
