DEFINITY[®]

Enterprise Communications Server

Release 8.2

Maintenance for R8r

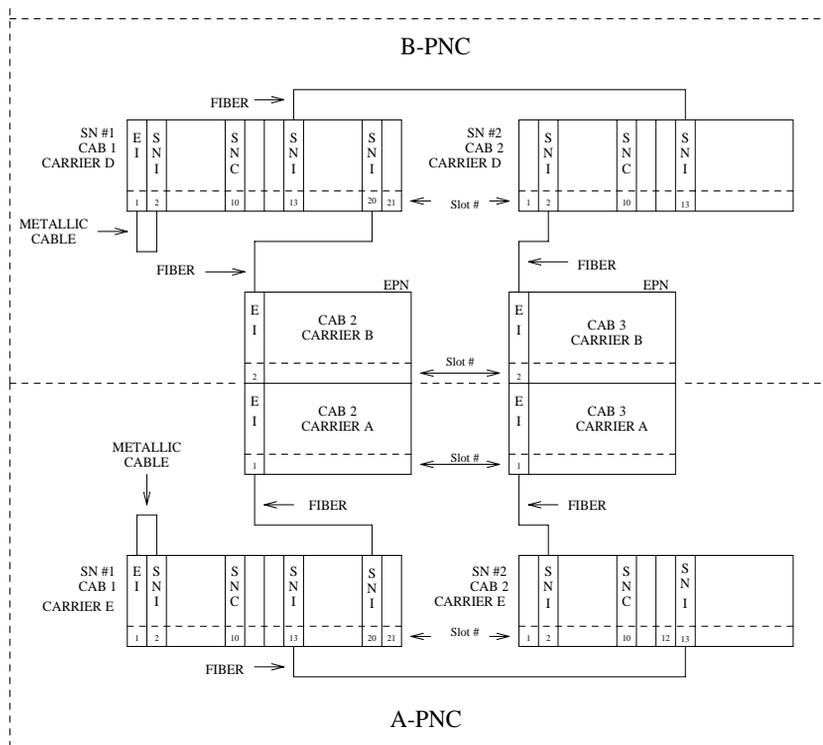
[Figure 9-38](#) shows the location of EIs in a typical two Switch Node Center Stage Switch configuration with duplicated PNC.

Figure 9-38. Center Stage Switch Configuration with Duplicated PNC

In a duplicated center stage switch configuration, two EIs are needed in each port network. One is located on the A-side PNC and the second one is located on the B-side PNC. Note that PNC designation (A or B) does not relate directly to carrier location. The EI that is on the active PNC is the one that is acting as the Archangel (TDM Bus Master) for the EPN. This is the EI that should have its yellow led blinking at a rate of 2 seconds on and 200 ms. off. The standby PNC EI should have its yellow led off. The PPN EI circuit packs are located in the first slot of the switch node carriers, although they may be located in port carriers.

In a Center Stage Switch configuration with duplicated Port Network Connectivity, the PPN Expansion Interface circuit pack may be located in the Switch Node Carrier (see [Figure 9-38](#)). In these cases, the Expansion Interface circuit pack and Switch Node Interface circuit pack may be connected via a metallic cable instead of an optical fiber link. Metallic cable should be tested and replaced in the same manner as the optical fiber.

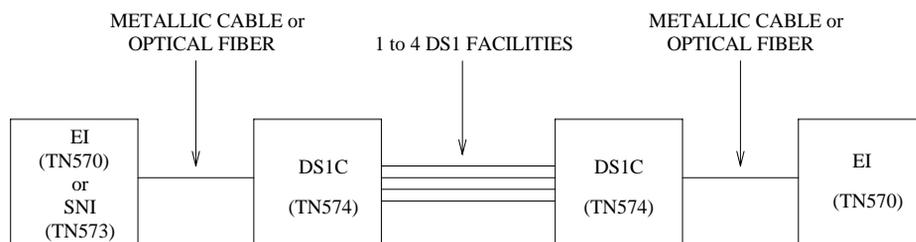
An EPN (and thus, the EIs contained in that EPN) can be removed via a DS1 converter complex. This requires that the associated fiber link which provides connectivity to the remoted EPN, be administered with a DS1 converter complex. The DS1 converter complex consists of two TN574 DS1 converter (DS1 CONV) circuit packs connected by from 1 to 4 DS1 facilities. [Figure 9-39](#) shows where the DS1 converter complex fits into an EI to SNI, or EI to EI fiber link. For more information, refer to the DS1 CONV circuit pack Maintenance documentation.

Figure 9-39. Fiber Link with DS1 Converter Complex

A PPN-EPN connection can be extended through a DS1 CONV Complex. (See [Figure 9-39](#)). When discussing problems that may be related to fiber link problems, the DS1 CONV will be considered part of the fiber link. If diagnosis of the problem points to the fiber connectivity, and a DS1 CONV circuit pack is part of this connectivity, problems with the DS1 CONV circuit pack should be investigated (See DS1 CONV-BD Maintenance documentation). The DS1 CONV circuit pack enters into diagnostics for the Expansion Interface circuit pack via such tests as the Neighbor Query Test (#237), the Fiber Out-of-frame Test (#238), the Two-way Transmission Test (#241), and the Packet Transmission Test (#589).

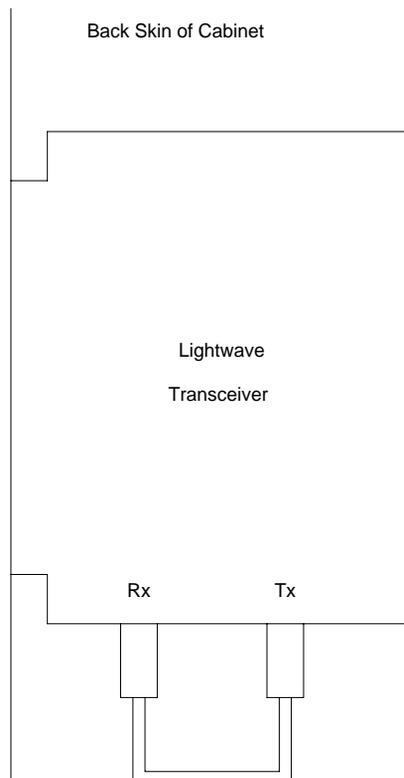
Figure 9-40. Interconnection of Lightwave Transceiver Transmit/Receive Jacks

- Using a fiber jumper cable, interconnect the transmit and receive jacks of the lightwave transceiver as shown in [Figure 9-40](#).

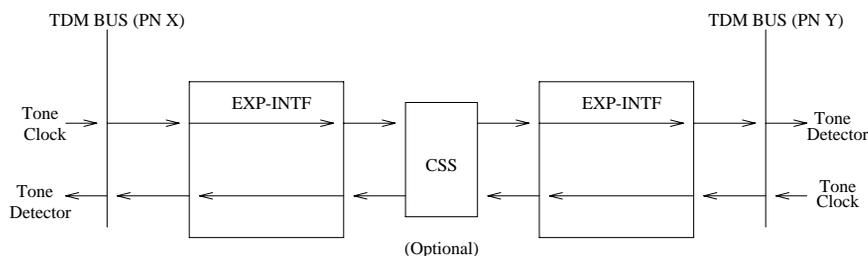
Figure 9-41. Two-Way Circuit Switch Transmission Test

This test is nondestructive. The EI 2-way transmission test is a basic connectivity test between two PNs. The test first sends dialtone from the cabinet of the EI circuit pack under test through the Center Stage Switch, through the DS1 CONV circuit packs, and through another EI circuit pack to a tone detector in the other cabinet. The connections are then reversed and the tone is passed in the opposite direction. If the system is equipped with a Center Stage Switch, and this test either fails or aborts with the above connection, a second PN is chosen (if one is available and the EI circuit pack is In-Service) and the same test is run on this new connection. This helps in the isolation of the fault. Since two EI circuit packs are involved in the connection, either one of them could be at fault and this repeated test can help determine which is actually at fault.

The path used in this test is represented in [Figure 9-41](#).

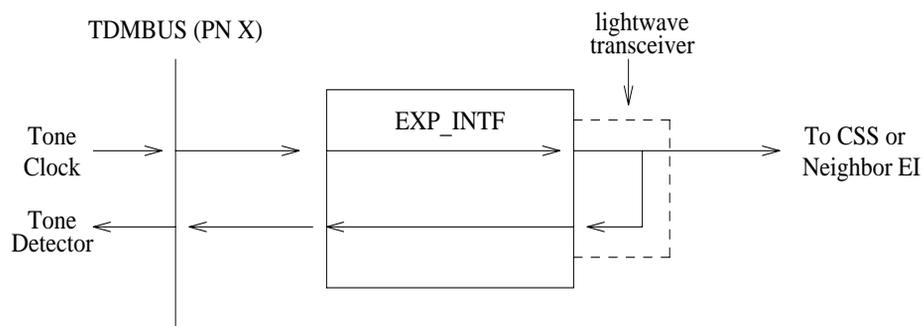
Figure 9-42. TDM BUS Lightwave Transceiver Looparound

This is a two part connectivity test. In the first part of the test, a digital count is transmitted from the cabinet of the Expansion Interface circuit pack under test, through the Expansion Interface circuit pack under test, out to its lightwave transceiver. The connection then loops back into the lightwave transceiver through the same Expansion Interface circuit pack again and into the originating cabinet. If the test tone is detected by a tone detector, the first part of the test passes. The path used for this part of the test is represented in [Figure 9-42](#).

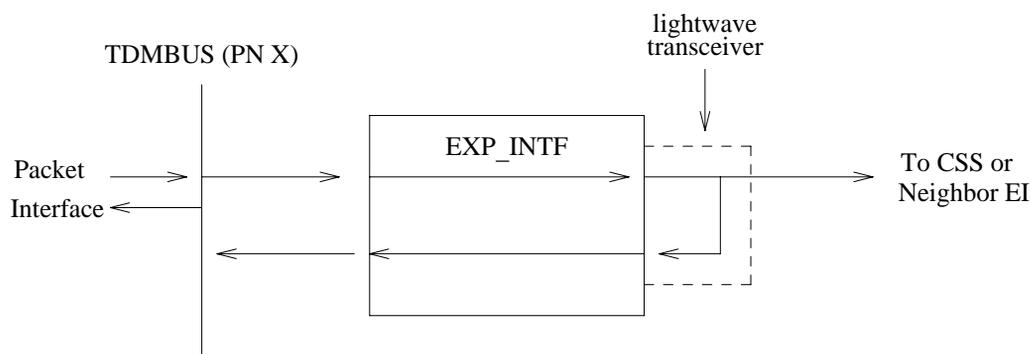
Figure 9-43. Packet BUS Lightwave Transceiver Looparound—PPN only

The path used for this test if the Expansion Interface is located in the PPN is represented in [Figure 9-43](#). The path used for this test if the Expansion Interface is located in an EPN is represented in [Figure 9-44](#).

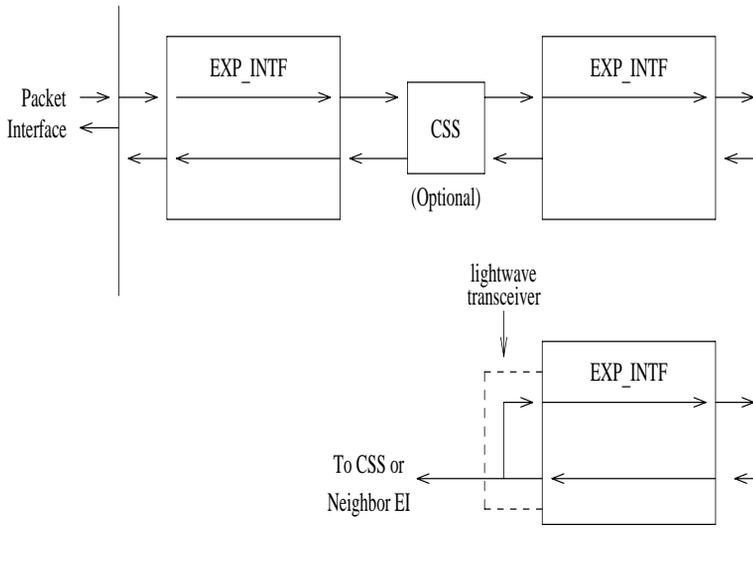
Figure 9-44. Packet BUS Lightwave Transceiver Looparound—EPN only

When the Expansion Interface circuit pack under test is in an EPN, the data packet must also pass through the Active Expansion Interface circuit packs and the Active DS1 CONV circuit packs (and the Active Switch Node Interface circuit pack(s) in a Center Stage Switch system) of the Active PNC link connecting the EPN to the PPN.

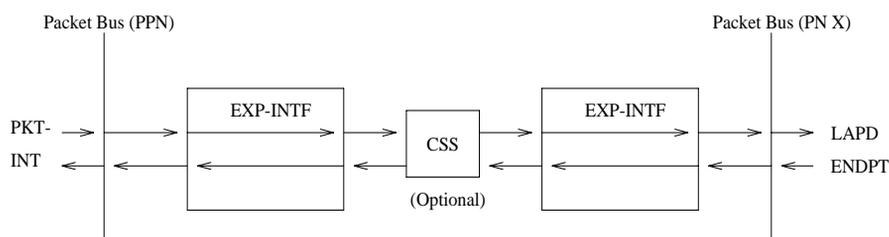
Figure 9-45. Expansion Interface Packet Interface Test—Packet Endpoint Loop

The path shown in [Figure 9-45](#) is used when testing an EPN EI that is on the active PNC.

This test is nondestructive. This test attempts to send a data packet from the TN1655 Packet Interface circuit pack through any intervening Expansion Interface circuit packs and/or Switch Node Interface circuit packs and through the Expansion Interface circuit pack to be tested. The path the data packet takes is dependent on the location of the Expansion Interface circuit pack to be tested and whether the system has duplicate Port Network Connectivity. The following diagrams and short discussion of each describe the different paths the test uses.

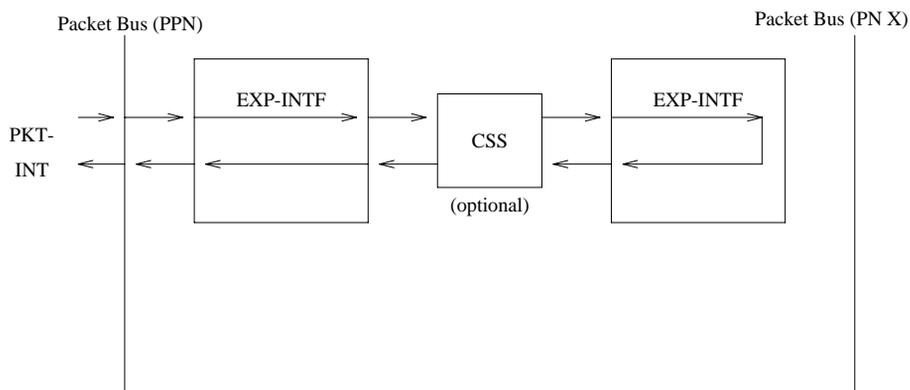
Figure 9-46. Expansion Interface Packet Interface Test—PPN to EPN loop

In a Center Stage configuration the path shown in [Figure 9-46](#) is used when testing an EPN EI that is on the standby PNC. In a Direct Connect configuration, this path is used on any PPN EI or on an EPN EI that is on the standby PNC.

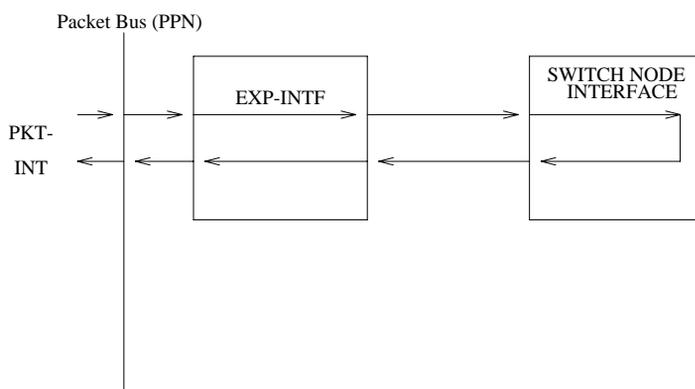
Figure 9-47. Expansion Interface Packet Interface Test—PPN to CSS Loop

The path shown in [Figure 9-47](#) is used when running the test on a PPN EI in a Center Stage configuration.

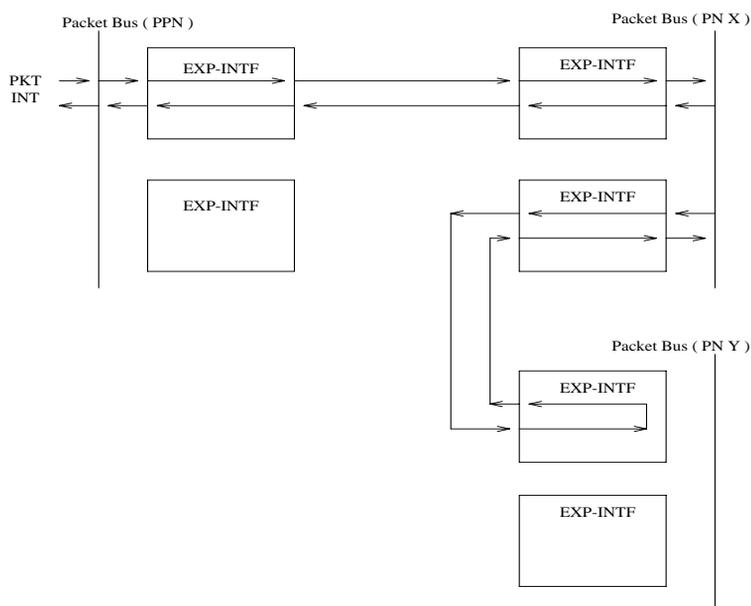
Figure 9-48. Expansion Interface Packet Interface Test-EPN to EPN link

The path shown in [Figure 9-48](#) is used when the EI under test is one that provides connectivity between the two EPN s in a Direct Connect configuration.

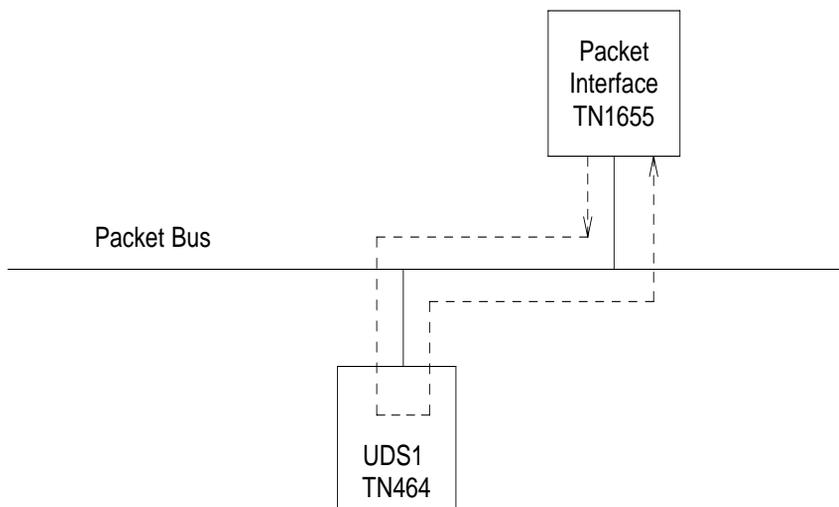
Figure 9-49. Signaling Port LAN (Packet Bus) Loopback

This test verifies the connectivity of an ISDN-PRI signaling port (D-channel) across the LAN bus, also known as the packet bus. It will execute only if the port is out-of-service. Failure of this test indicates a fault associated with the port hardware on the circuit pack.

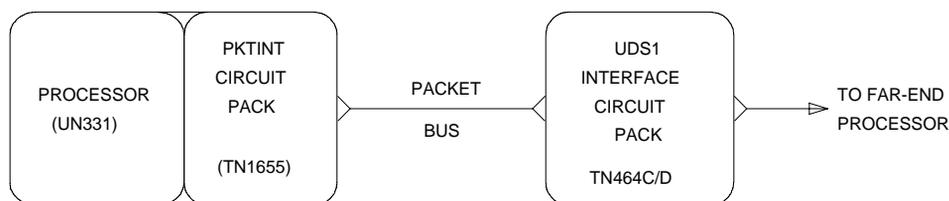
Figure 9-50. Remote Layer 3 Query (Test #637)

Tests #639 and #636 check the health of the D-channels and DS1/UDS1 Interface Circuit Packs. As shown in [Figure 9-50](#), this test goes one step further by checking the communication path from the processor from the processor, through the TDM/Packet Bus and DS1/UDS1 Interface circuit pack, and on to the far-end switch or terminal adapter. A special ISDN message is sent to the far-end switch or terminal adapter, which must respond within a specified amount of time. This test is designed to ensure that the communication path between the switch and the far-end is up and operational, and that the two endpoints can properly exchange ISDN control messages.

[Figure 9-50](#) illustrates a UDS1 Interface Circuit Pack located in the PPN. When the UDS1 board is located in an EPN, there is additional Port Network Connectivity hardware connecting the packet busses of the PPN and EPN. Examples of such hardware are the Center Stage Switch and fiber-optic cables.

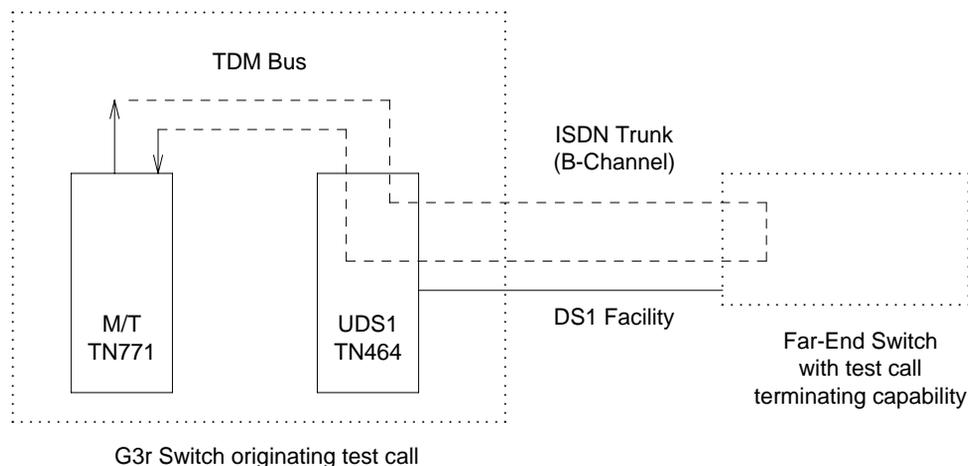
Figure 9-51. Outgoing ISDN-PRI Test Call

A test call connection is established to a far-end switch over the ISDN trunk to be tested. The digital port on a TN711D Maintenance/Test circuit pack generates a test-pattern bit stream which is sent to the far-end switch and echoed back. The received pattern is then compared to the sent pattern and checked for errors that indicate a loss of integrity on the communications path.

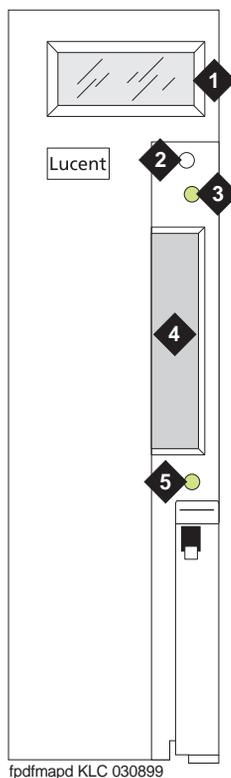
Figure 9-52. TN802 faceplate

[Figure 9-52](#) shows the TN802 faceplate.

Step	Description	Comments
1.	Restore IP Trunk administration	At the Windows NT desktop, double-click on the IP Trunk Back UP Restore icon. The IP Trunk Backup/Restore Utility screen appears.
2.	Select utility	In the IP Trunk Backup/Restore Utility dialog screen, click Files, Restore . The IP Trunk Backup screen appears
3.	Select restore	In the IP Trunk Backup screen, click on the Restore button.
4.	Wait	Wait until the yellow Disk-In-Use LED (Note 5 in Figure 9-52) light is out.

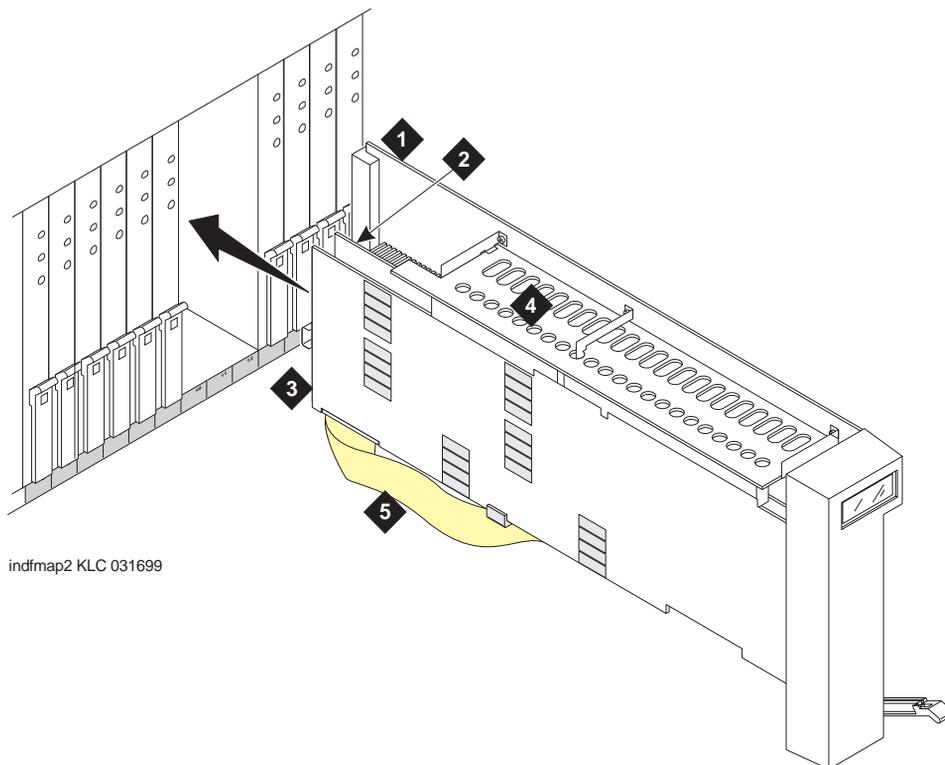
Figure 9-54. TN802 board assembly

[Figure 9-54](#) shows the circuit pack with the two additional boards connected through the side plane.

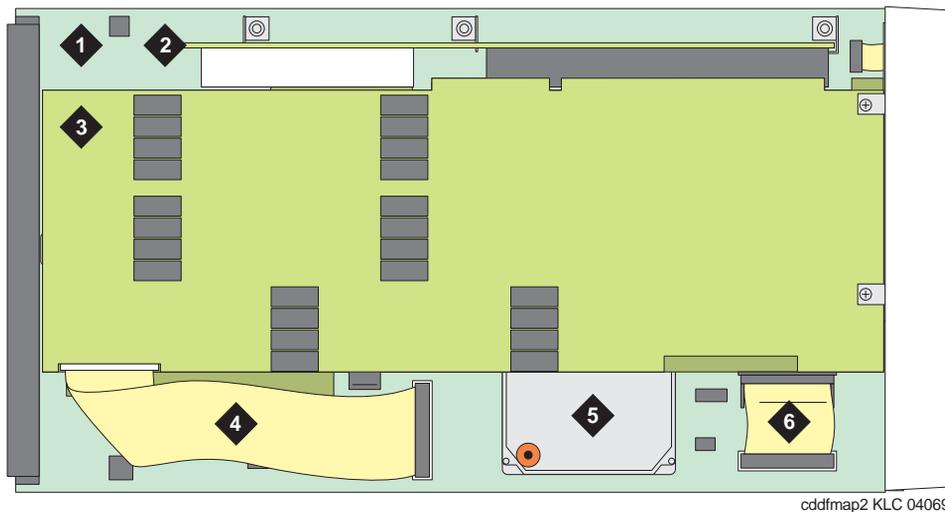
Figure 9-55. TN802 board assembly and cables (side view)

[Figure 9-55](#) shows a side view of the three boards and interconnecting cables that make up the TN802.

- a. Verify the IP address
 - b. Check the physical connections to and from the TN802 circuit pack.
 - c. Check the internal cables on the TN802 circuit pack (Notes 4 and 6 in [Figure 9-55](#)).
 - d. Try pinging another device on the same subnet.
 - e. Try pinging the gateway to the rest of the network from the subnet.
 - f. Try pinging a device not on the local subnet but on the network or another subnet.
5. When finished, at the command prompt type **exit** and press Enter.

- a. Check that the internal cables on the TN802 circuit pack (Notes 4 and 6 in [Figure 9-55](#)) have not worked loose.
 - b. Otherwise, replace the circuit pack.
3. At the command prompt, type **ping 10.32.64.97** (the internal IP trunk server address) and press Enter.

- a. Check that the internal cables on the TN802 circuit pack (Notes 4 and 6 in [Figure 9-55](#)) have not worked loose.
 - b. Otherwise, replace the circuit pack.
4. At the command prompt, type **ping 10.32.64.96** (the IP address of the internal Motorola MPC860 processor) and press Enter.

- a. Check that the internal cables on the TN802 circuit pack (Notes 4 and 6 in [Figure 9-55](#)) have not worked loose.
 - b. Otherwise, replace the circuit pack.
5. Ping the gateway: at the command prompt, type **ping XX.XXX.XXX.XXX** (the IP address of the gateway) and press Enter.
 6. When finished, at the command prompt type **exit** and press Enter.

The TN802 hard drive (Note 5 in [Figure 9-55](#)) is field-replaceable.

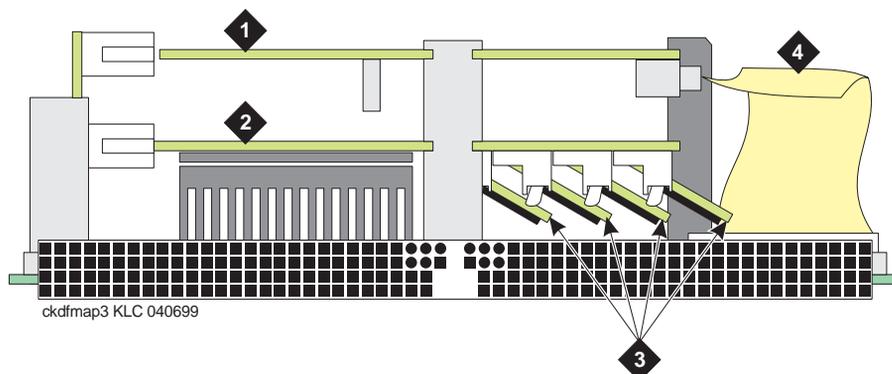
Figure 9-56. TN802 board assembly and cables (end view)

[Figure 9-56](#) shows the end view of the three boards and interconnecting cables on the TN802.

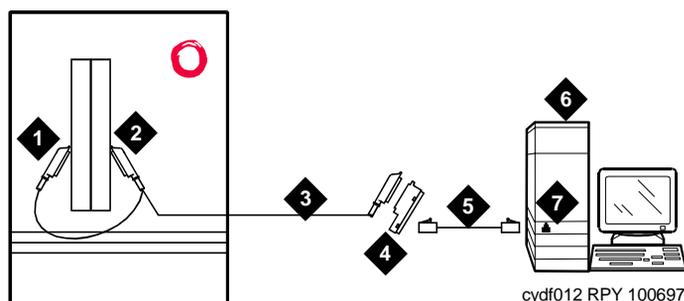
Figure 9-58. Typical ESM connections

The TN2207 circuit pack permits connecting an Expansion Services Module (ESM). See [Figure 9-58](#) for connectivity.

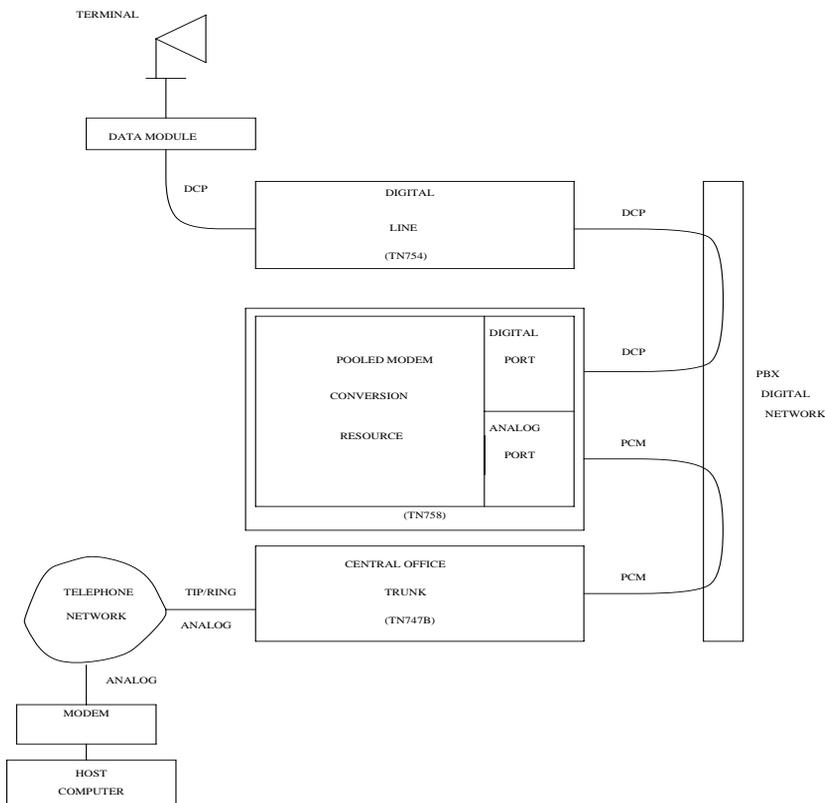
Figure 9-60. Typical Modem Pool Switched Connection with Integrated Pooled Modem

There are two primary types of Modem Pool conversion resources available: an Integrated Pooled Modem and a Combined Modem Pool. The integrated TN758 Pooled Modem circuit pack contains two independent 300 or 1200 baud conversion resources. Each conversion resource contains two interfaces to the PBX digital network: an analog port and a digital port. The analog port is connected through the PBX network to the analog line or trunk port containing the analog modem signals. The digital port connects through the PBX network to the digital line or trunk port in the call. The figure below shows a typical end-to-end connection using a conversion resource on the integrated Pooled Modem circuit pack.

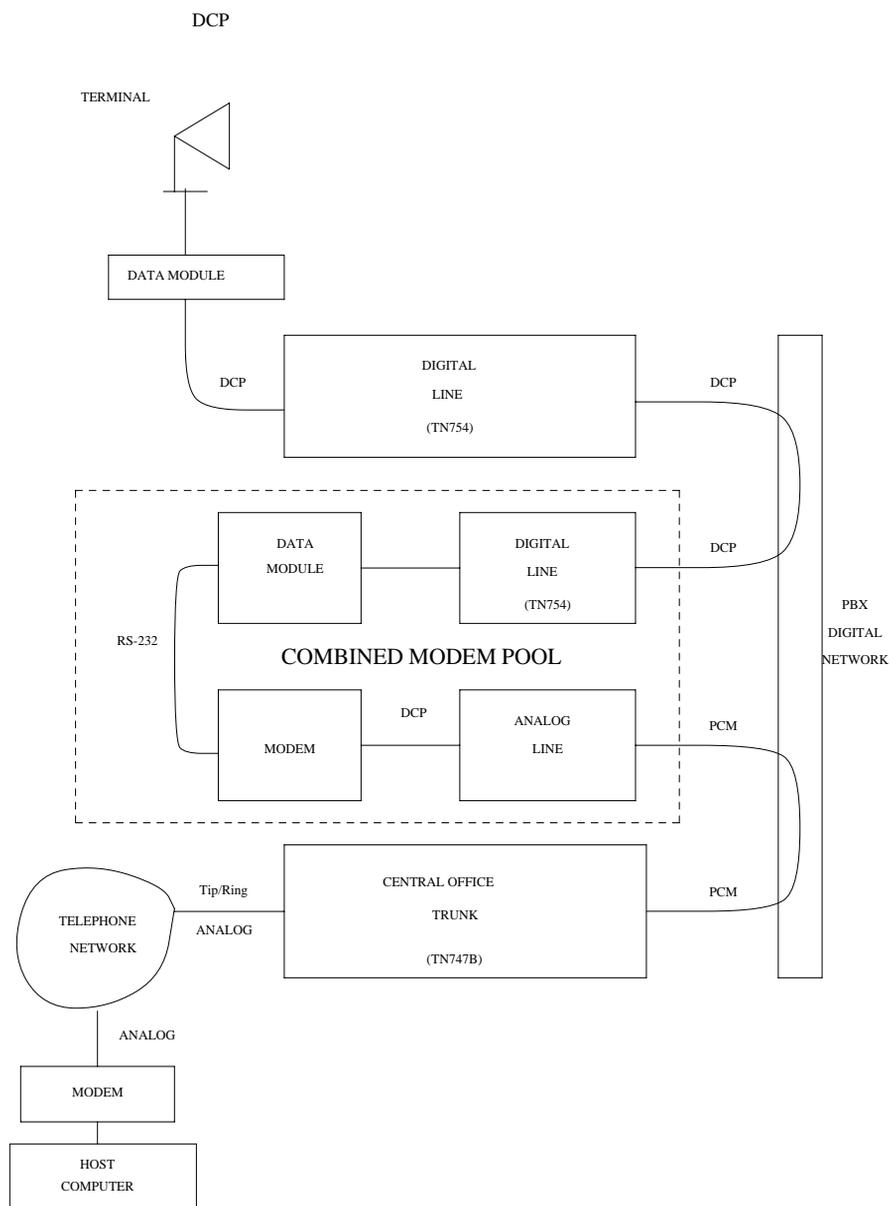
Figure 9-61. Typical Modem Pool Switched Connection with Combined Modem Pool

The Combined Modem Pool conversion resource is the second type available. The function served by the Combined Modem Pool is similar to that of the integrated Pooled Modem circuit pack, but the physical implementation is much different. It has the advantage of supporting any speed the external modem can support. The integrated Pooled Modem circuit pack can only support 300 or 1200 baud transmission rates. The Combined Modem Pool conversion resource consists of a port on an Analog Line circuit pack, an external modem, a Data Module, and a port on a TN754 Digital Line circuit pack. The tip and ring interface of the Analog Line is connected to the modem, the RS-232C interface of the modem connects to the Data Module, and the DCP interface on the Data Module is connected to the Digital Line port.

The analog modem signals pass through the Analog Line port to the modem. The modem converts these to RS-232C signals which are passed on to the Data Module. The Data Module further converts the signals to the DCP protocol for the Digital Line port which passes the signals on to the PBX network.

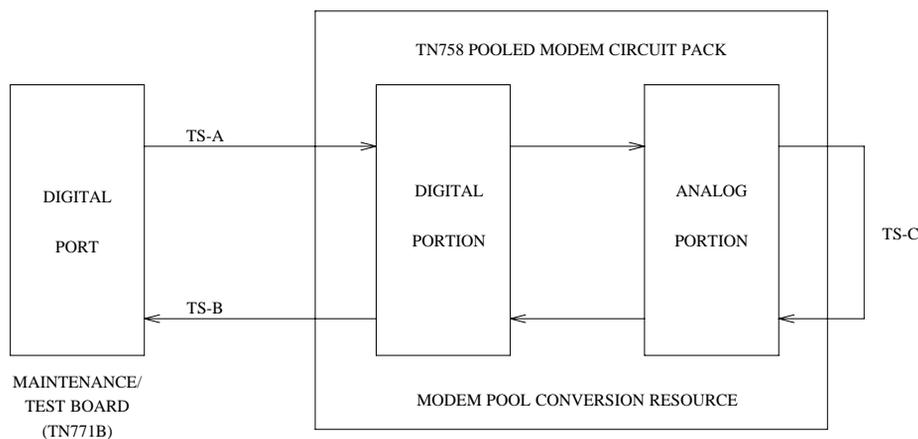
Figure 9-62. Modem Pool Conversion Resource Loop-Around

Test data patterns are transmitted from a Maintenance/Test Board digital port over network time slot A through the digital port on the conversion resource, looped around through the analog port via time slot C back to the Maintenance/Test Board digital port circuit via time slot B where the patterns are checked for accuracy. Finally, the test forces a disconnect by breaking the connection between the Maintenance/Test Board digital port and the Modem Pool Port (time slot A) and verifying that the Maintenance/Test Board digital port and Modem Pool Port go on-hook within the proper time. This test attempts to allocate a Maintenance/Test Board digital port, Modem Pool Port, and other internal resources. If any of these allocation attempts fail, the test cannot be completed and a specific abort error is reported.

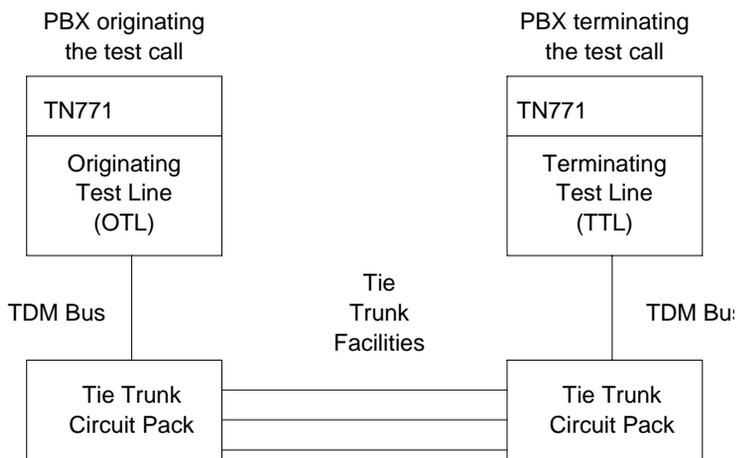
Figure 9-63. ATMS Tie Trunk Test Call

The Maintenance/Test Analog Port is port number 1 on the TN771 Maintenance/Test circuit pack. This port is used by the Automatic Transmission Measurement System (ATMS) as an Originating Test Line (OTL) or Terminating Test Line (TTL) for test calls over analog trunks. For more details, see "Automatic Trunk Transmission System" in [Chapter 6, "Additional Maintenance Procedures"](#). [Figure 9-63](#) shows a typical ATMS configuration.

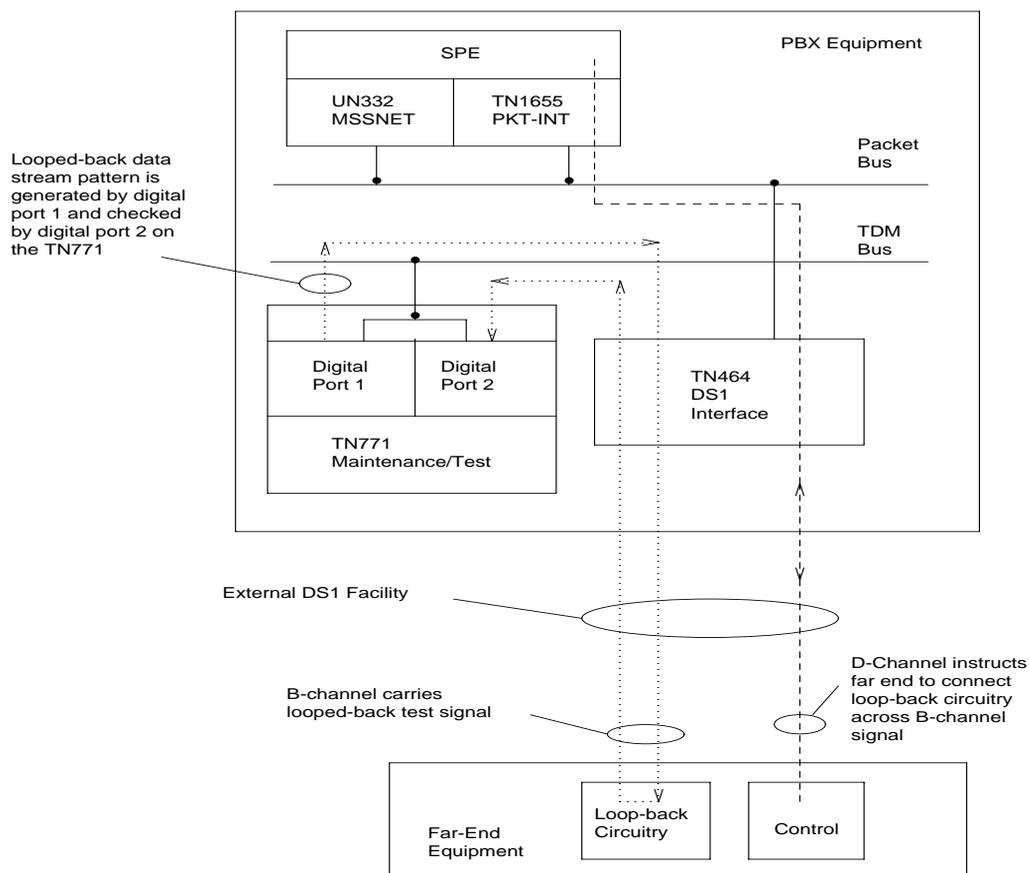
Figure 9-64. ISDN-PRI Outgoing Test Call

The Maintenance/Test Digital Port is a port on the TN771D circuit pack. Ports 2 and 3 are Digital Ports. The Maintenance/Test Digital Port provides the ability to perform digital (i.e., ISDN-PRI) trunk testing via the TDM Bus. For an ISDN-PRI test call, connections are set up in the system as shown in [Figure 9-64](#).

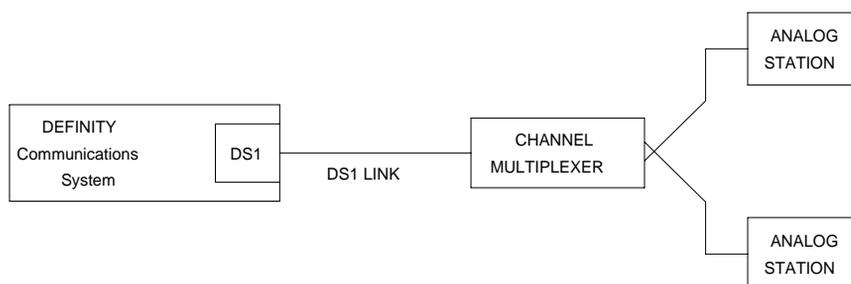
Figure 9-65. DS1 OPS Line Interactions

The DS1 OPS Line Maintenance provides a strategy to maintain an OPS Line via a trunk port of the TN767 DS1 Interface circuit pack or the TN464 UDS1 Interface circuit pack. (Throughout this section, the term DS1 Interface can apply to either of these circuit packs.) The strategy covers initialization tests, periodic tests, scheduled tests, system technician-demanded tests, and alarm resolution and escalation. Two service states are specified in a DS1 OPS Line maintenance. They are: *out-of-service*, in which the line is in a deactivated state and cannot be used for either incoming or outgoing calls; or *in-service*, in which the line is in an activated state and can be used for both incoming and outgoing calls. If the DS1 Interface circuit pack is out-of-service, then all lines on the DS1 Interface circuit pack are put into the out-of-service state, and a Warning alarm is raised.

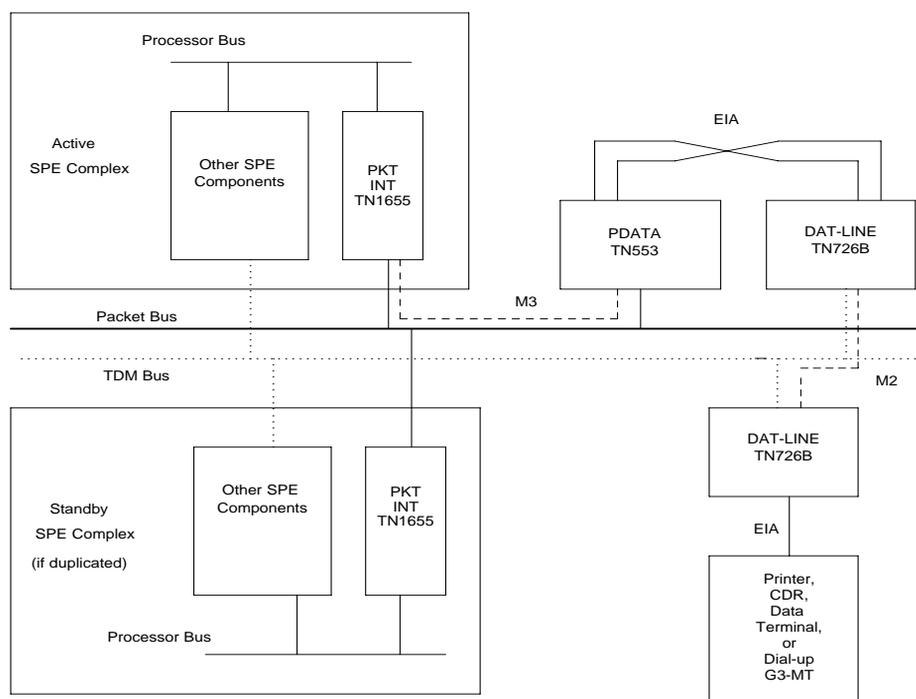
Figure 9-66. Typical System Port Connection

As part of each data application, the SPE connects itself to the application device through a system port. The application device may be an external terminal, printer, or data-module, or it may be circuitry internal to the switch, as is the case for the Announcement Circuit pack data-module used to save and restore recorded announcements. The figure below is an example of a system port connection using a second Data Line circuit pack (DAT-LN-BD) port to provide dial-in access for a remote terminal.

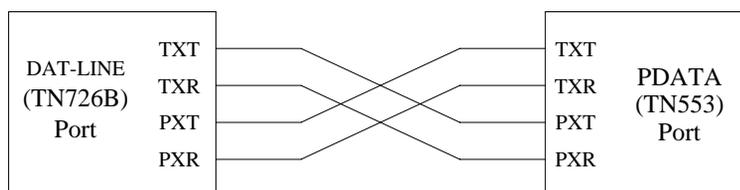
Figure 9-67. System Port Wiring Scheme

If you find that you are having trouble with a PDATA port and you do not know which extensions are being affected or which Data Line port is attached, enter **display port** UUCSSpp with the PDATA port number to display the extension of the System Port. With this extension you can run **display data-module** ext, which will in turn identify the Data Line port. The PDATA and Data Line ports are wired together in a manner similar to a null-modem. The figure below illustrates the wiring scheme for the EIA ports. The subsequent table gives the full wiring sequence for eight Data Line ports attached to eight PDATA ports.

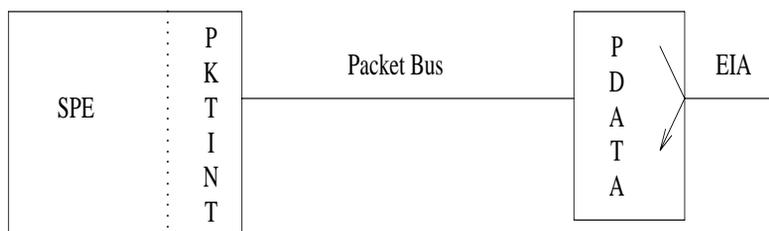
Figure 9-68. Configuration for LAPD Connectivity Test

This is a connectivity test which checks if a specific PDATA port is capable of establishing a Level 2 LAPD link. The SPE will assign a LAPD bearer link between the SPE Packet Bus interface (i.e. the Packet Interface, also called PKTINT, TN1655) and the PDATA port. The SPE will send a test packet from the PKTINT to the PDATA port and it will expect to receive a reply from the PDATA port. Failure of this test may indicate an on-board fault associated with the port hardware on the PDATA circuit pack.

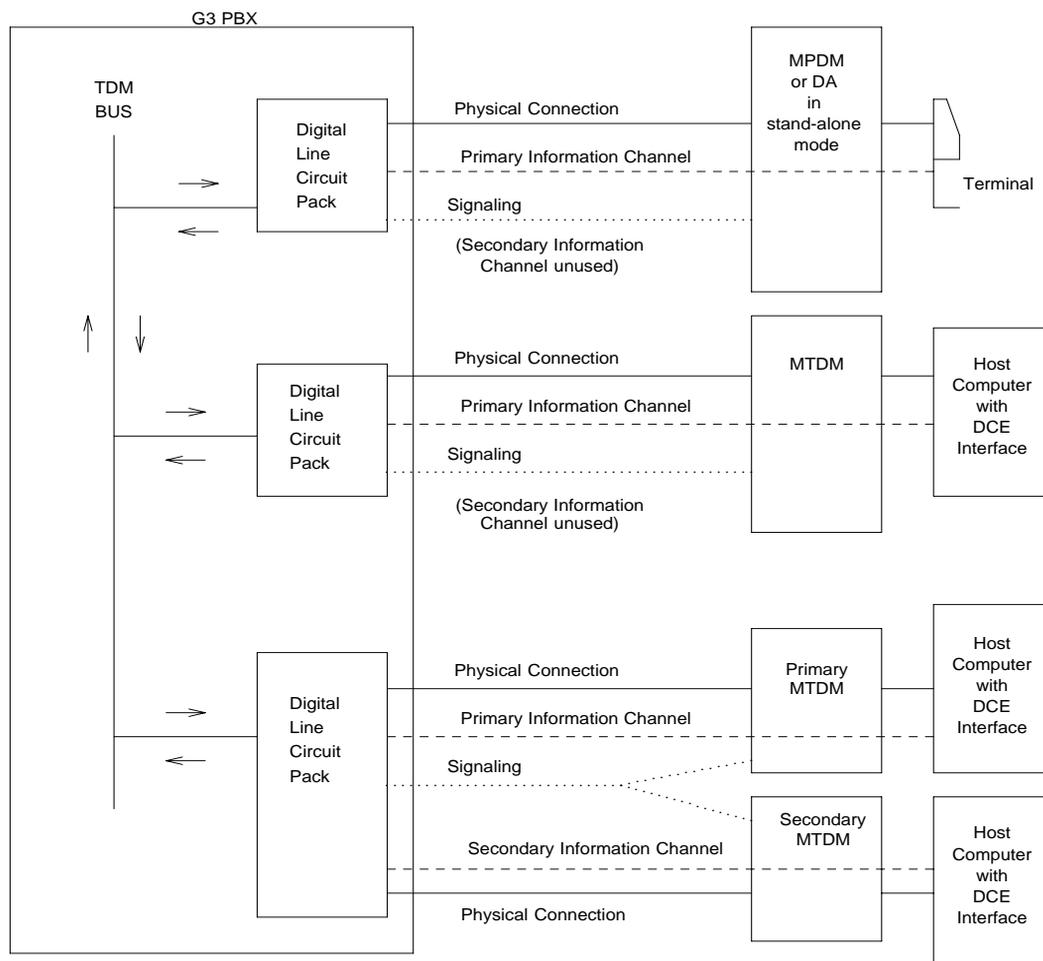
Figure 9-70. Typical Data Module Configurations

Data modules provide a variety of option switches to allow the customer to select data rates, parity, keyboard dialing, local, and remote loop back, etc. (The DAA2 Data Adaptor has an AT (Hayes) type interface that allows selection of the above parameters as well as mode — linked or stand-alone.) An incorrect selection will not necessarily cause errors, alarms or test failures, but it can result in service disruption. Refer to the installation manual provided with the data module for more information about those options.

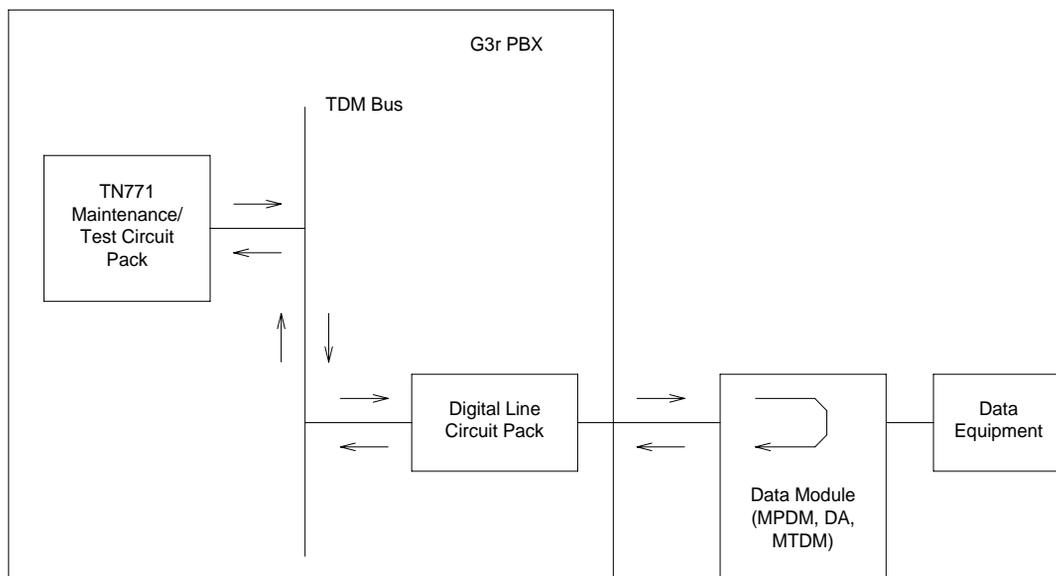
Figure 9-71. Internal Looparound Test

This test verifies that a data message can be sent from the PBX, through the building wiring, through an internal loop-around path in the data module, and back to the PBX. This path is illustrated below.

A signaling message is sent through the digital port circuit pack to the data module, requesting it to enter loop-around mode. A test pattern is then sent from the TN771 Maintenance/Test circuit pack, over the path illustrated above, and back to the TN771 where it is checked for consistency.

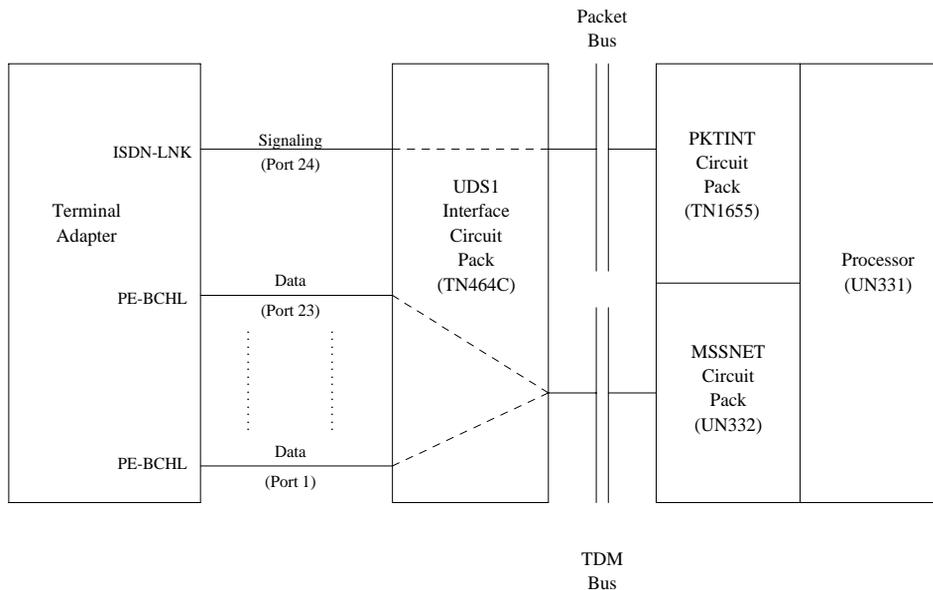
Figure 9-72. PRI Endpoint Port Interactions

A PRI endpoint port is a port on a UDS1 interface circuit pack and thus depends on the health of the circuit pack for proper operation (see the following figure). A problem on the associated ISDN-PRI Signaling Link Port D-channel (ISDN-LNK) can also affect the PRI endpoint. The ISDN-PRI Signaling Link Port in turn depends on the SYS-LINK (System Link) to the Packet Interface. Keep this hierarchy of dependencies in mind when diagnosing problems.

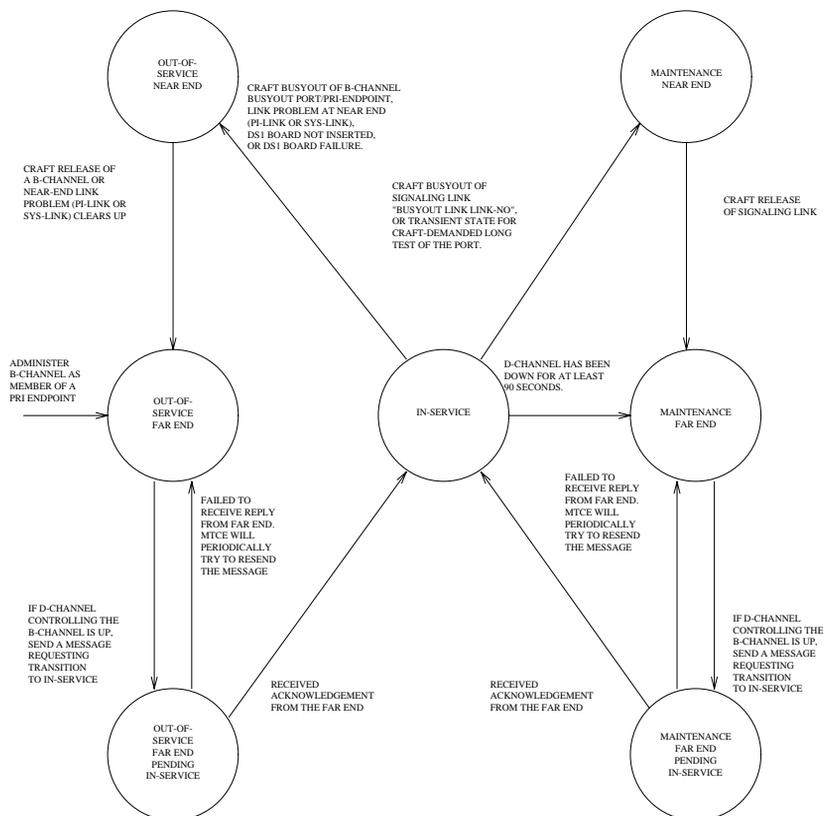
Figure 9-73. Common Progressions in PRI Endpoint Service States

Service State ¹	Alarm	Possible Cause	Possible Solution
INS		Normal operating state. ISDN wideband calls being completed.

- 1. OOS Out of Service
- MTC Maintenance
- FE Far-end
- NE Near-end
- PINS Pending in-service

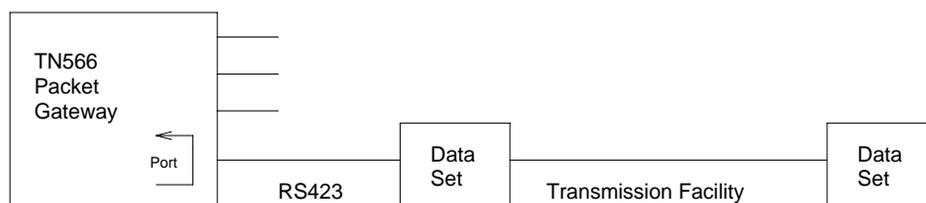
Figure 9-74. Packet Gateway Port Local Loop-Around Test

This test verifies the functionality of a port circuit on the Packet Gateway circuit pack. When the switch sends the test request, the Packet Gateway circuit pack automatically loops back the signal at the port as shown in the the figure below. Failure of this test indicates the existence of a fault in the port hardware on the circuit pack.

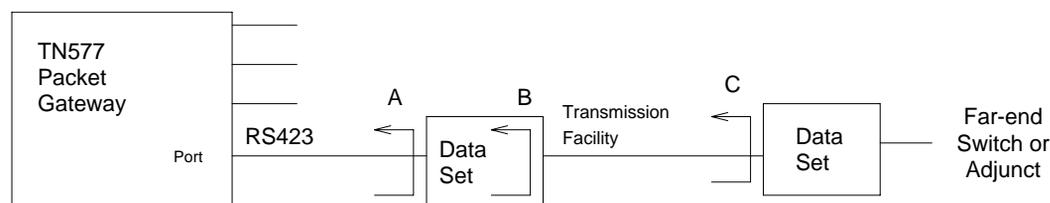
Figure 9-75. Packet Gateway Port Remote Loop-Around Test

This test checks the integrity of cabling and devices external to the Packet Gateway port hardware. Packet Gateway firmware executes this test on demand by sending a test frame which is looped back to the Packet Gateway by a loop-around that has been externally activated or installed at one of several points in the external connectivity (see loopbacks A, B and C in the figure below). The test passes when the sent and received test frames are identical. The test fails if the sent and received test frames do not match, or if no test frame is received prior to a time out.

If you suspect a problem in cabling or external devices, then repeat this test at points that are progressively further from the PGATE port until either a failure point is identified or the integrity of the entire path is verified. Certain site configurations may require teamwork with those who maintain the off-site transmission facilities.

Manual activation of the loopback is required for this test. If available, the Local Loopback (B in the above figure), Digital Loopback (C), and Remote Loopback (D) capabilities of external data sets may be used in conjunction with this test for fault isolation. Execution of this test with the data set in the Local Loopback mode verifies the integrity of the external port cabling. Execution of this test with the data set in the Digital Loopback mode verifies the integrity of the data set. Execution of this test with the far-end data set in the Remote Loopback mode verifies the integrity of the transmission facility.

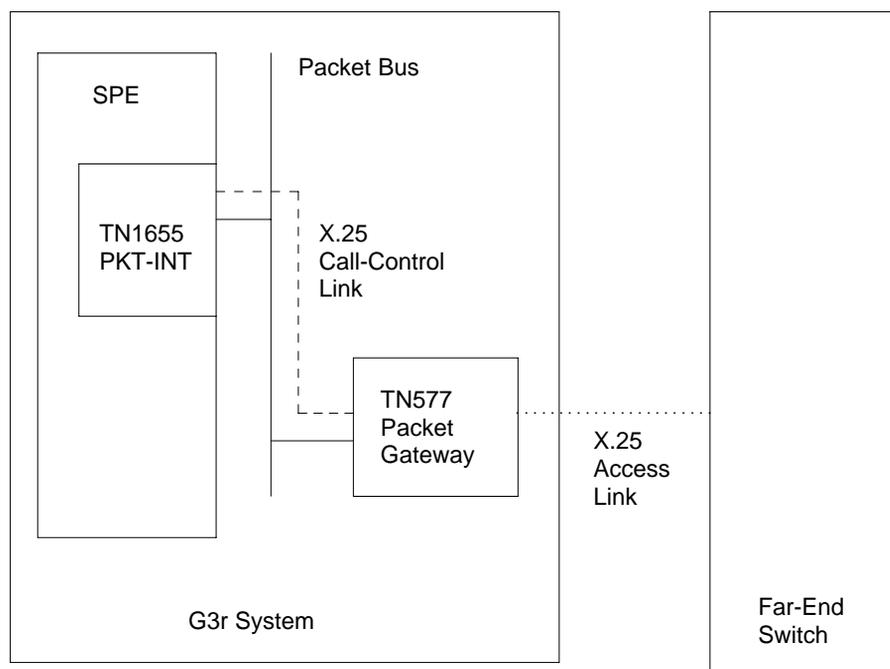
Figure 9-76. Packet Gateway Links

This test determines if the X.25 Access Link is connected or disconnected. The switch determines the state of the X.25 Access Link by sending a query to the Packet Gateway circuit pack. This test passes if the X.25 Access Link is connected and fails if it is disconnected.

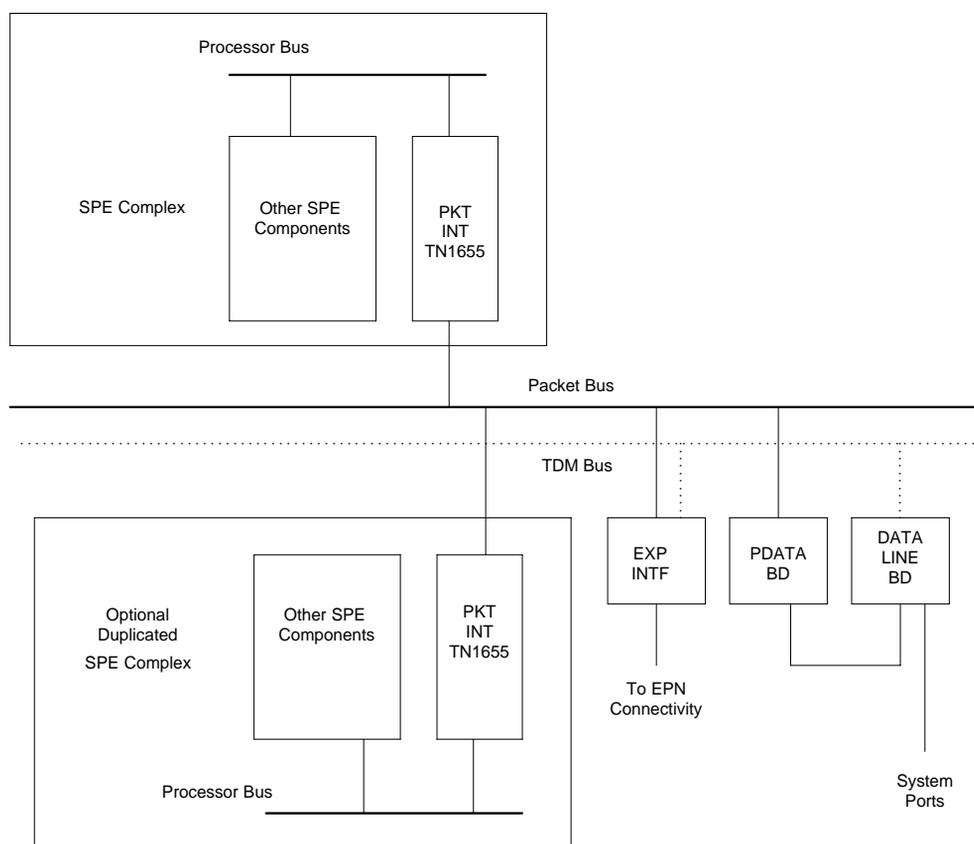
Figure 9-77. Packet Interface Connectivity

The PBX has been designed for a maximum of three Packet Interface circuit packs but only one Packet Interface circuit pack is required for the current PBX hardware configuration. The Packet Interface circuit pack will normally be inserted in the first Packet Interface slot provided in the control carrier although it will operate in any one of the three slots provided. If more than one Packet Interface circuit pack is inserted, an alarm will be generated. For a system equipped with duplicated SPEs, the slot used for the Packet Interface circuit pack on the standby SPE must be the same slot position as that used on the active SPE or an alarm will be generated against the Packet Interface circuit pack in the standby SPE.
