DEFINITY[®]

Enterprise Communications Server

Release 8.2

Maintenance for R8r

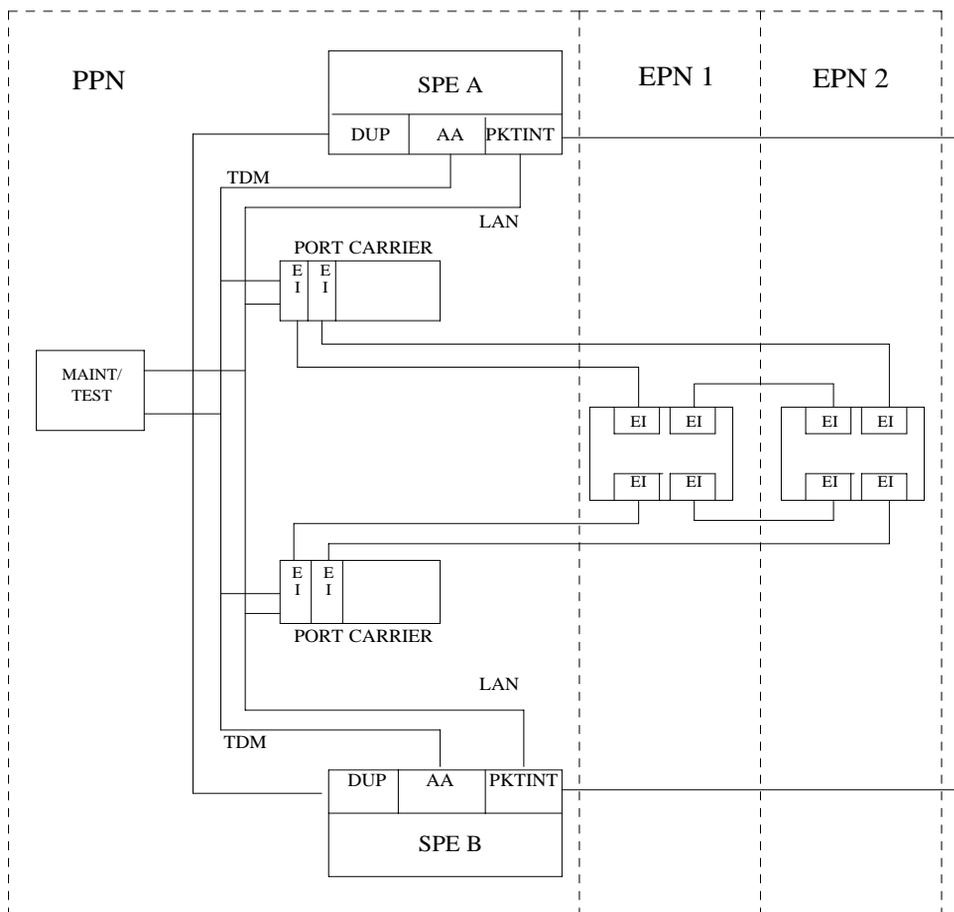
Figure 9-78. Duplicated Direct Connect PNC Connectivity

- An active PNC component cannot be busied-out.
- A standby PNC component can only be busied-out when the standby PNC is first busied-out.
- The standby PNC cannot be released unless all standby PNC components are released.

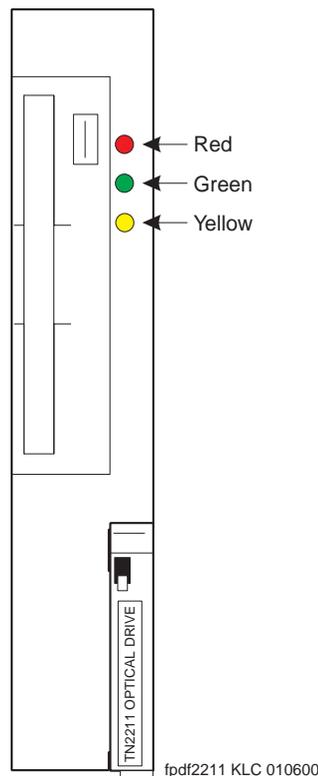
Figure 9-80. TN2211 faceplate

The Mass Storage System (MSS) provides non-volatile storage for system software, translation data, announcement data and program update data. As shown in the figure below, the MSS consists of a Host Adapter circuit on the UN332C MSS-Network Control circuit pack (MSSNET), a Small Computer System Interface (SCSI) bus, a TN2211 Optical Drive circuit pack or a TN1656 Tape Drive circuit pack, and the TN1657 Disk Drive circuit pack. The Disk Drive acts as the primary storage device. The TN2211 Optical Drive or TN1656 Tape Drive serves as a backup device and as a removable medium for system data. The faceplate details are shown in [Figure 9-80](#).

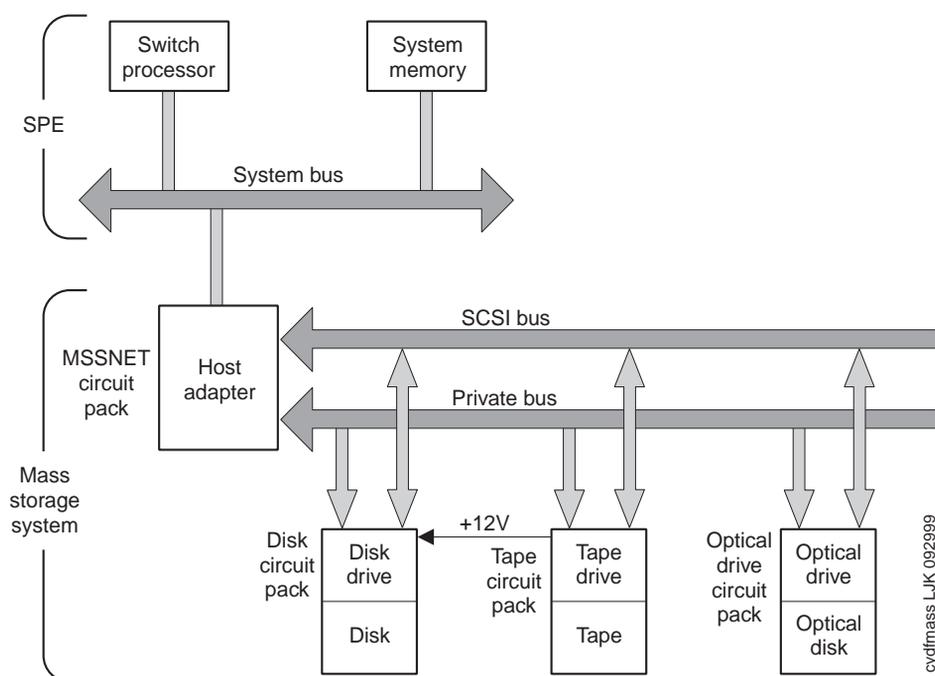
Figure 9-81. Mass Storage System interactions

The Host Adapter circuit pack, Removable Media Drive circuit pack, and Disk circuit pack are treated as separate, but related, maintenance objects (H-ADAPTR, R-MEDIA, and DISK). Since the Disk circuit pack is controlled by SCSI commands which are generated by the Host Adapter, problems with the Host Adapter can prevent communications with the Disk. Whenever the Host Adapter is taken out of service by the **busy-out host-adapter** command, or due to failure of a critical Host Adapter test, the Removable Media (R-MEDIA) and Disk (DISK) maintenance objects are also placed in a maintenance busyout state.

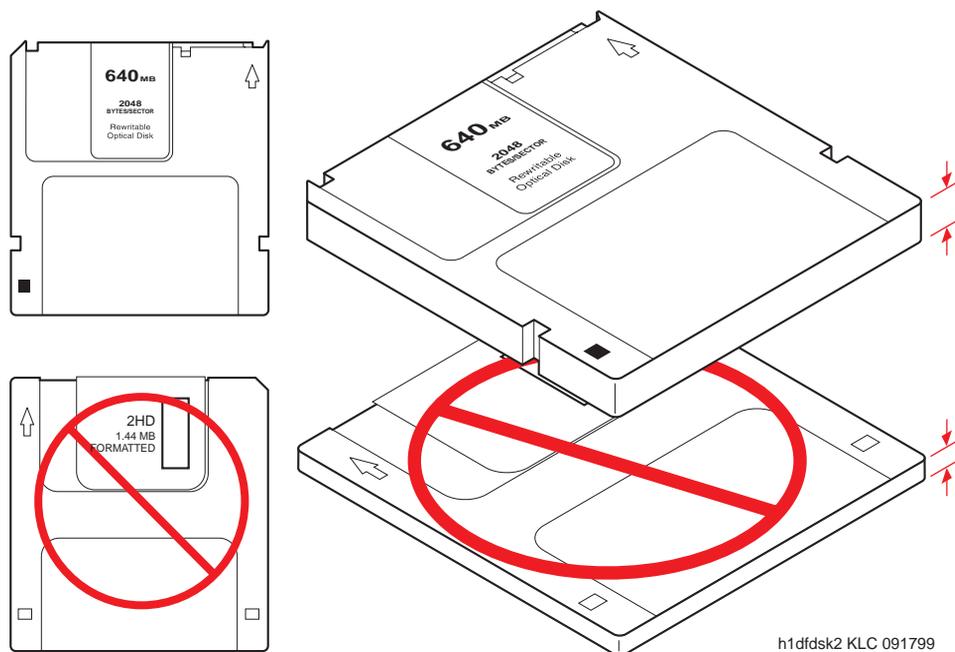
Figure 9-82. Use a 640Mb optical disk only, not a 1.44Mb floppy disk

- Make sure there is disk in the drive. Optical disks look similar to 1.44Mb floppy disks, but are thicker (see [Figure 9-82](#)).

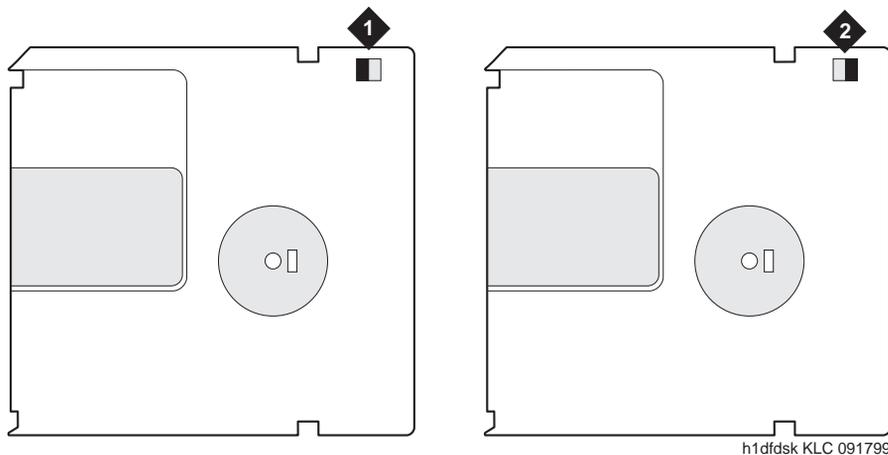
Figure 9-83. Optical disk write-protection tab

- Make sure that the write protect lock is not active (see [Figure 9-83](#)). To deactivate write protect on a tape cartridge, slide the RECORD switch on the tape cartridge in the direction of the arrow on the switch. To deactivate write protect on an optical disk cartridge, slide the *square* switch on the back of the optical disk so that the hole is covered.

1. Write-protect disabled
2. Write-protect enabled

- k. **Error type 1537:** indicates that the removable media cartridge is write protected. Check the write-protect switch on the removable media cartridge ([Figure 9-83](#)). It should cover the opening (opposite position).

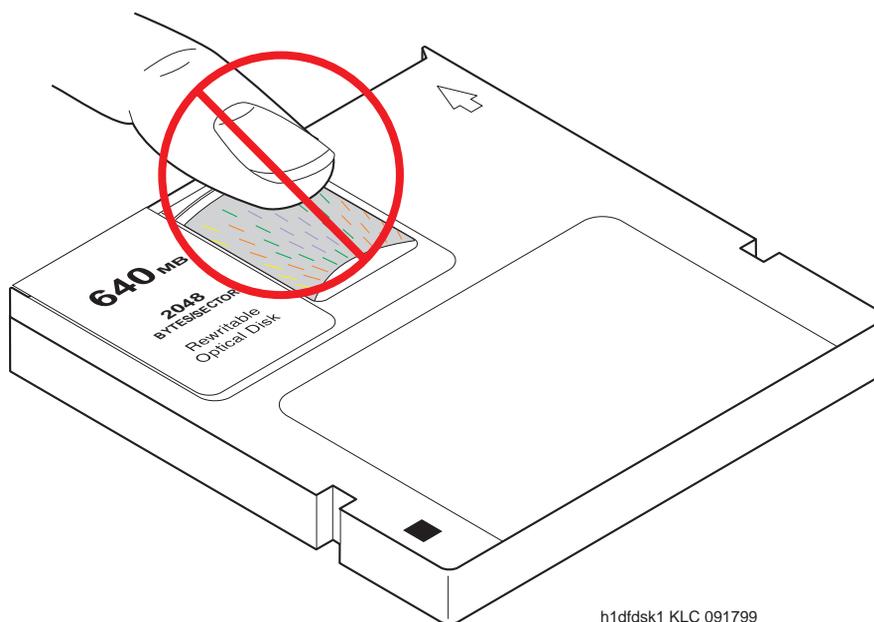
Figure 9-84. Do not touch the surface of the optical disk

Be sure not to touch the surface of the optical disk as this can render the disk unusable. ([Figure 9-84](#))

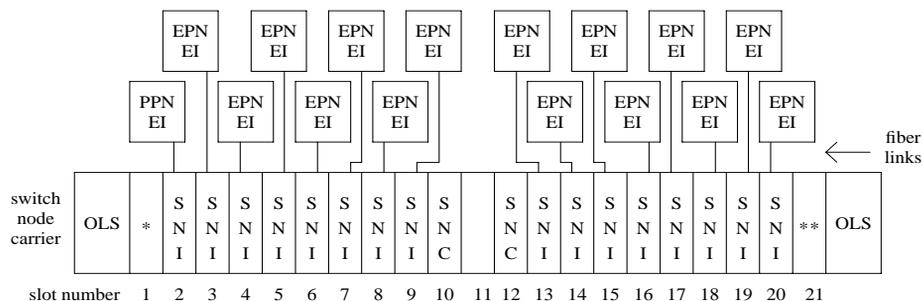
Figure 9-85. A Center Stage Switch Configuration

* = An EI or a DS1C circuit pack may reside in this slot
** = A DS1C circuit pack may reside in this slot

Switch Node Clock (SNC) TN572
Switch Node Interface (SNI) TN573
Expansion Interface (EI) TN570
DS1 Converter (DS1C) TN574
Online Switcher (OLS) power supply

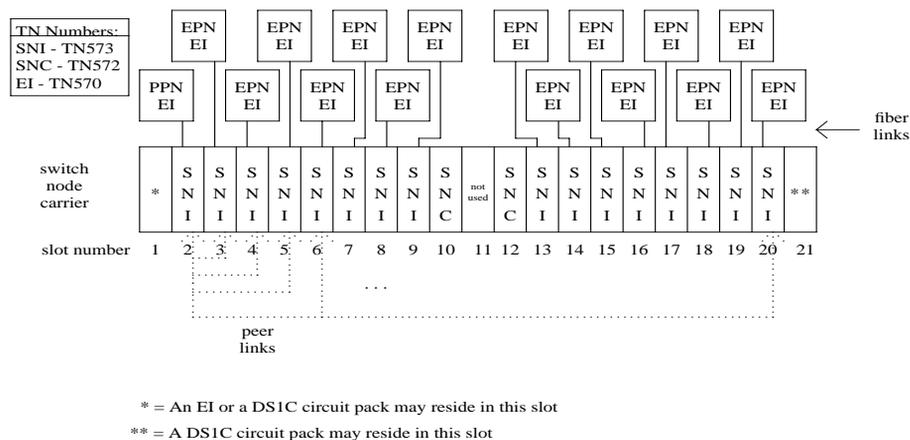
Figure 9-87. CSS Configuration with Simplex PNC and 1 Switch Node Carrier

[Figure 9-87](#) shows an unduplicated CSS with one switch node. A single switch node can accommodate up to 16 port networks, including the PPN. A system with two switch nodes can accommodate up to 22 port networks. [Figure 9-88](#) shows a two-switch node CSS with duplicated PNC (four switch node carriers). In this configuration, each PNC (A and B) contains two switch nodes. The cabinet numbers for the switch node carriers are typical cabinet numbers. The EPNs and PPN on the top half of the figure (PNC A) are the same as the EPNs and PPN on the bottom half of the figure (PNC B).

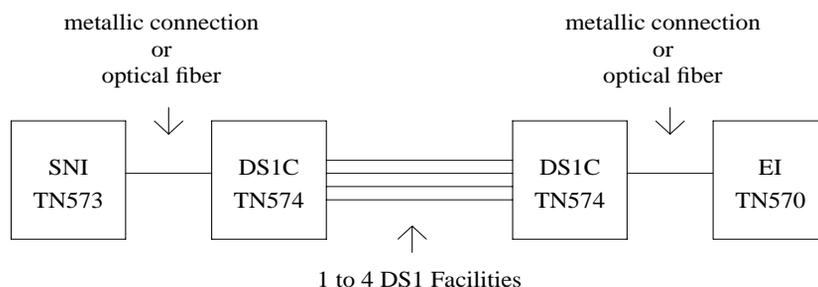
Figure 9-89. Fiber Link over a DS1 Converter Complex

A DS1 converter complex can be used to provide connectivity to a remotely located port network. The DS1 converter complex consists of two TN574 DS1 converter (DS1C) circuit packs connected by 1 to 4 DS1 facilities. The DS1C complex is administered as a fiber link.

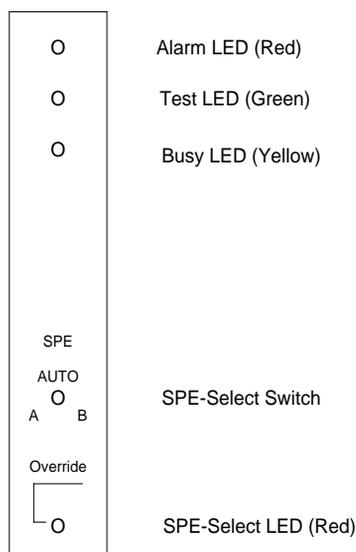
Figure 9-91. Duplication Interface Circuit Pack

- If one SPE Select switch is in the AUTO position and one selecting either A or B carrier as active, or one switch selects A and the other selects B, the boards default to handling the selection of which carrier is active as if both switches were in the AUTO position. A WARNING alarm appears after one hour. The alarm is resolved 5 minutes after the switches are returned to identical positions.

- If both switches select either A carrier or B carrier active, then the Duplication Interface boards will force that carrier active (irrespective of state-of-health) and the red Override LED is lit. A MAJOR alarm is raised by SPE-SELE if the switches remain in these positions for more than 6 hours. The alarm is resolved within 5 minutes of the switches being returned to AUTO.

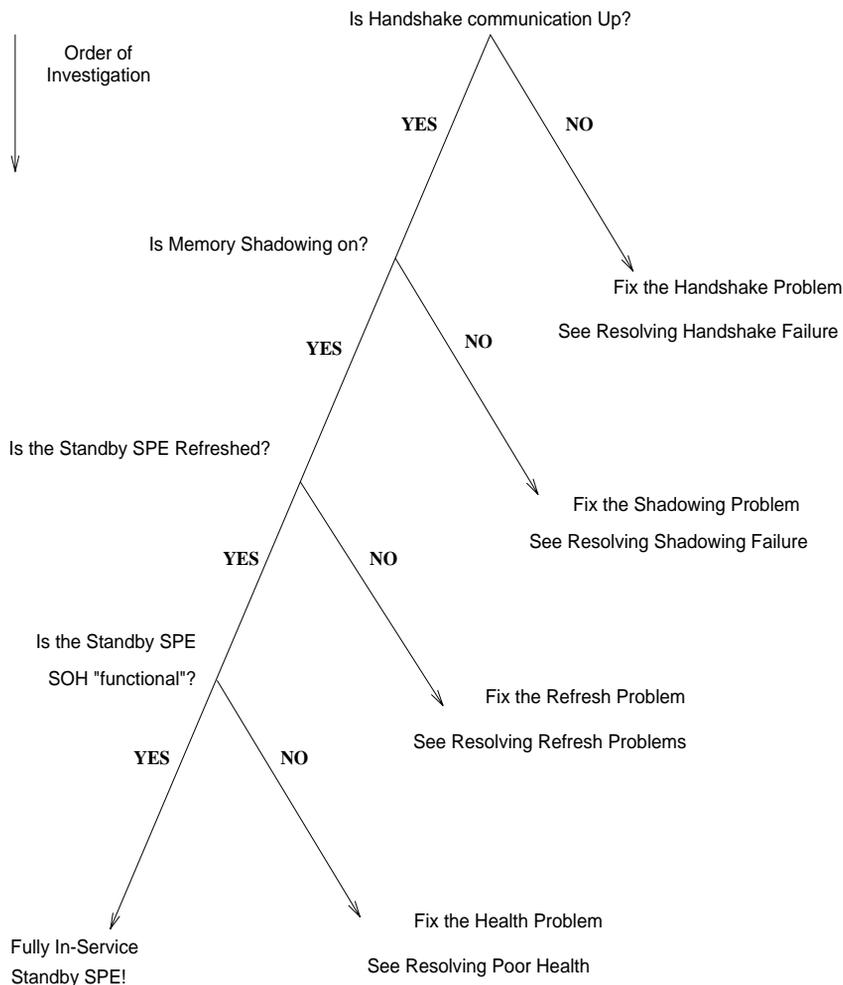
Figure 9-92. Resolving Standby-SPE Errors

A hierarchical approach is recommended in the above order. Follow the steps presented in the following diagram.

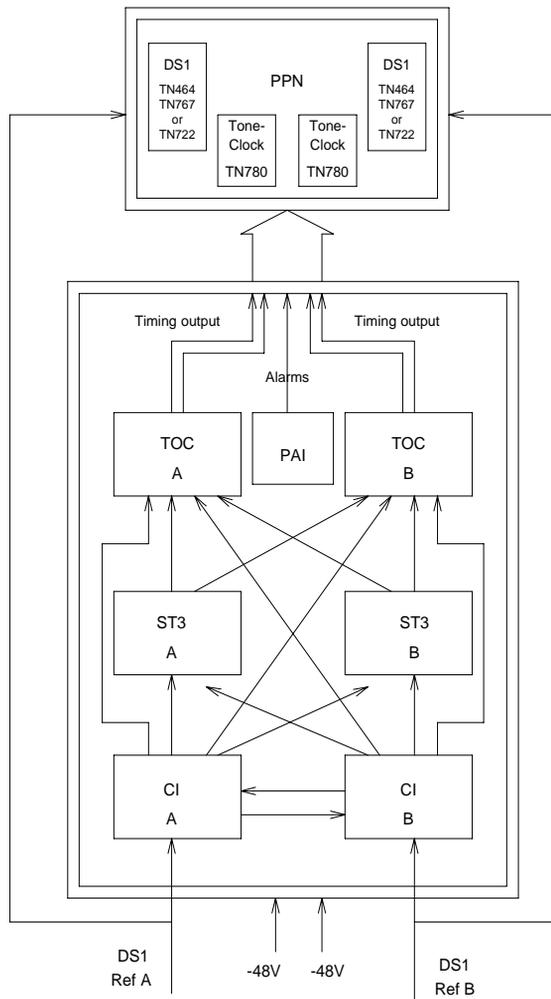
Figure 9-93. Stratum 3 Clock Hardware Configuration

In the system, the Stratum 3 clock has been implemented as an external which follows the specification in PUB 60110 for Stratum 3. The only external Stratum 3 clock that is supported is the Telecom Solutions Digital Clock Distributor™ for Customer Premise Timing (DCD-CPT) Stratum 3 clock. [Figure 9-93](#) shows how the Stratum 3 hardware configuration provides clock and alarm signals to the TN780 Tone-Clock circuit pack(s). The reference DS1 facilities connect directly to

the Stratum 3 clock for timing purposes, but the DS1 data may be routed into the switch by using a Y connector (H-600-274 G1 for the 50 pin DS1 end or H-600-274 G2 for the 15 pin DS1 end).

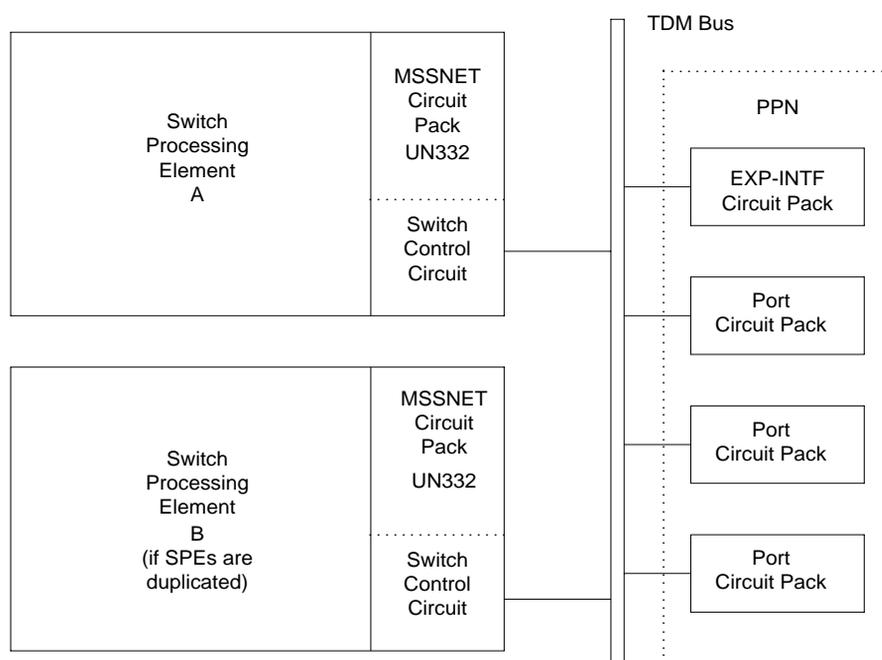
Figure 9-94. Switch Control Connectivity

The Switch Control sends control information between the SPE and port circuit packs on the Processor Port Network (PPN) as shown in [Figure 9-94](#). This control information is sent via the PPN cabinet's TDM (Time Division Multiplexed) bus. The portion of the TDM bus used to transmit control messages is called the control channel. The control channel can be on either TDM bus A or TDM bus B, but only one of the two buses is used for the control channel at any give time.

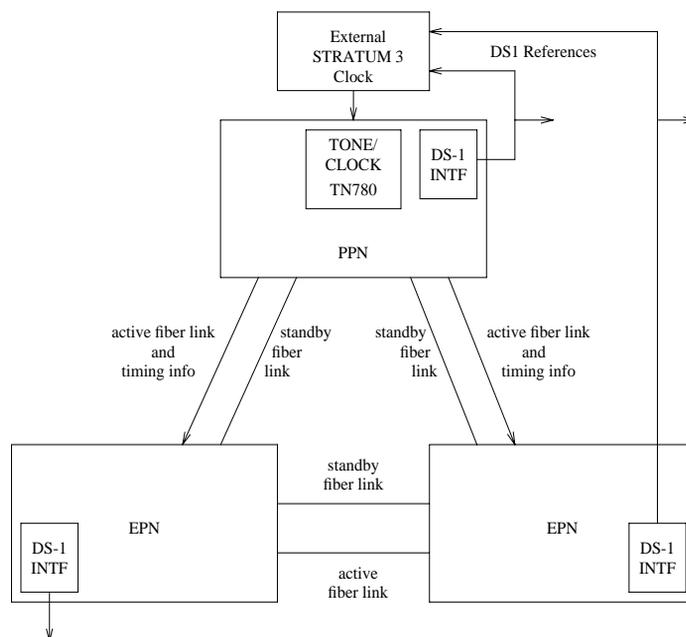
Figure 9-95. Typical Duplicated Direct-Connect Stratum 3 Synchronization Configuration

[Figure 9-95](#) illustrates one possible configuration of Stratum 3 synchronization.

* The EPN to EPN fiber link does not carry timing

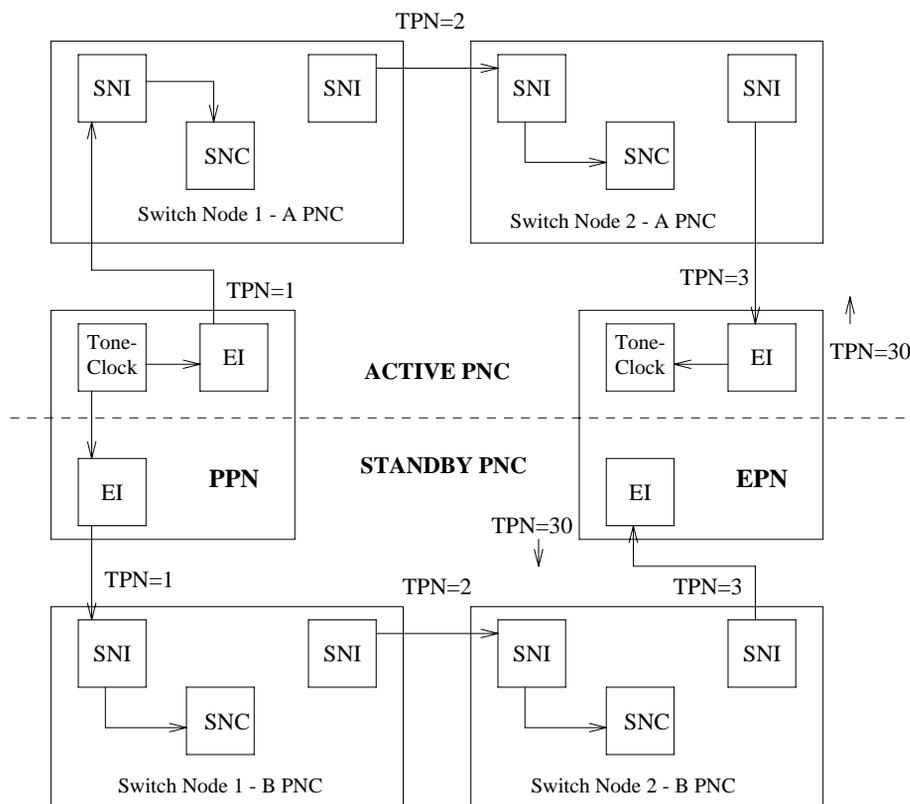
Figure 9-96. Typical Center Stage Switch Synchronization Configuration -Two Switch Nodes, Duplicated PNC

In the following typical duplicated Center Stage Switch (CSS) configuration, the timing signal from the *master* port network, the PPN in this diagram, is sent to all circuit packs in its network. The timing signal is sent from the Expansion Interface (EI) circuit packs in the PPN to the Switch Node Interface (SNI) circuit packs in the switch node carriers. The EIs in the *master* port network also sends out a timing priority number (TPN) of 1. Every *slave* port network EI sends out a TPN of 30. The active Switch Node Clock (SNC) circuit pack in each switch node carrier decides which SNI is providing the timing signal that the switch node carrier should synchronize to by looking at each SNI's incoming TPN. The SNC chooses the SNI with the lowest numbered TPN to synchronize to. The SNC then sends the timing signal to all SNIs and the standby SNC, if a standby SNC is present, in the switch node carrier. The SNC also sends out a TPN equal to 1 plus the lowest incoming TPN. Each SNI in the switch node sends the timing signal received from the SNC and the TPN from the SNC out on its associated fiber.

Timing information is sent through both the active and standby PNCs, but the EPNs normally derive timing from the EIs on the active PNC.

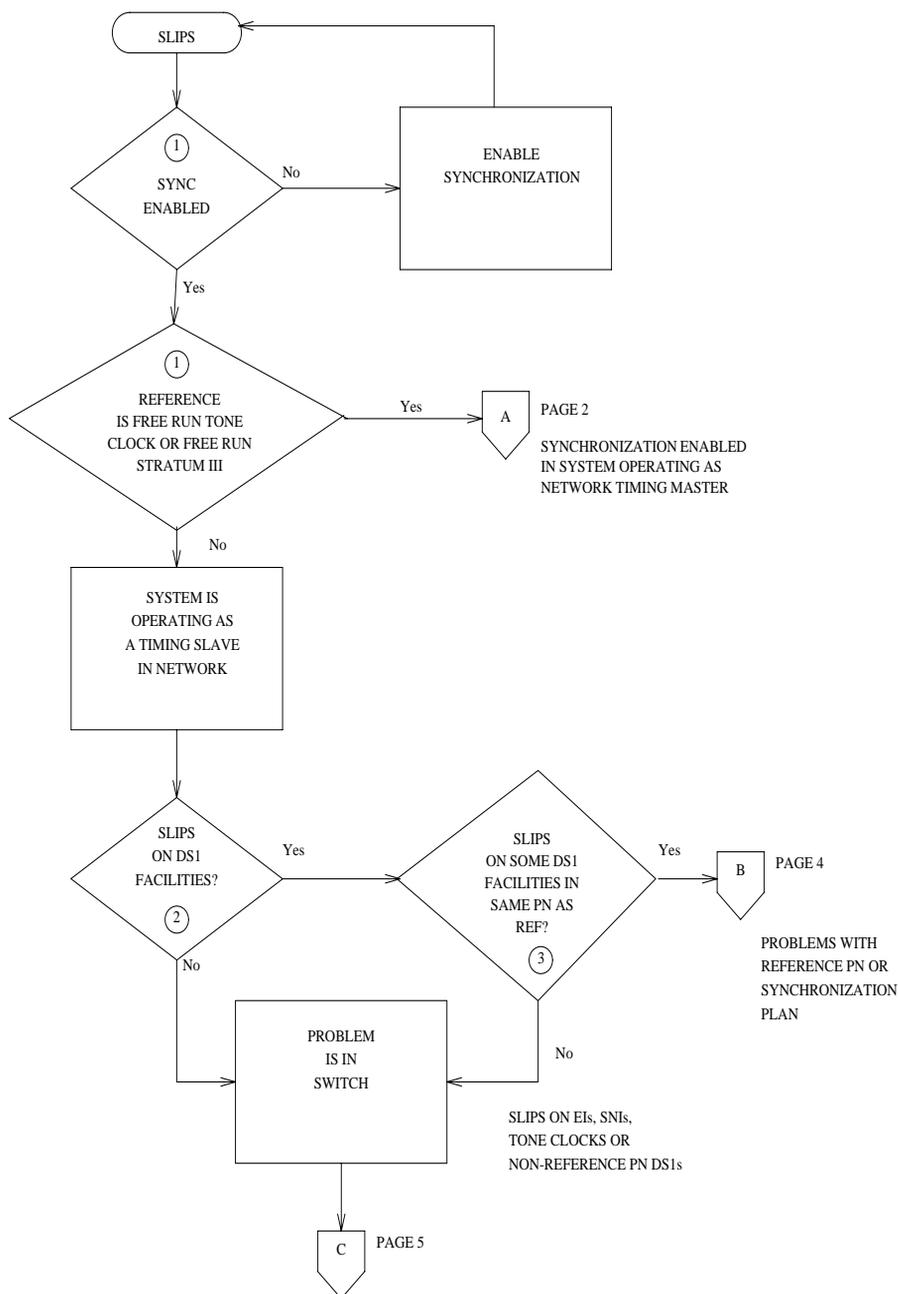
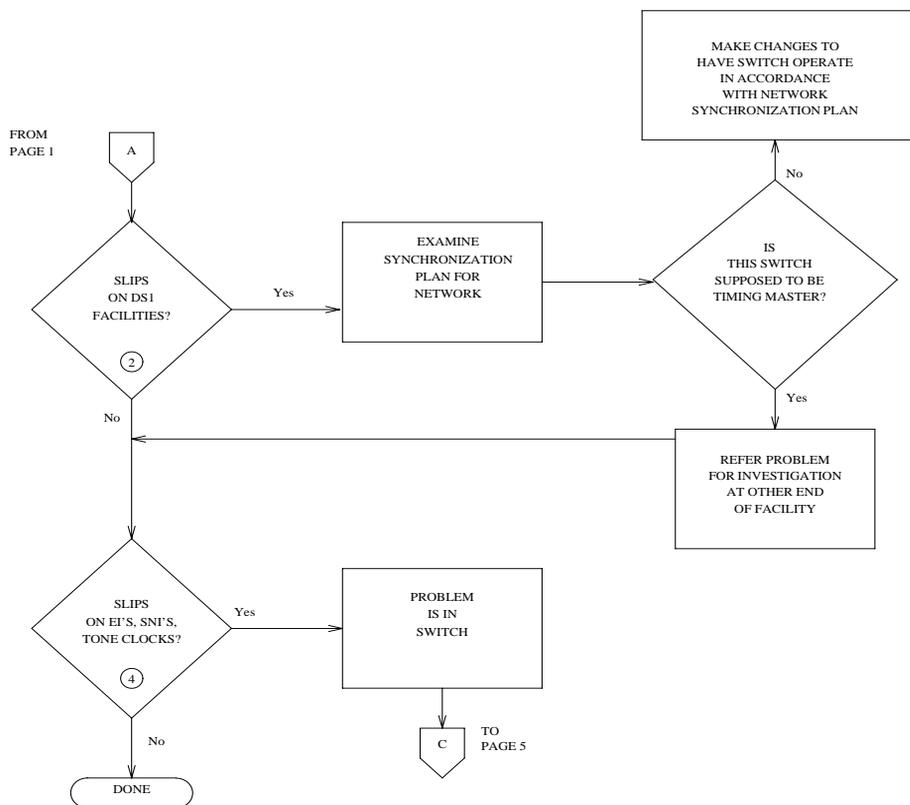
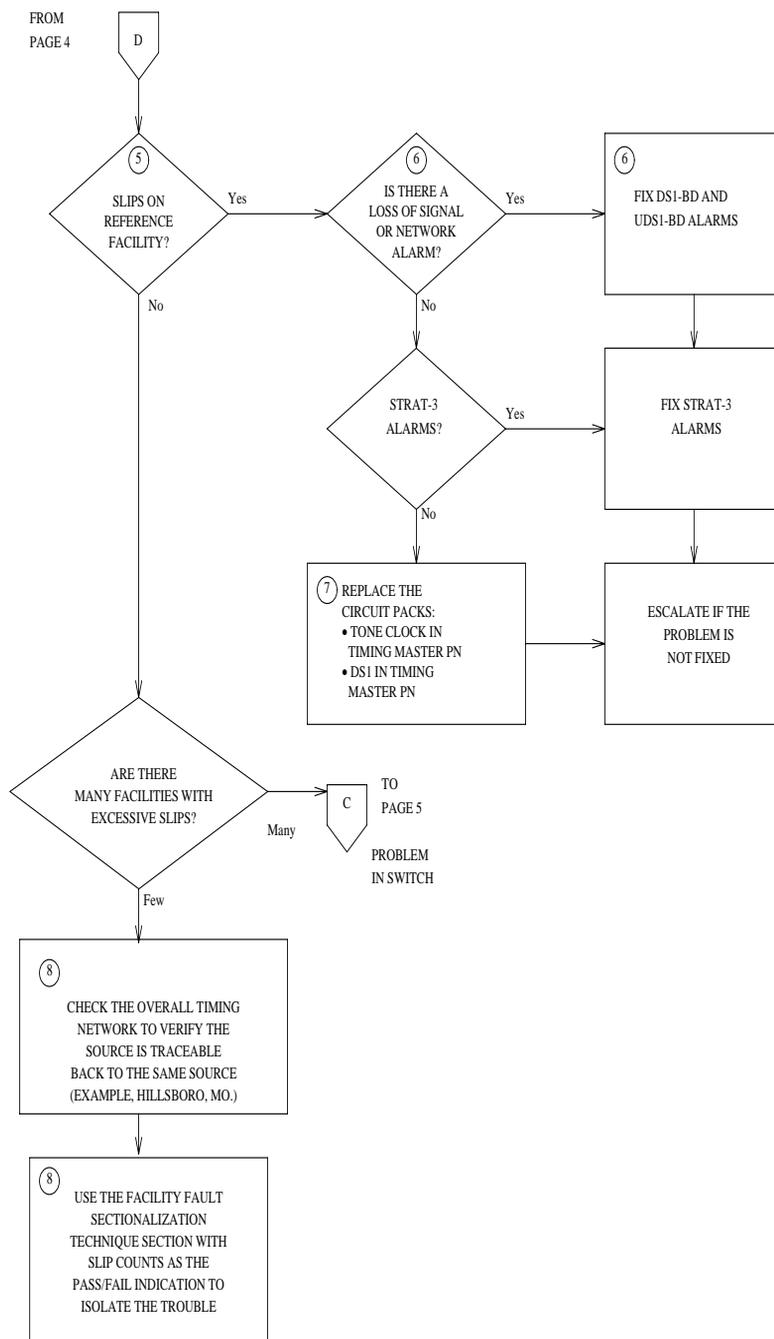
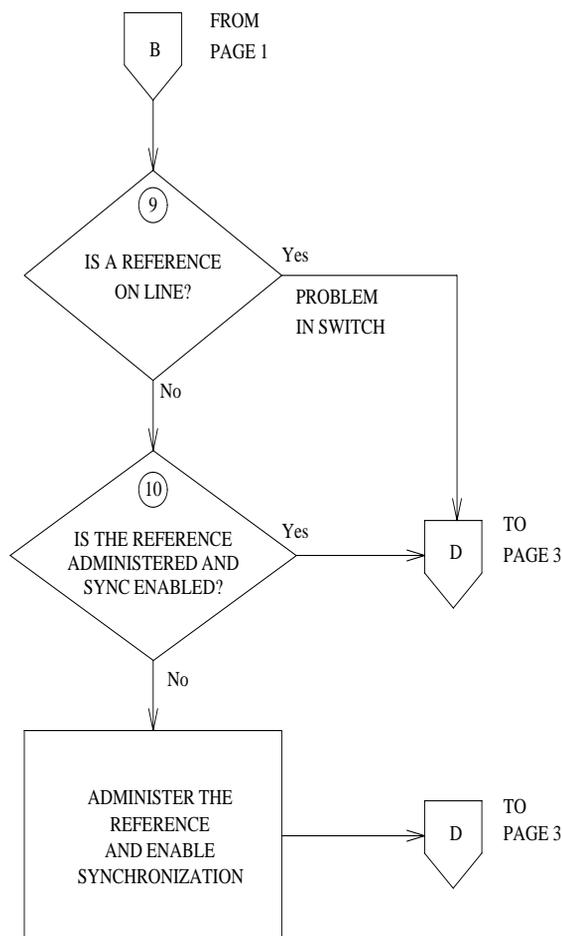
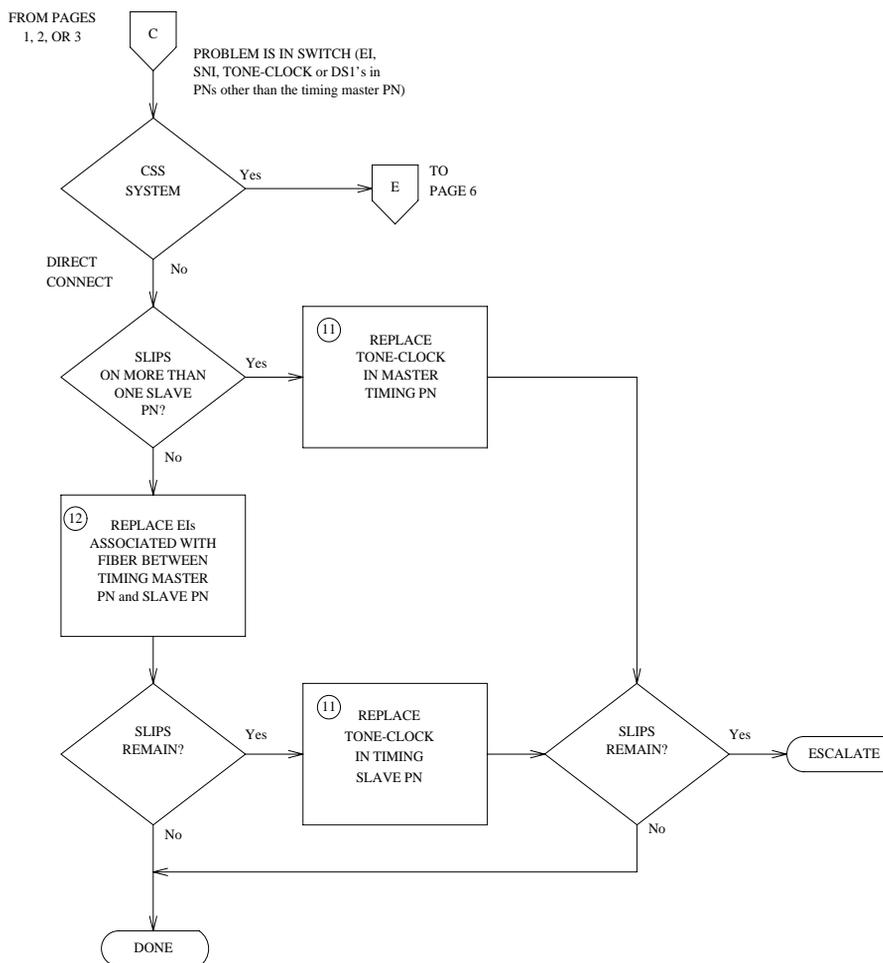
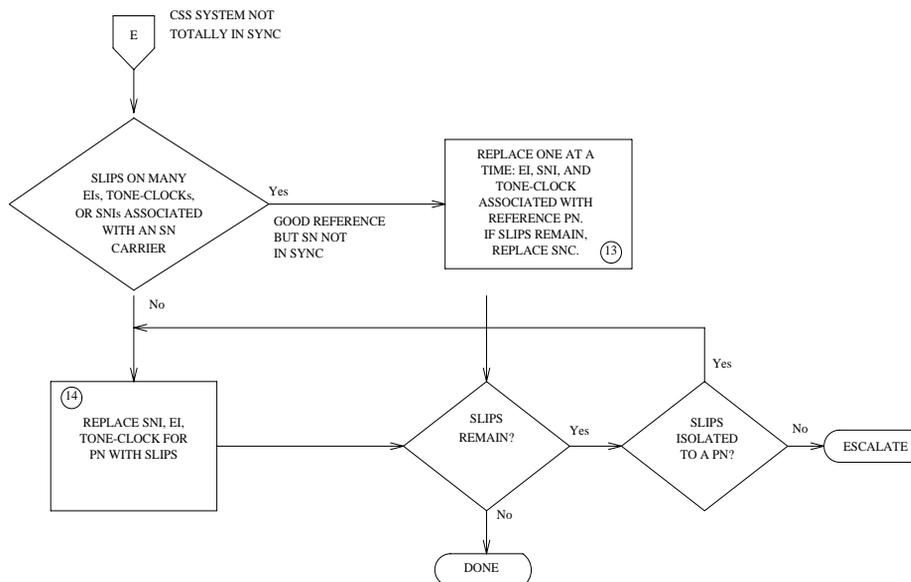
The following flow chart presents a logical approach to troubleshooting synchronization problems in conjunction with the background information presented above. Explanatory notes follow the charts.

Figure 9-97. Synchronization Troubleshooting, Page 1 of 6

Notes for Sheet 1 through Sheet 6 flowcharts (when checking for slip errors, use the table above, *Error Log Entries for Slip Errors*):

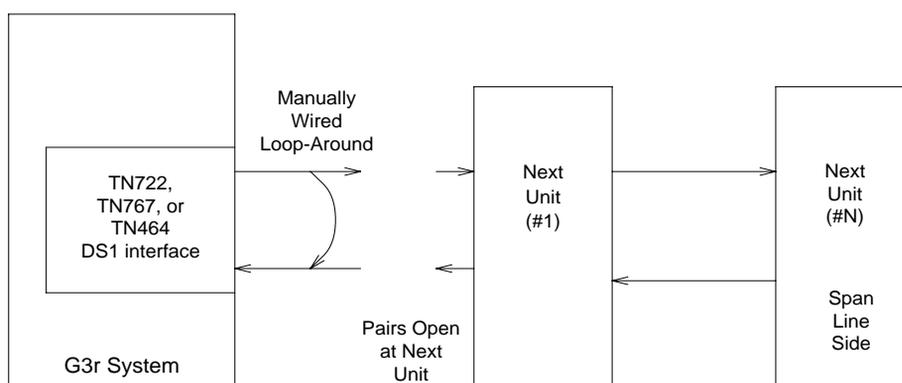
Figure 9-103. Manual Looparound for Facility Fault Sectionalization

[Figure 9-103](#) shows a sequence of units (1 though n) that may be connected as the on-site equipment. A typical example is the case where the only on-site equipment is channel-terminating equipment designated Unit #1. A more complex, less typical example might have a DACS as Unit #1, a protection switch as Unit #2, and a DS-1-level microwave radio system as Unit #3.

Remove the transmit signal from the TN722, TN767, or TN464 circuit pack inputs and outputs and loop it around to the receive signal going toward the TN722, TN767, or TN464 circuit pack at the first unit wired to the TN722, TN767, or TN464 circuit pack. (See [Figure 9-103](#)).

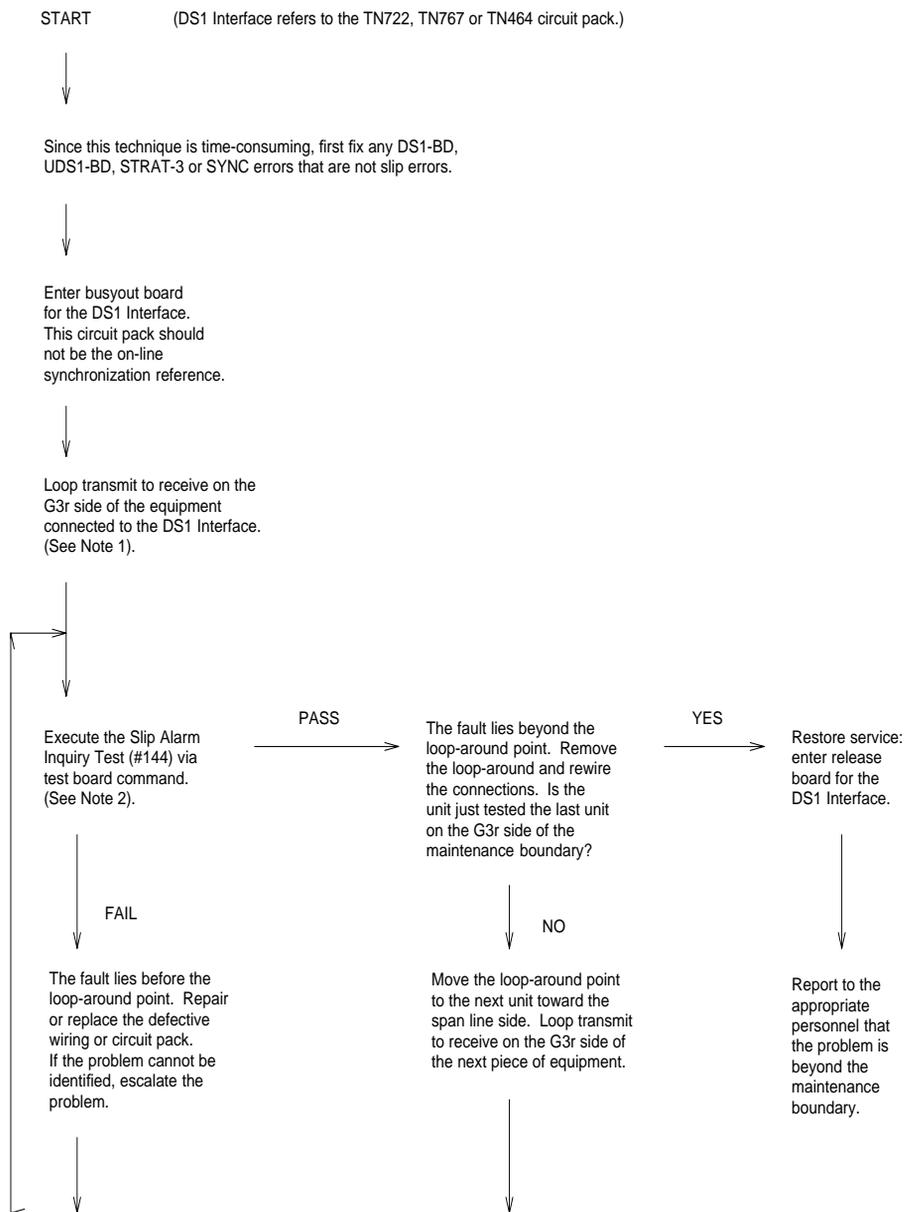
Figure 9-104. Facility Fault Sectionalization

The flowchart in [Figure 9-104](#) gives an overview of the facility fault sectionalization technique. It is important that you know the configuration and wiring of the equipment for the problem facility in order to support this technique.

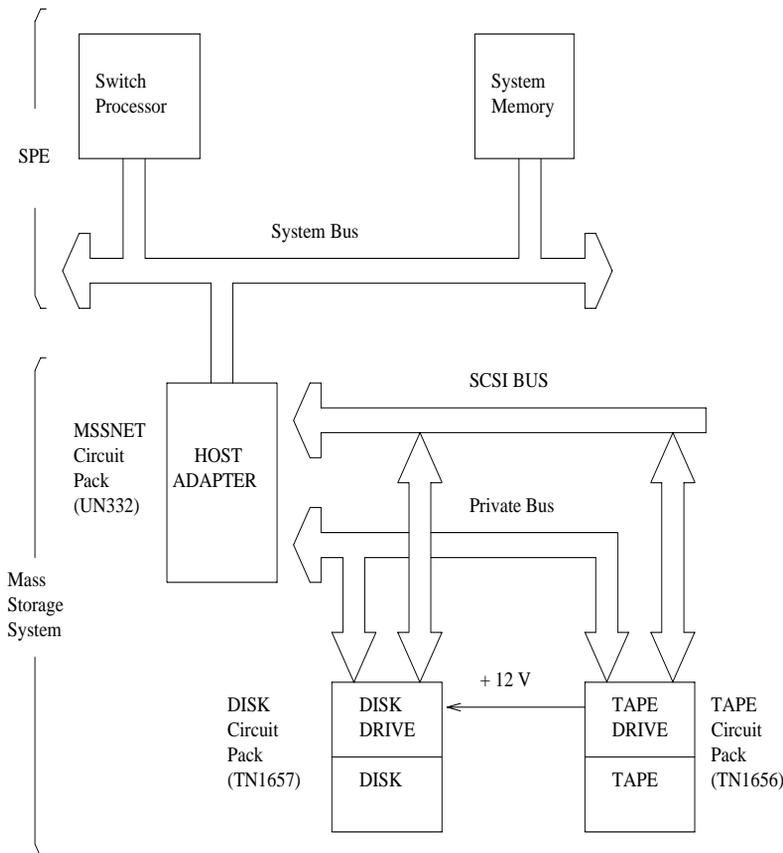
Figure 9-105. Mass Storage System Interactions

The TN1656 Tape circuit pack is part of the Mass Storage System (MSS). The MSS provides non-volatile storage for system software, translation data, announcement data and program update data. As shown in [Figure 9-105](#), the MSS consists of a Host Adapter circuit on the UN332 MSS-Network Control circuit pack (MSSNET), a Small Computer System Interface (SCSI) bus, a TN1656 Tape circuit pack and the TN1657 Disk Drive circuit pack. The Disk Drive acts as the primary storage device. The Tape Drive serves as a backup device and as a removable medium for system data.

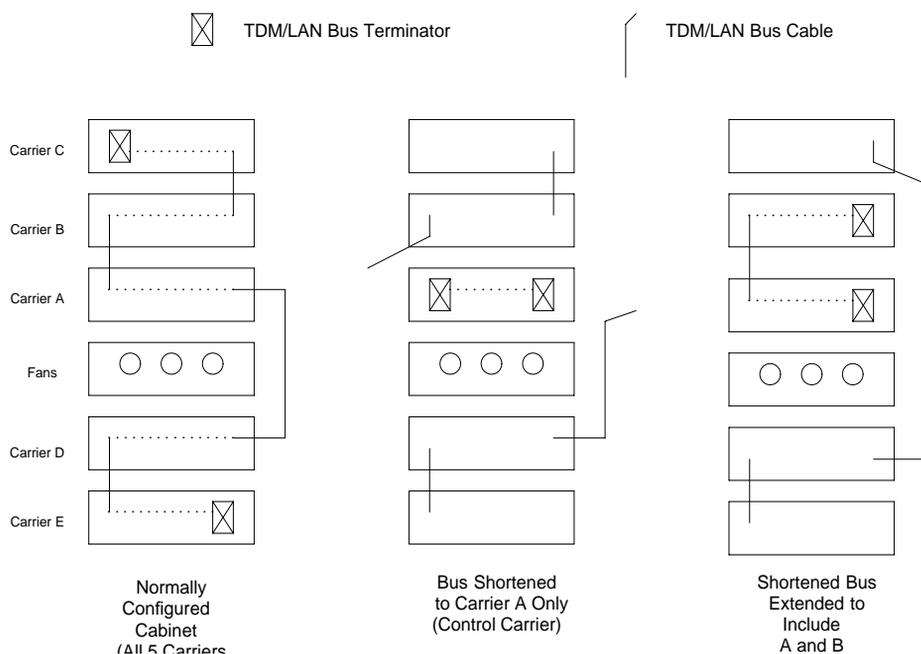
Figure 9-110. Carrier Rewiring Example—Rear View of Five-Carrier Cabinet

In this procedure, the TDM/LAN Cable Assemblies and TDM/LAN Bus terminators are replaced. If this action does not resolve the TDM Bus fault, the carriers are reconfigured so that certain carriers are disconnected from the TDM Bus. This is done by moving the TDM/LAN Bus terminators (ZAHF4) on the carrier backplane. To terminate a TDM Bus at the end of a particular carrier, the TDM Bus cable that connects the carrier to the next carrier should be unplugged and replaced with the TDM/LAN Bus terminator (see [Figure 9-110](#)). When the length of the TDM Bus is modified the circuit packs that are essential to the system operation and TDM Bus maintenance (for example, MSSNET and Tone/Clock), must still be connected to the new *shortened* TDM Bus.

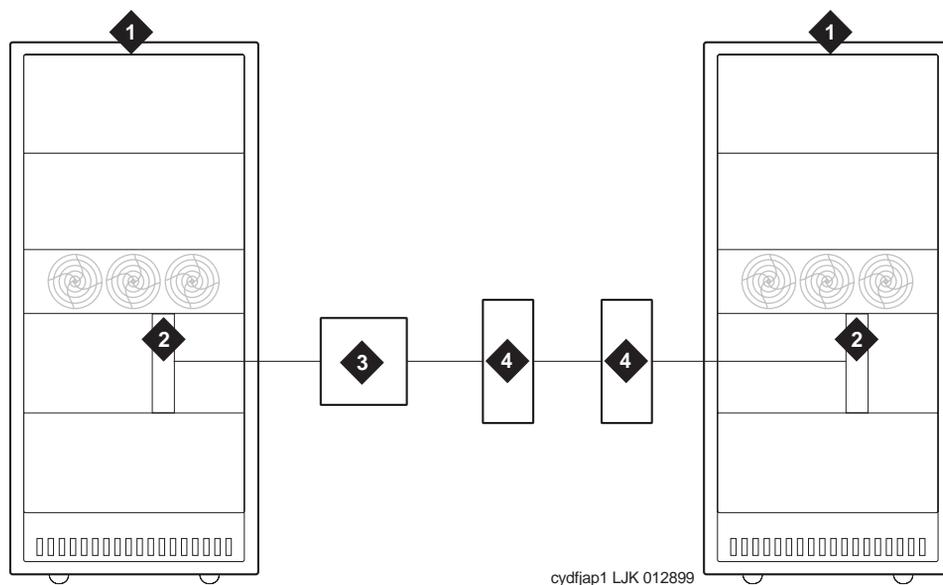
Figure 9-111. Japanese TTC public network connections

[Figure 9-111](#) shows the hardware connections for public network access in Japan. The upgrade procedure requires removing the JRC (Japan Radio Corporation) external converter in [Figure 9-112](#).

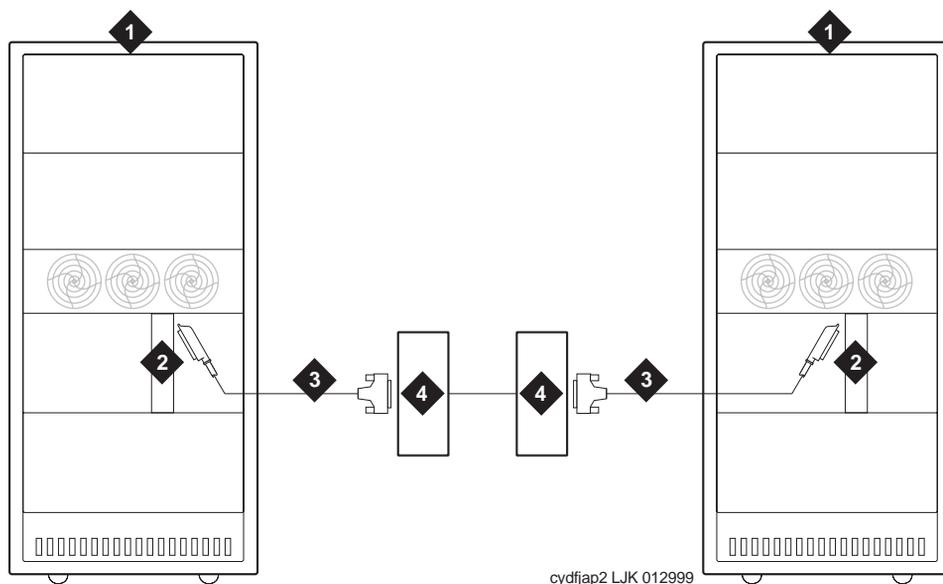
Figure 9-112. TN2242 Japan trunk TTC private network connections

[Figure 9-112](#) shows the hardware connections for private network access using the TN2242 circuit pack.

1. DEFINITY Release 7
2. TN2242 2Mbit Japan trunk circuit pack
3. H600-513 cable assembly cable. (See "[H600-513 cable pinout](#)").
4. TDM facilities

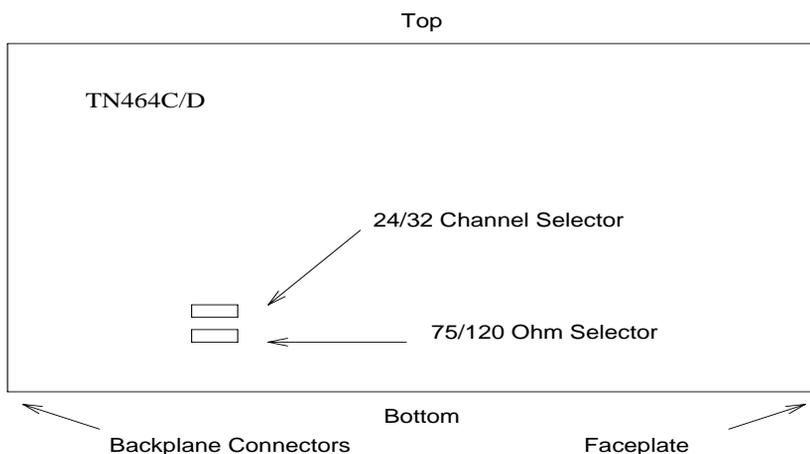
Figure 9-114. TN464C/D DS1 Option Jumpers

Two option jumpers located on the side of the TN464C/D circuit pack must be installed correctly. The figures on the following page shows how to configure the circuit pack for 24-channel or 32-channel DS1, and for 75*W (coaxial) or 120*W trunk connections. The channel selection must match the parameters administered on the corresponding DS1 Circuit Pack Form. (US applications use 24 Channels.)

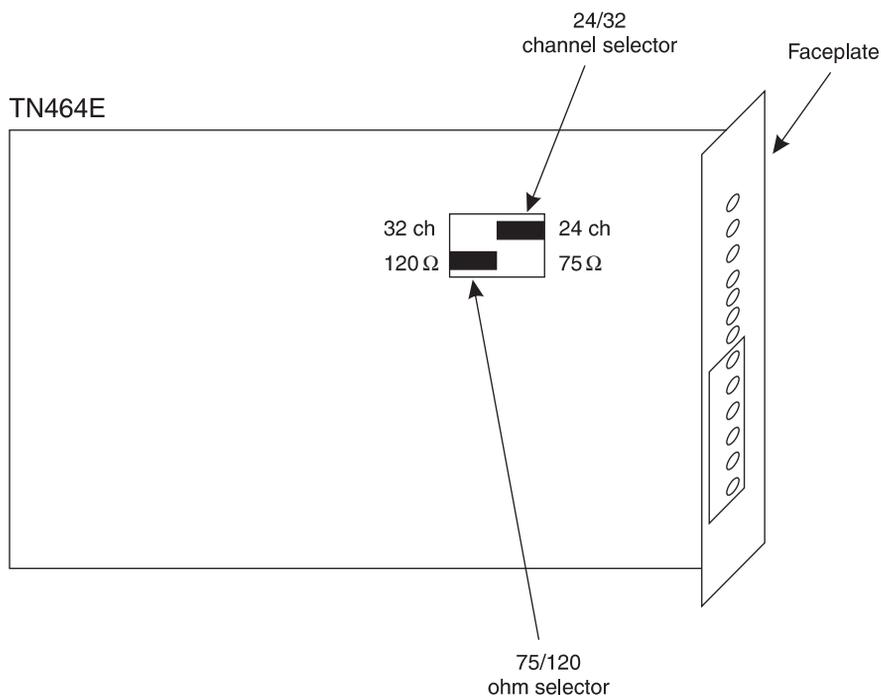
Figure 9-116. TN464E/F DS1 Option switches

The option switch located on the component side of the TN464E/F circuit pack must be set correctly. [Figure 9-115](#) shows how to configure the circuit pack for 24-channel or 32-channel DS1. The channel selection must match the parameters administered on the corresponding DS1 Circuit Pack Form. (US applications use 24 Channels.)

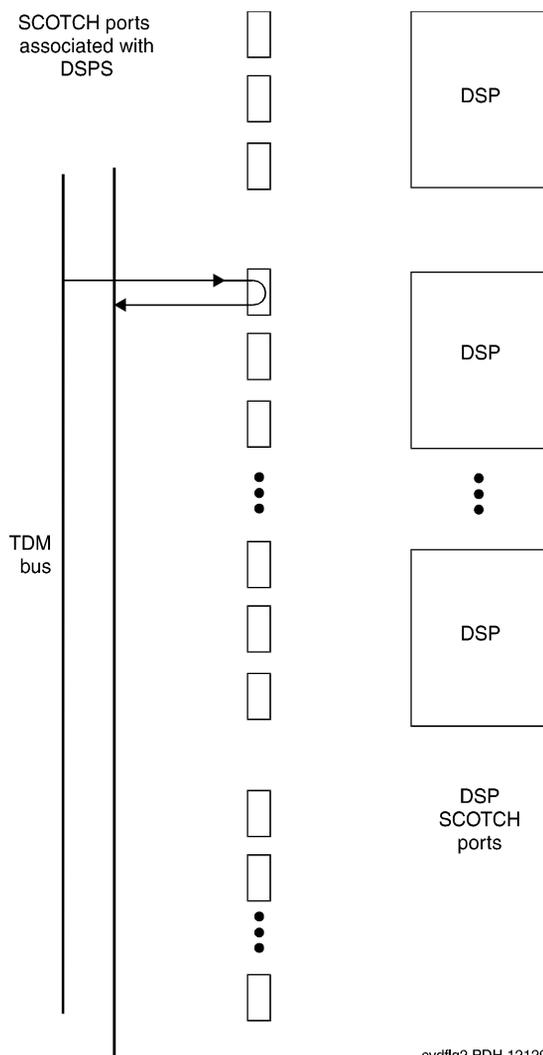
Figure 9-117. VC Circuit Pack DSP Port Local TDM Loopback Test

1. A Looparound test across the TDM bus.
2. A conference Circuit Test.

The tests are run in the above order; if one test fails, an error code is returned and the remaining tests in the sequence are not executed.

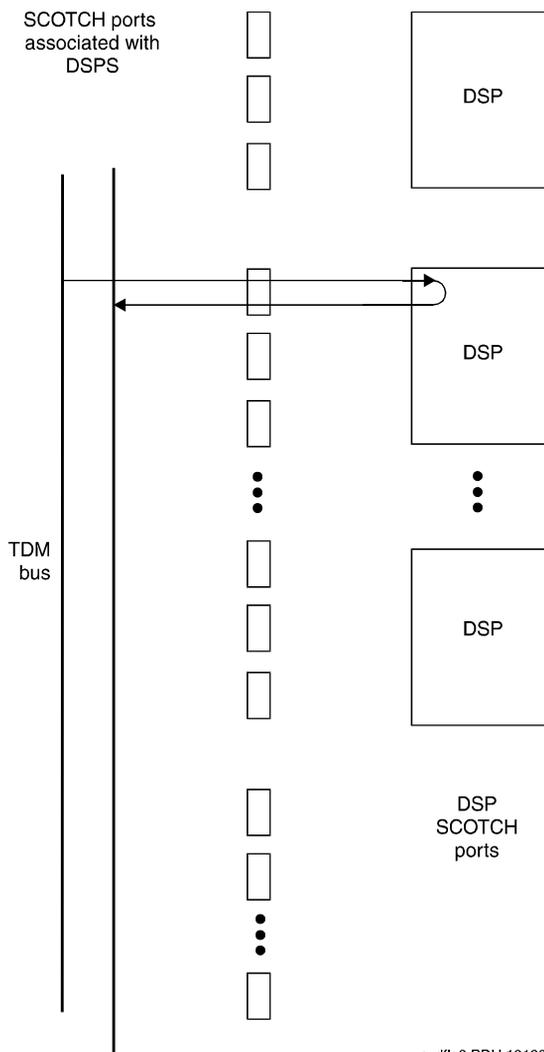
Figure 9-118. VC Circuit pack DSP Port DSP Looparound Test

This test verifies the connectivity of a VC-DSPPT across the TDM bus. It aborts if calls associated with the port are in progress. Failure of this test indicates an on-board fault associated with the port hardware on the circuit pack.

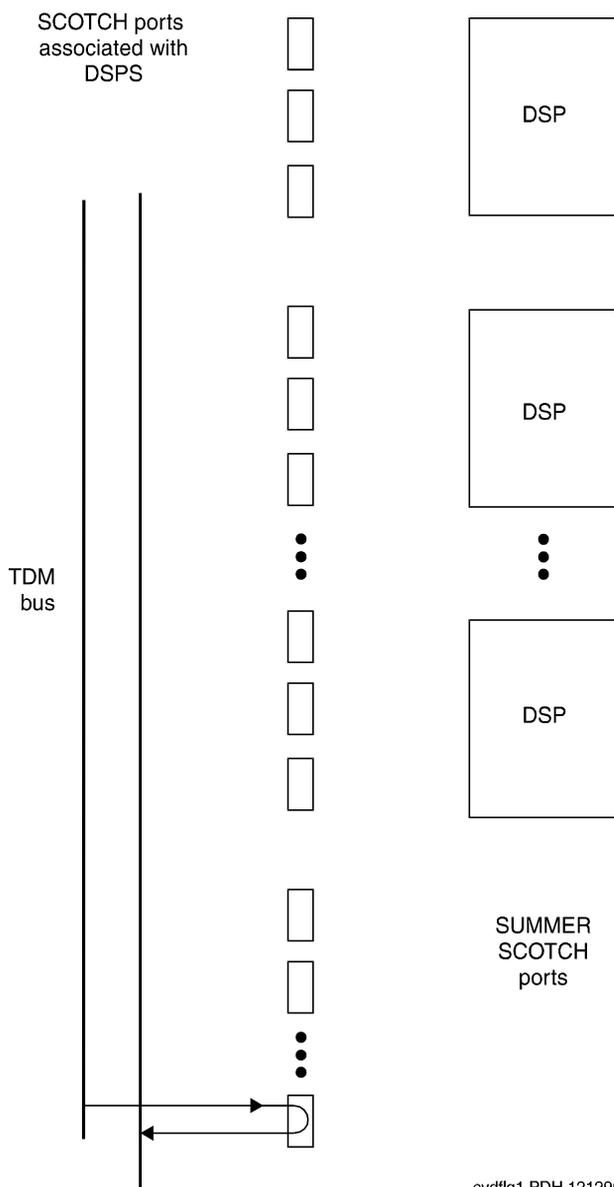
Figure 9-119. VC Circuit Pack Summer Port Loopback Test

- A Looparound test across the TDM bus.
- A conference circuit test.

The tests are run in the above order. If the first test fails, the switch returns an error code, and the second test is not executed.
