DEFINITY[®]

Enterprise Communications Server

Release 8.2

Maintenance for R8.2si

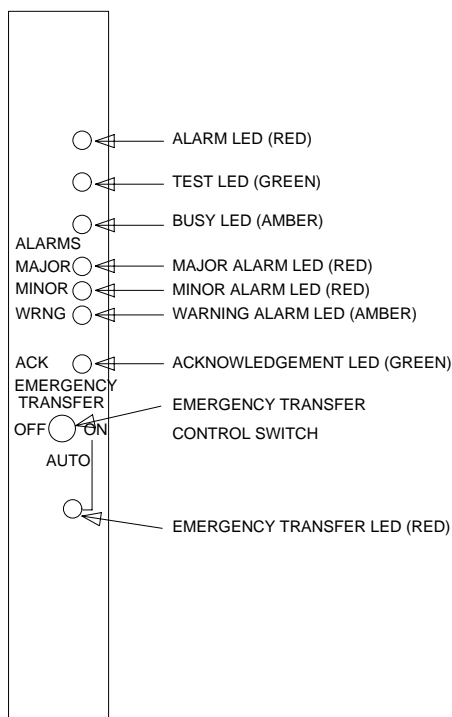
Figure 7-1. Indicators on Maintenance and Processor Circuit Packs

The front panels of the Processor circuit pack and the Maintenance circuit pack are identical. Each has two groups of LEDs. One group indicates the status of the pack, and the other group (which includes the Major, Minor, and Warning alarms described previously) reflects maintenance conditions in the entire system (that is, the PPN and EPN cabinets). See [Figure 7-1](#).

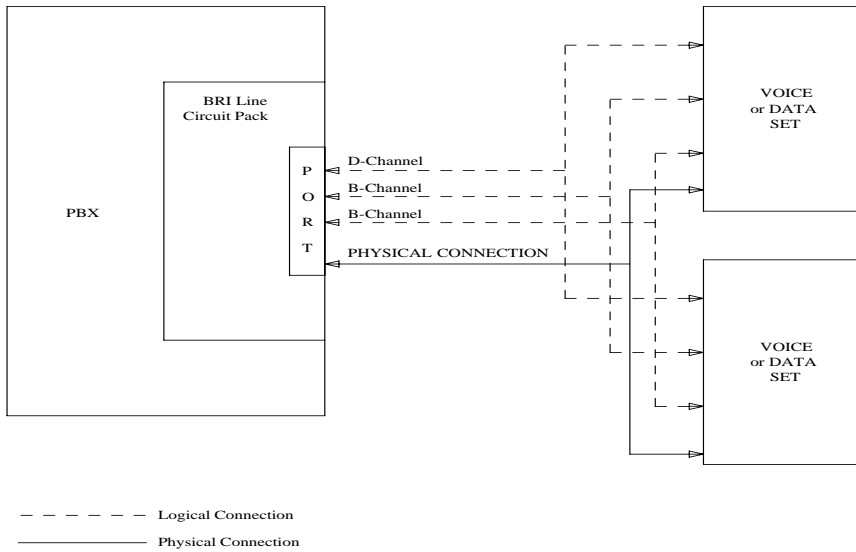
Figure 10-17. ISDN-BRI Set Interactions

Figure 10-9 illustrates the physical connection (solid line) between an ISDN-BRI Circuit Pack and a voice or voice/data set. Each physical connection allows for two B-channels, as stated above, plus one D-channel. Each ISDN-BRI circuit pack can support up to 12 of these PHYSICAL connections to different voice and voice/data sets or ASAI and Lucent adjuncts.

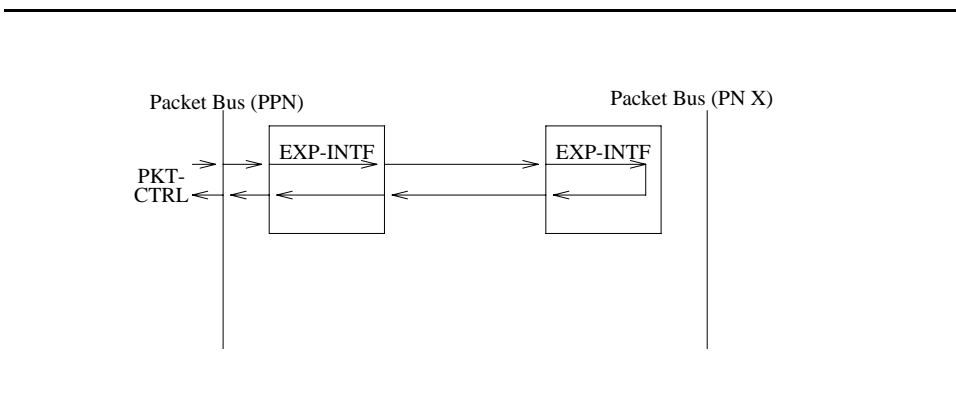
If the Expansion Interface circuit pack to be tested is on either EPN and is part of a Standby link from PPN to either EPN, the path shown in Figure 10-32 is used. The path in this figure is also used if the Expansion Interface circuit pack to be tested is on the PPN.

Figure 10-39. (Standby EXP-INTFs on EPNs or PPN EXP-INTFs Only)

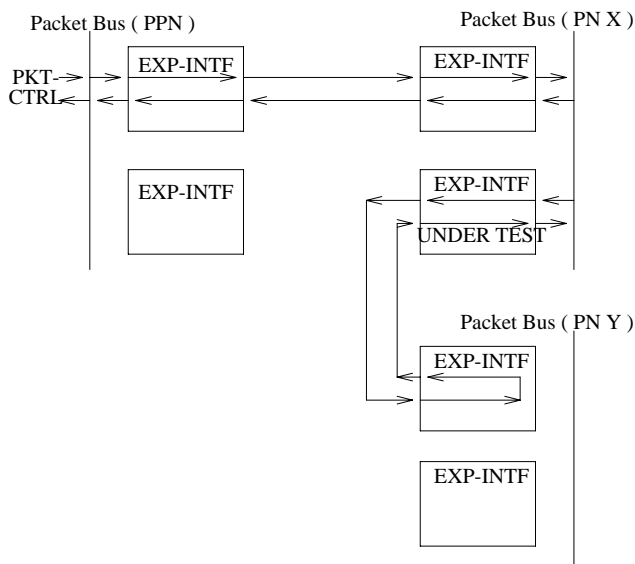
If the Expansion Interface circuit pack to be tested is part of a link from EPN to EPN, the path shown in Figure 10-33 is used.

Figure 10-40. Expansion Interface Packet Interface Test—EPN to EPN

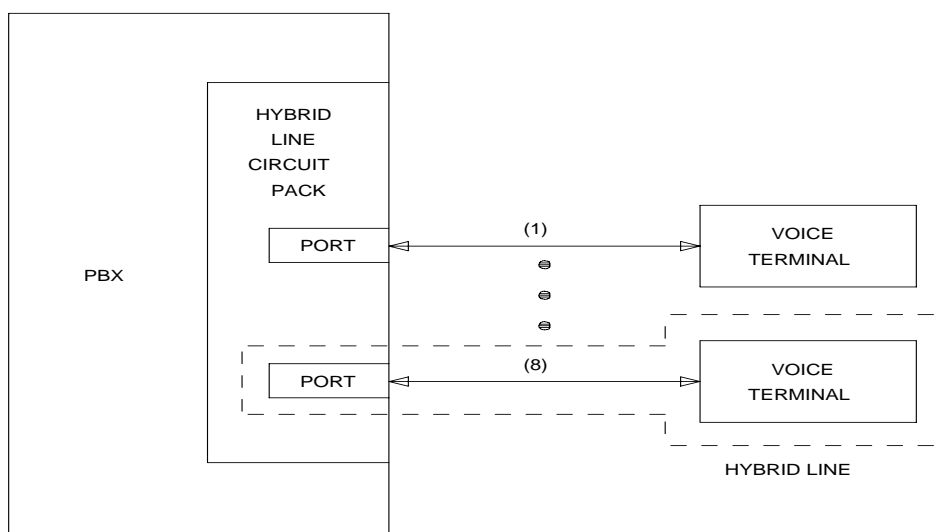
The TN762B Hybrid Line circuit pack supports eight of these multifunction analog telephone sets, as shown in the following figure. The Hybrid Line sets use three pairs of wires: an analog voice pair, a transmit/receive pair, and a power pair.

Figure 10-41. Hybrid Station Interactions

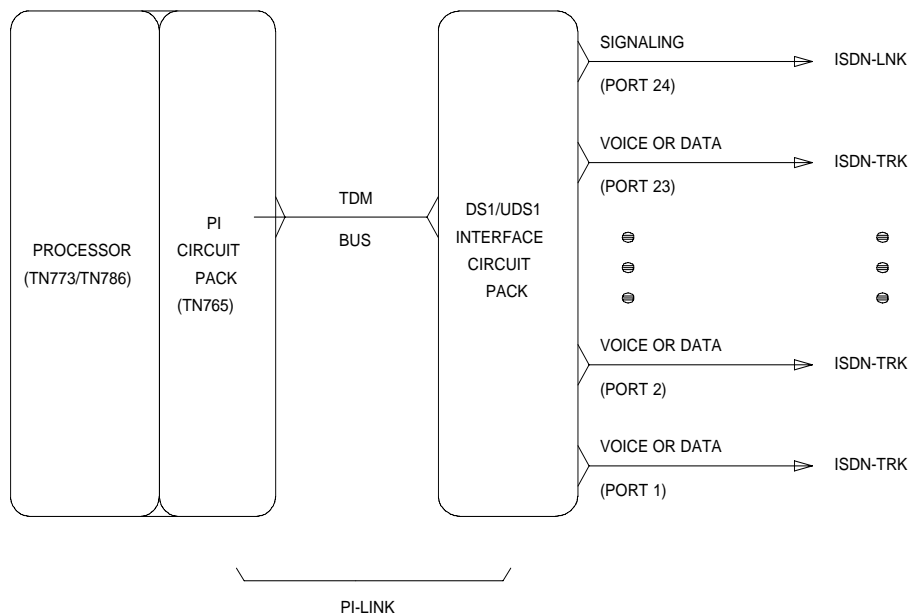
Figure 10-43. ISDN-PRI Signaling Link Port Interactions (24-Channel)

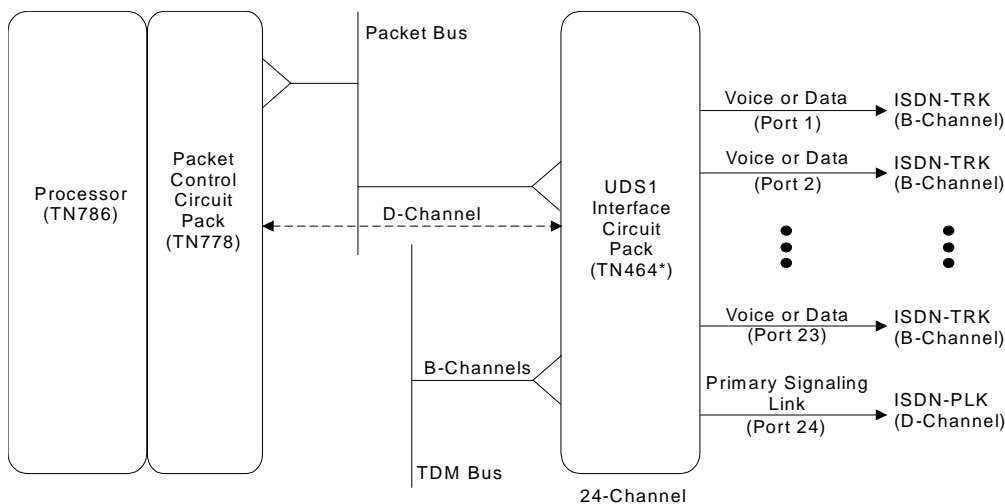
—— Physical connection
 - - - - Logical connection

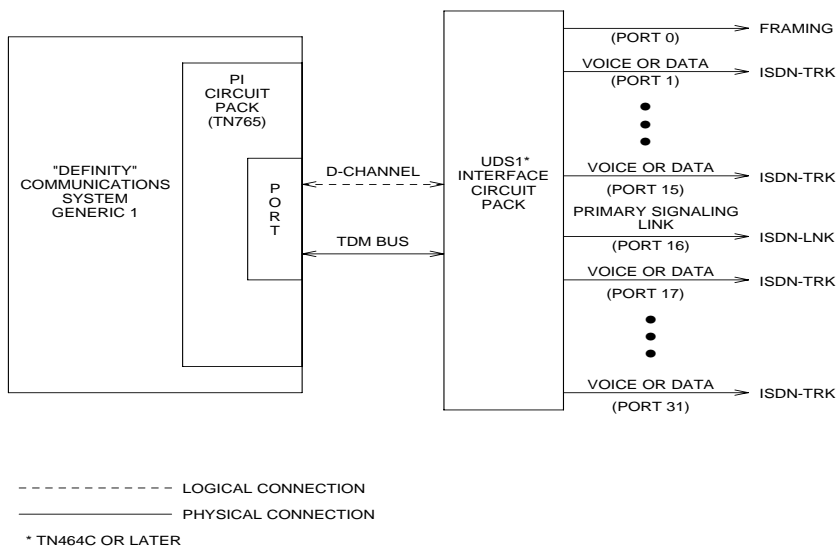
Figure 10-48. FAS ISDN-PRI Signaling Group (32 Channel) over Processor Interface

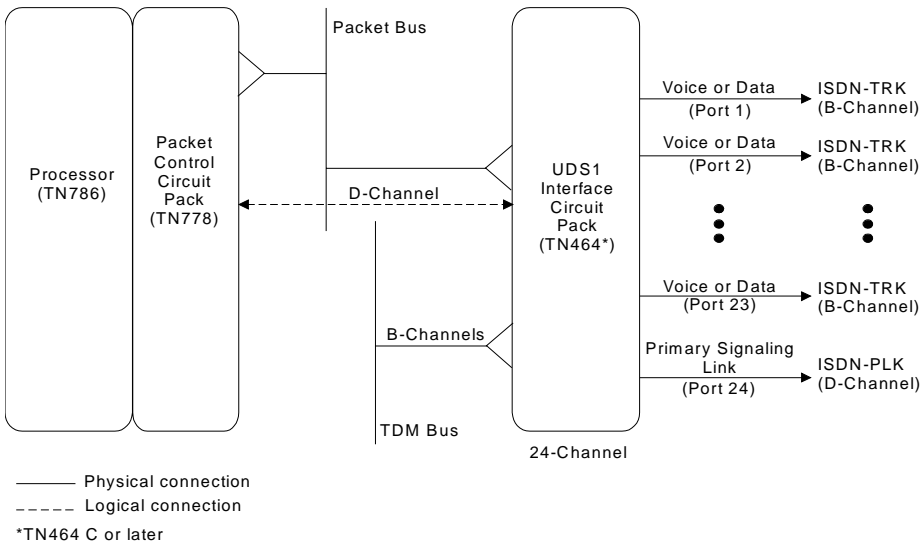
Figure 10-53. FAS ISDN-PRI Over PACCON Signaling Group (24 Channel)

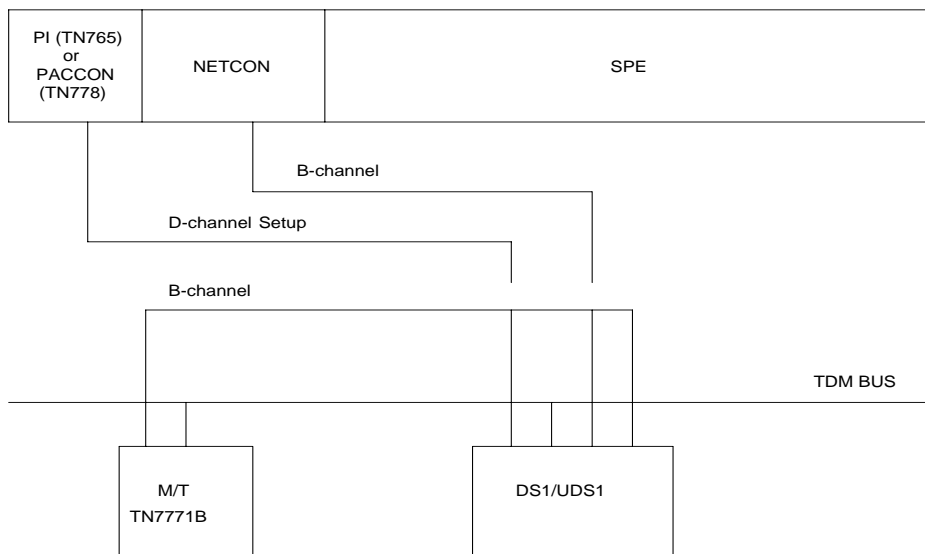
Figure 10-68. ISDN-PRI Outgoing Test Call

In the second method, the test call connection is established over the TDM Bus of the transmit and receive sides of the ISDN-PRI trunk to a digital trunk testing port on the Maintenance/Test circuit pack. The Maintenance/Test Digital Port generates a pseudo bit stream. A pictorial description of the outgoing ISDN-PRI test call connectivity is contained in the following figure.

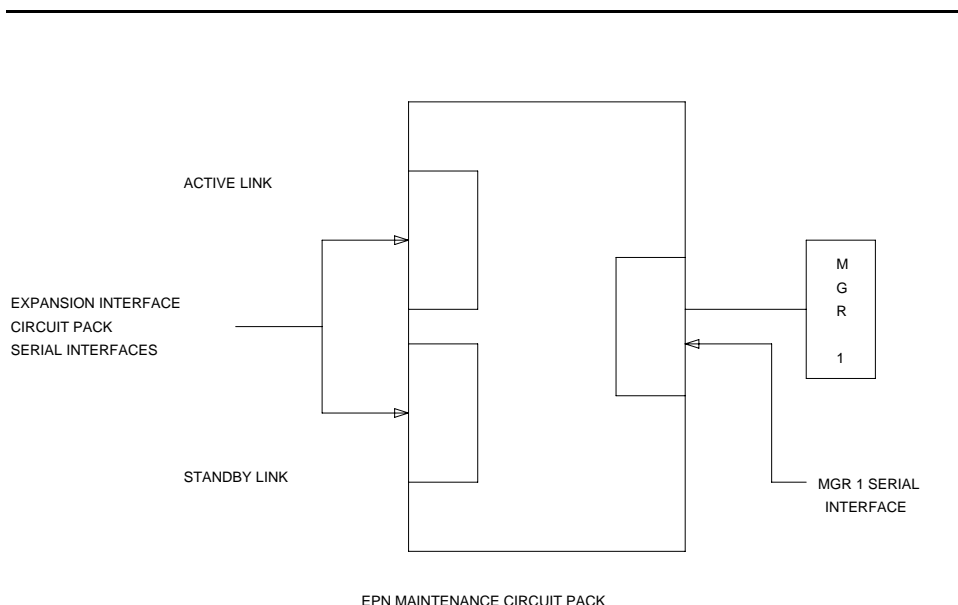
Figure 10-70. EPN Manager I (G1) or G3MT Connection

This test checks the on-board circuitry of the EPN Maintenance circuit pack associated with the serial link for the terminal connection. This test does not cause the terminal to become disconnected. However, any data being displayed on the terminal while the test is running is lost. [Figure 10-70](#) shows the three serial interfaces on the EPN Maintenance circuit pack and is meant to clarify that only the one dealing with the EPN terminal is being tested.

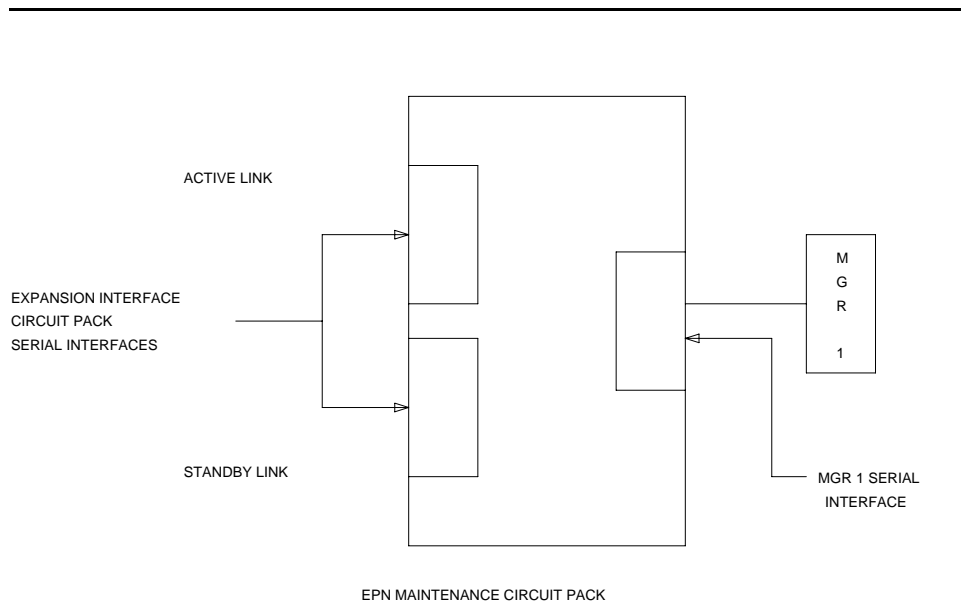
Figure 10-71. EPN Expansion Links Connections

This test checks the on-board circuitry of the EPN Maintenance circuit pack associated with the serial links to the Expansion Interface circuit pack. [Figure 10-71](#) shows the three serial interfaces on the EPN Maintenance circuit pack and is meant to clarify that the two dealing with the Expansion Links are being tested. A request is sent to the EPN Maintenance circuit pack over the Active link via the Active Expansion Interface circuit pack serial interface circuitry to test the serial

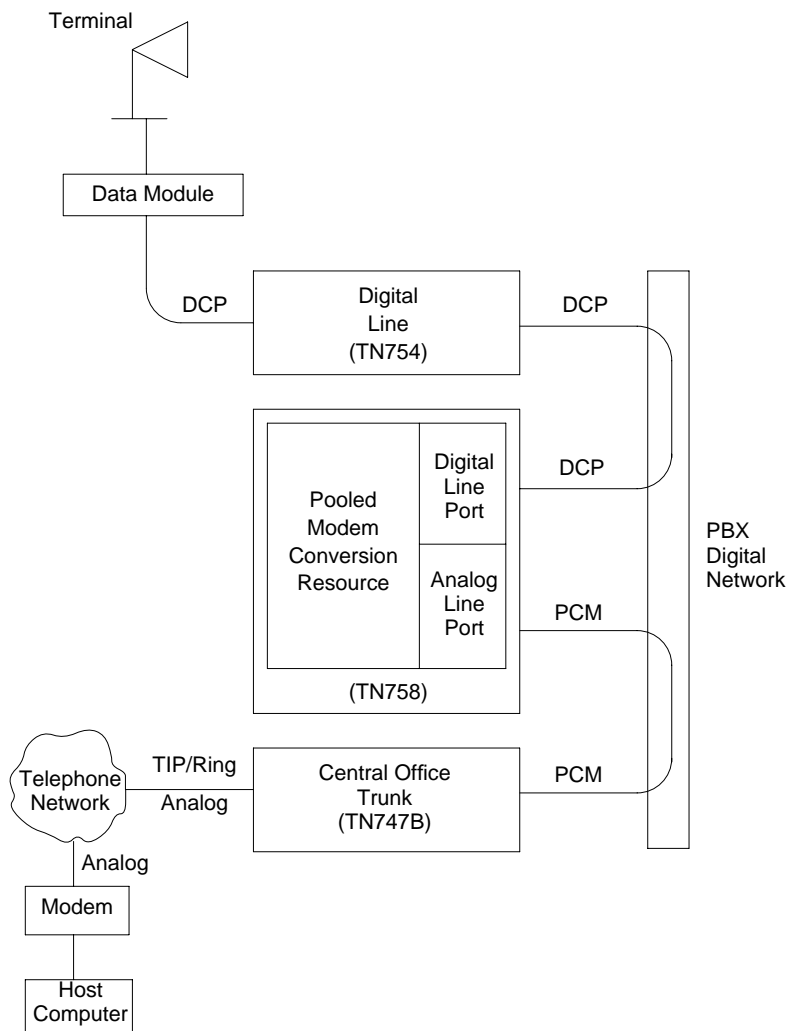
Figure 10-78. Typical Modem Pool Switched Connection with Integrated Pooled Modem

There are two primary types of Modem Pool conversion resources available: an Integrated Pooled Modem and a Combined Modem Pool. The integrated TN758 Pooled Modem circuit pack contains two independent 300 or 1200 baud conversion resources. Each conversion resource contains two interfaces to the PBX digital network: an analog port and a digital port. The analog port is connected through the PBX network to the analog line or trunk port containing

the analog modem signals. The digital port connects through the PBX network to the digital line or trunk port in the call. [Figure 10-78](#) shows a typical end-to-end connection using a conversion resource on the integrated Pooled Modem circuit pack.

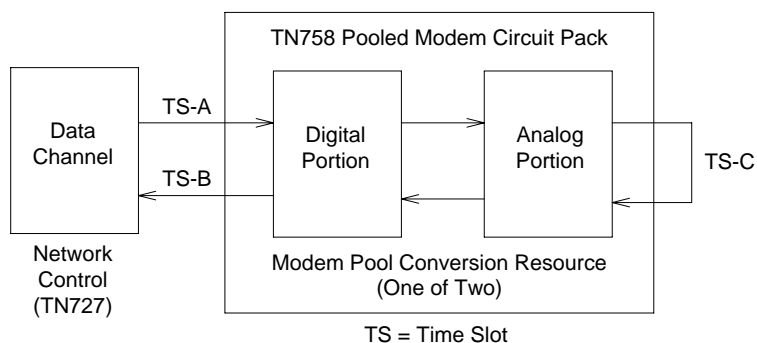
Figure 10-80. Modem Pool Conversion Resource Loop Around Test Set-up

The Modem Pool Conversion Resource Loop Around Test is set up as follows:

Test data patterns are transmitted from the Network Control Channels 1 or 3 over network time slot A through the digital port, looped around through the analog port via time slot C back to the Network Control Channel circuit via time slot B where the patterns are checked for accuracy. Finally, the test forces a disconnect by breaking the connection between the Data Channel and Modem Pool Port (time slot A) and verifying that the Data Channel and Modem Pool Port go on-hook within the proper time.

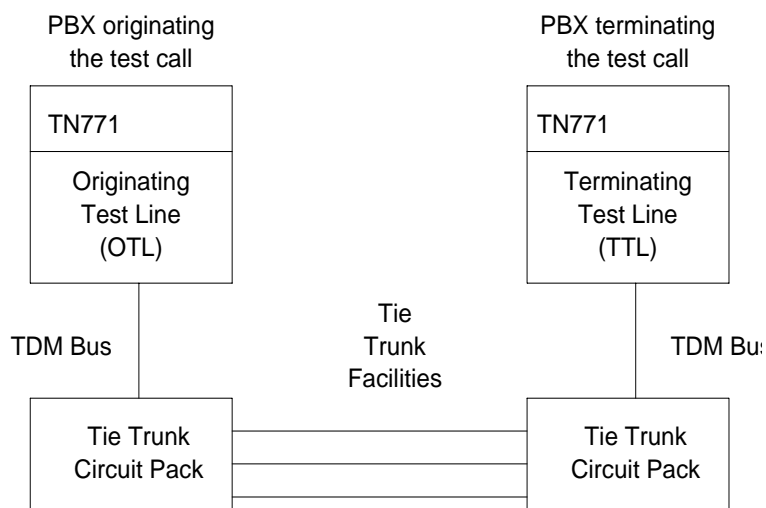
Figure 10-84. ATMS Tie Trunk Test Call

The Maintenance/Test Analog Port is port number 1 on the TN771 Maintenance/Test circuit pack. This port is used by the Automatic Transmission Measurement System (ATMS) as an Originating Test Line (OTL) or Terminating Test Line (TTL) for test calls over analog trunks. [Figure 10-84](#) shows a typical ATMS configuration.

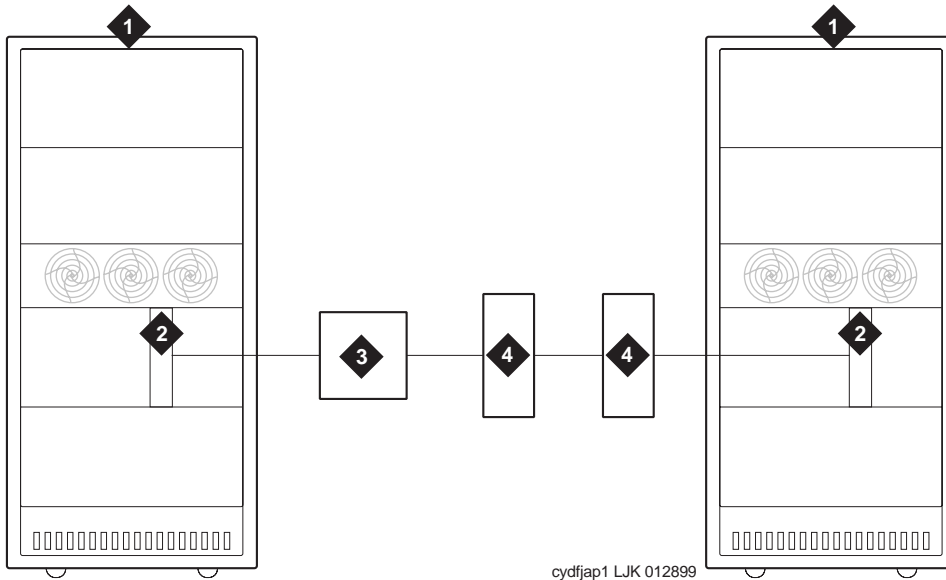
Figure 10-108. Japanese TTC public network connections

[Figure 10-108](#) shows the hardware connections for public network access in Japan. The upgrade procedure requires removing the JRC (Japan Radio Corporation) external converter in [Figure 9-37](#).

1. DEFINITY Release 7
2. TN464F DS1-CONV circuit pack (24-trunk digital tie-trunk)
3. JRC (Japan Radio Corporation) external converter
4. TDM facilities
