SERVICE MANUAL

DATSUN 240Z SPORTS
MODEL S30 SERIES

SECTION ST

STEERING

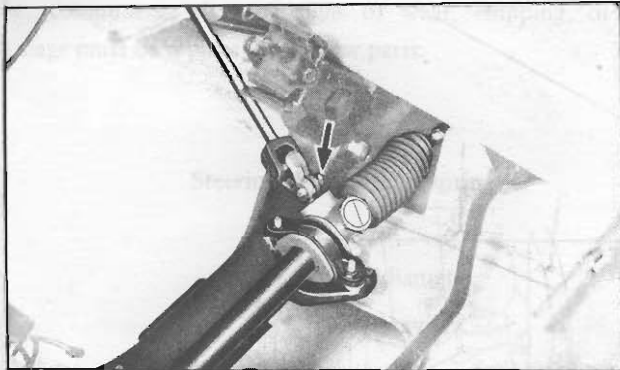
Fig. ST-13 Disconnecting lower joint from pinion

Loosen the bolt securing the steering lower joint to the pinion, and then remove the lower joint assembly from engine compartment.

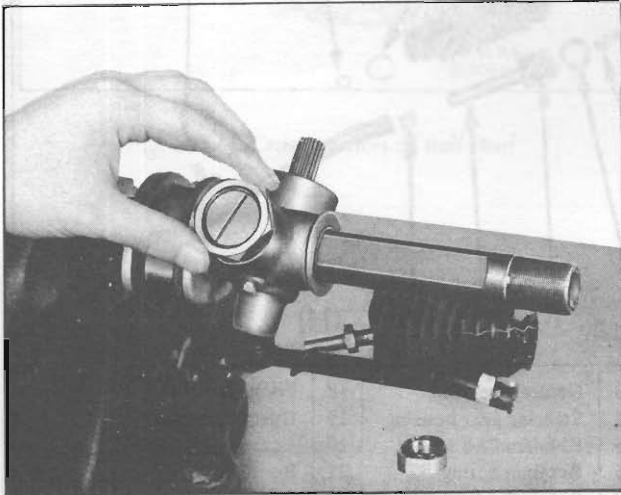
Fig. ST-18 Removing side rod outer socket

6. Loosen the side rod lock nut and disconnect the side rod outer socket assembly from the side rod bar.

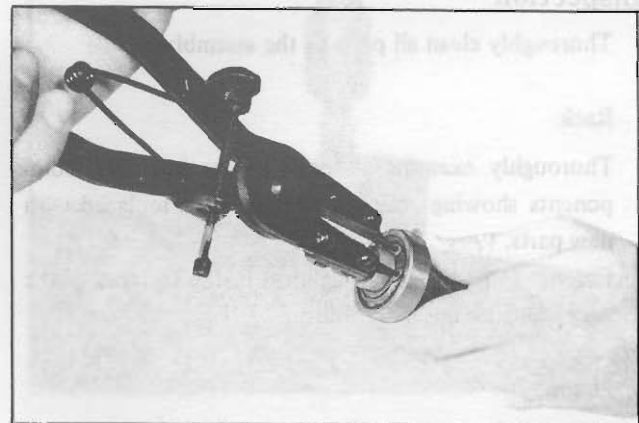
Fig. ST-22 Removing snap ring

10. Remove the snap ring and draw out the bearing from the pinion.

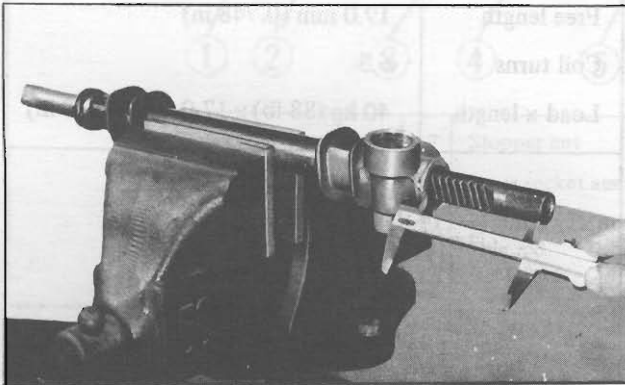
Fig. ST-26 Measuring protruding portion of rack

- Clamp the steering gear housing in a vise.
- Evenly apply recommended multipurpose grease to teeth and friction surfaces of the rack, and lubricate the gear housing from the pinion housing side.
- Make sure that the rack protrudes by the same amount from both ends of the housing [96 mm (3.78 in)] and that rack teeth are directed toward the pinion shaft.

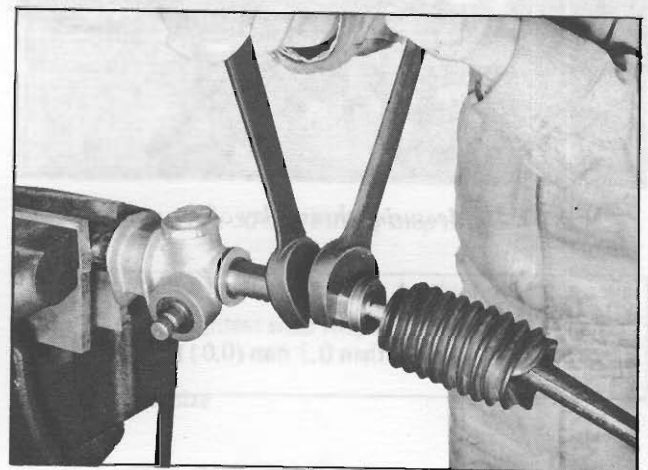
Fig. ST-38 Locking the stopper nut

21. Tighten the inner socket portion until the ball seat reaches the rack end, and lock with the stopper nut.

Stopper nut tightening torque:
7 to 9 kg-m (50.6 to 65.1 ft-lb)
