# SERVICE MANUAL

# DATSUN 240Z MODEL S30 SERIES

# STEERING SYSTEM

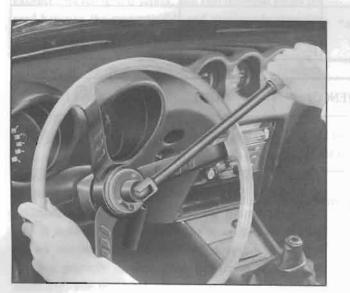
Fig. ST-3 Removing steering wheel

1. Remove the horn button by pulling rearward. Remove the steering wheel after removing the steering wheel nut.

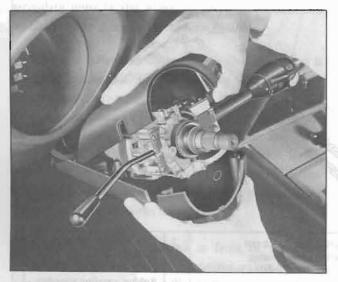
Fig. ST-4 Removing shell cover

2. Remove upper and lower steering column shell covers by loosening six screws. Then loosen two screws retaining the turn signal and lighting switch assembly to steering column and remove the switch assembly.

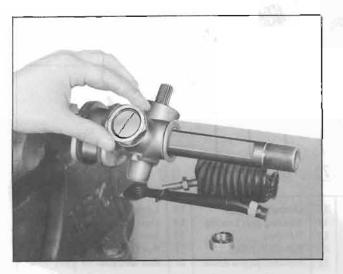
Fig. ST-18 Removing side rod outer socket

- 5. With draw the spring seat and side rod spring.
- 6. Loosen the side rod lock nut and disconnect the side rod outer socket assembly from the side rod bar.
