SERVICE BULLETIN

EL08-028

INTELLIGENT KEY INOPERATIVE

APPLIED VEHICLES: All Nissan with Intelligent Key

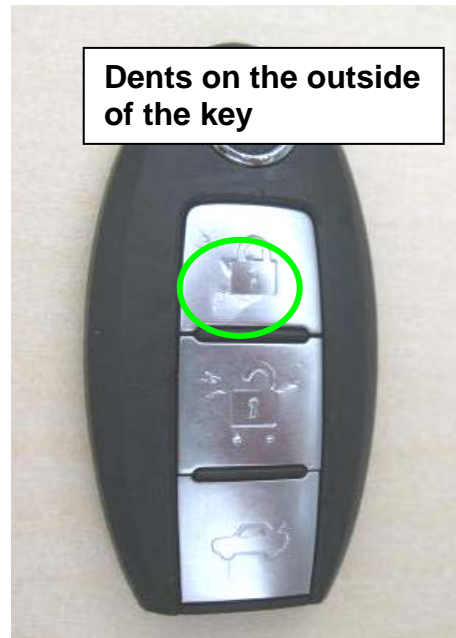
Figure 1

EXAMPLE OF PHYSICAL DAMAGE

Look for cracks, dents, or other signs of physical damage.

1. Check the outside of the Key for physical damage.

NOTE: Non-operation of the Intelligent Key due to physical damage is not covered under the vehicle warranty.

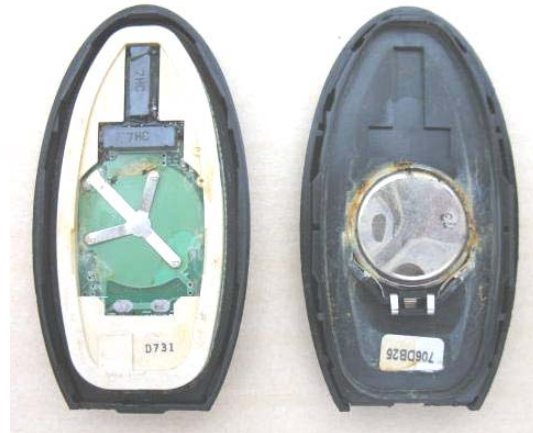
Figure 3

Corrosion on the circuit board and around the battery.

2. Check for water intrusion inside the Key.

NOTE: Non-operation of the Intelligent Key due to water intrusion is not covered under the vehicle warranty.
