**SECTION IP**  
**INSTRUMENT PANEL**

### PRECAUTIONS

### INSTRUMENT PANEL ASSEMBLY

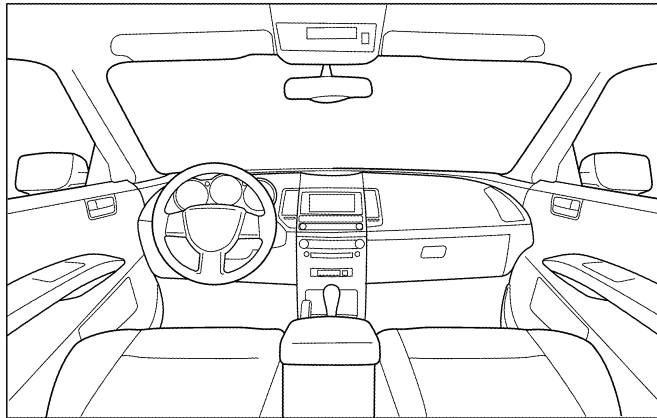
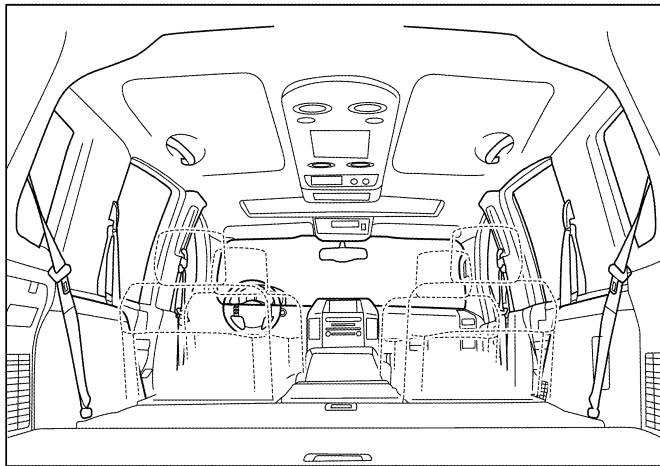
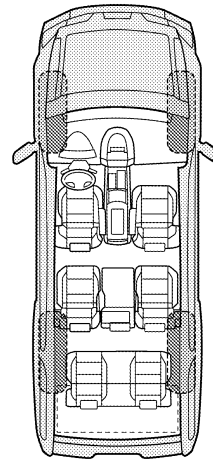
#### I. WHERE DOES THE NOISE COME FROM? (circle the area of the vehicle)

The illustrations are for reference only, and may not reflect the actual configuration of your vehicle.
