SECTION **IP**
INSTRUMENT PANEL

SERVICE INFORMATION

INSTRUMENT PANEL ASSEMBLY

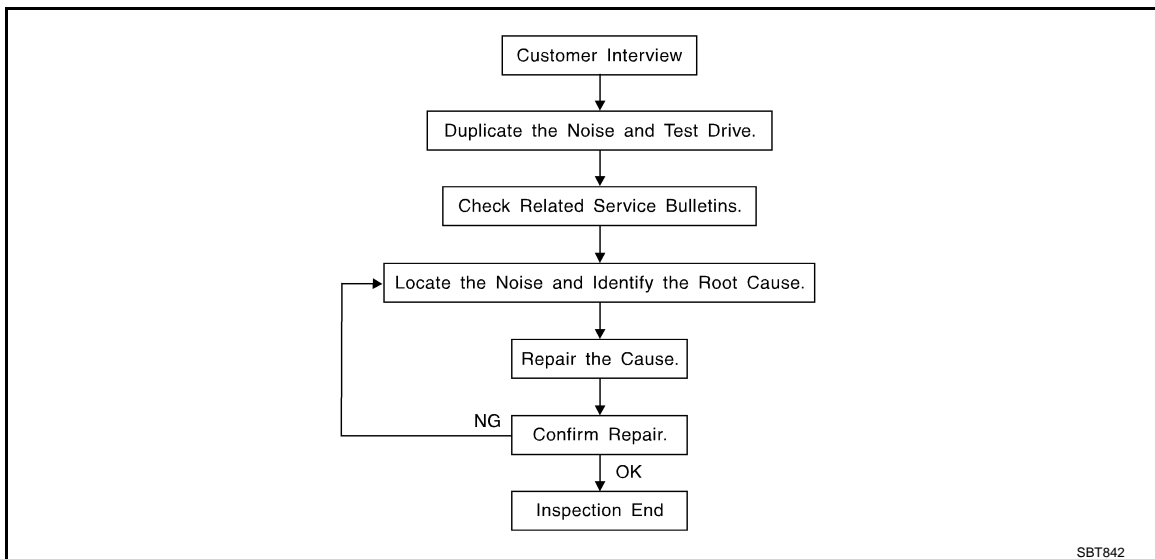
CUSTOMER INTERVIEW

DUPLICATE THE NOISE AND TEST DRIVE

LOCATE THE NOISE AND IDENTIFY THE ROOT CAUSE

REPAIR THE CAUSE

CONFIRM THE REPAIR

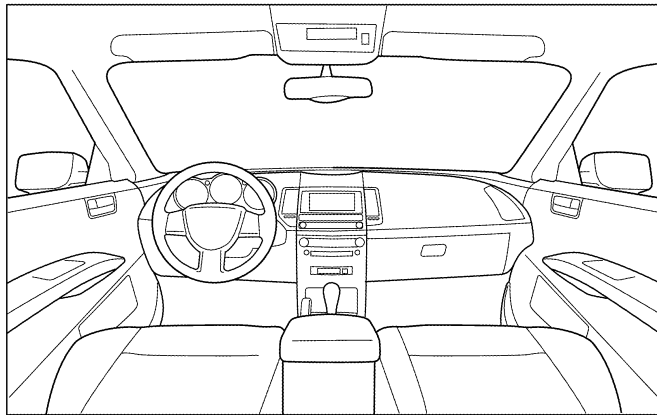
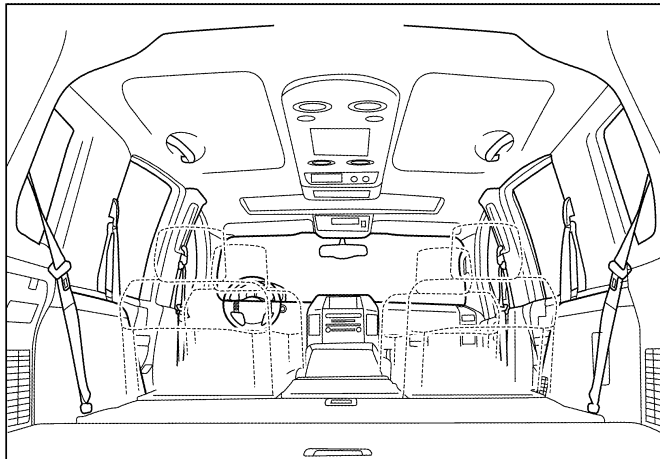
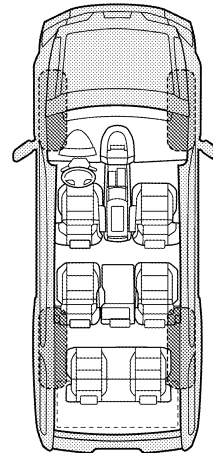
I. WHERE DOES THE NOISE COME FROM? (circle the area of the vehicle)

The illustrations are for reference only, and may not reflect the actual configuration of your vehicle.

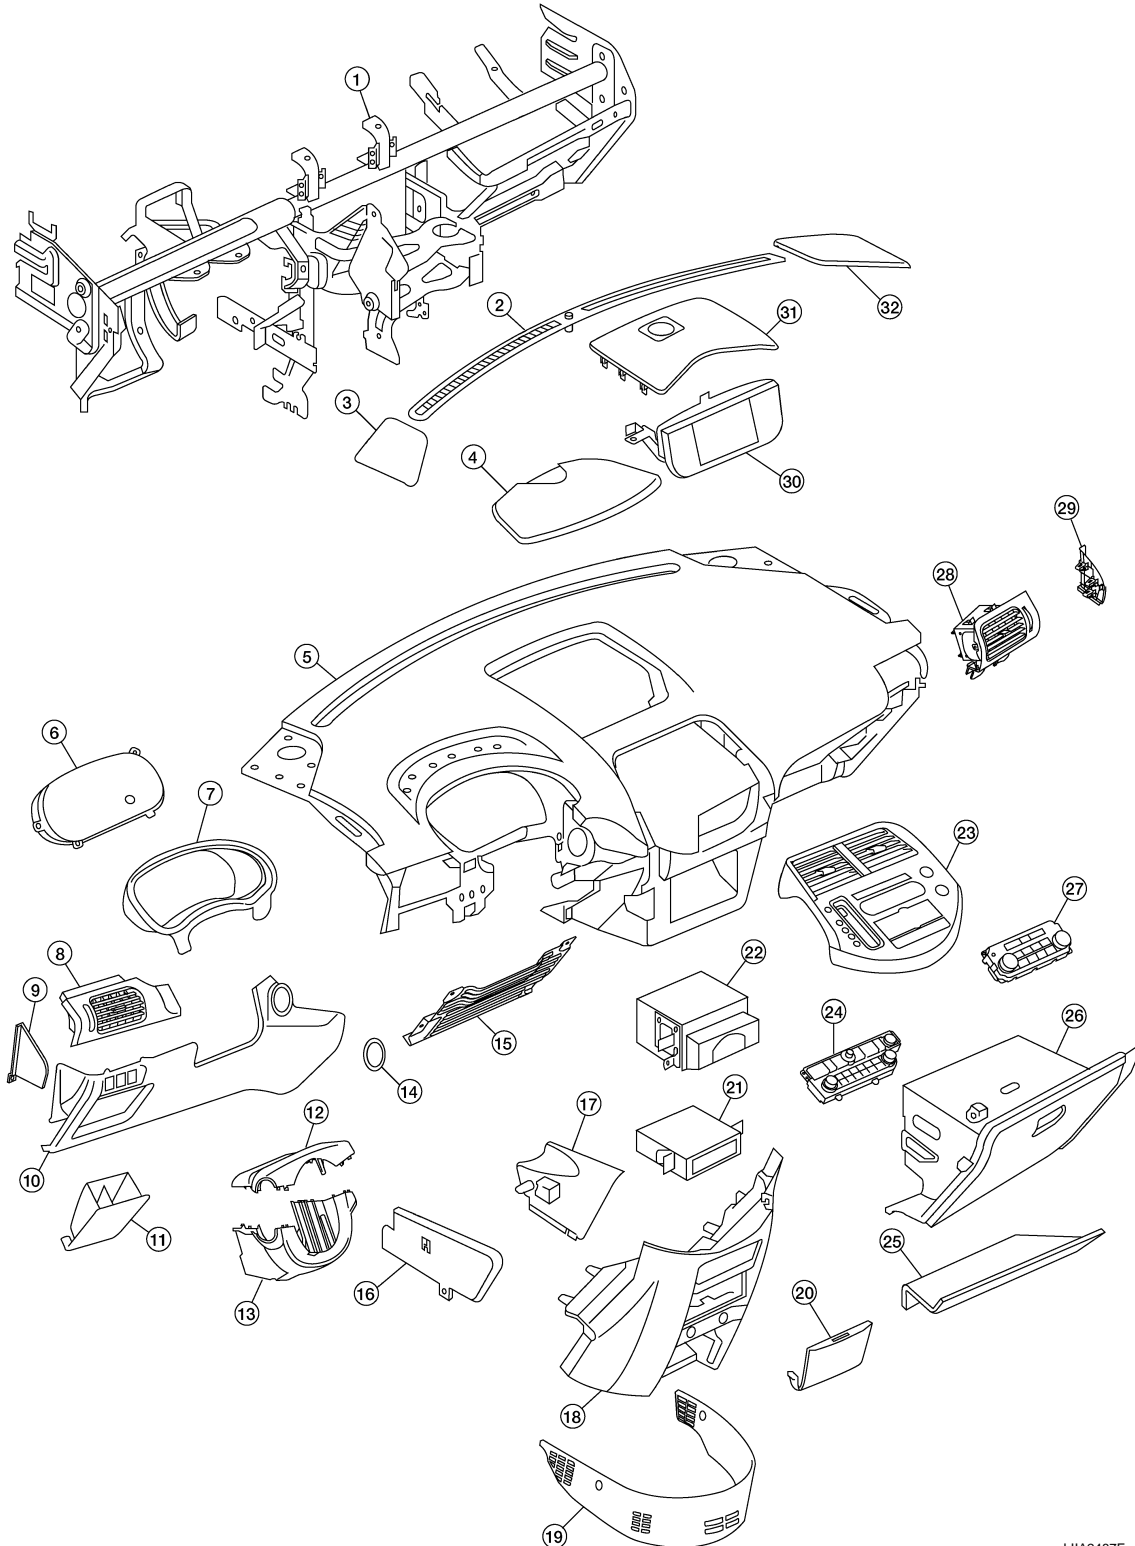
COMPONENTS

- 1. Steering member assembly
- 4. Meter cover

- 2. Defrost grille
- 5. Instrument panel

- 3. Speaker cover LH
- 6. Combination meter

| 7. Cluster lid A | 8. LH vent grille | 9. Instrument panel side finisher LH |
| 10. Instrument lower panel LH | 11. Storage bin | 12. Steering column upper cover |
| 13. Steering column lower cover | 14. Ignition switch bezel | 15. Knee protector |
| 16. Instrument panel side cover LH | 17. Instrument panel side cover RH | 18. Center stack trim panel |
| 19. Center lower trim | 20. DVD door | 21. DVD deck |
| 22. Audio unit | 23. Cluster lid C | 24. AV switch |
| 25. Assistant under cover panel | 26. Glove box assembly | 27. Front air control |
| 28. RH vent grille | 29. Instrument panel side finisher RH | 30. Display unit |
| 31. Cluster lid D | 32. Speaker cover RH | |

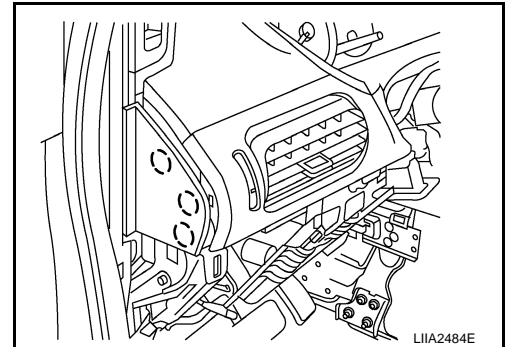
1. Remove instrument panel side finisher.

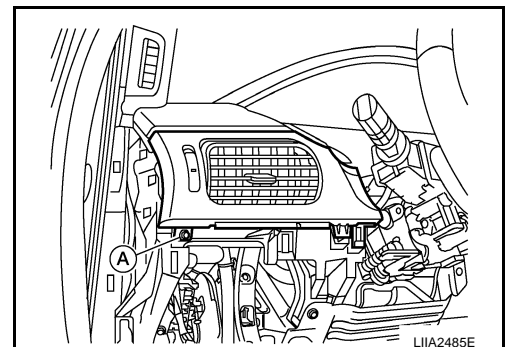
2. Remove screw (1) and LH vent grille.

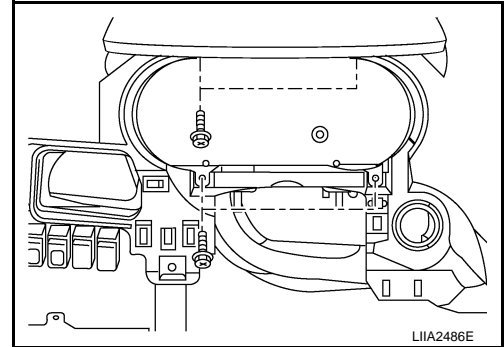
1. Disconnect battery negative terminal.
2. Remove cluster lid A. Refer to [IP-11, "Cluster Lid A"](#).
3. Remove the combination meter, using power tool.
4. Disconnect combination meter electrical connectors.

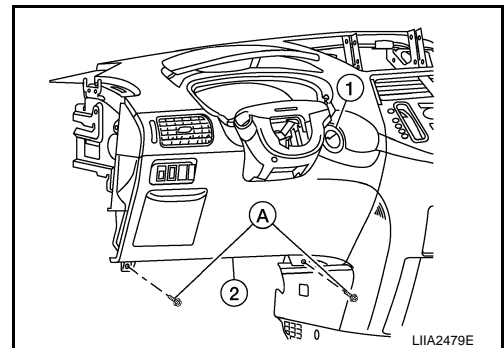
1. Disconnect battery negative terminal.
2. Remove the ignition switch bezel (1), screws (A), and instrument lower panel LH (2).

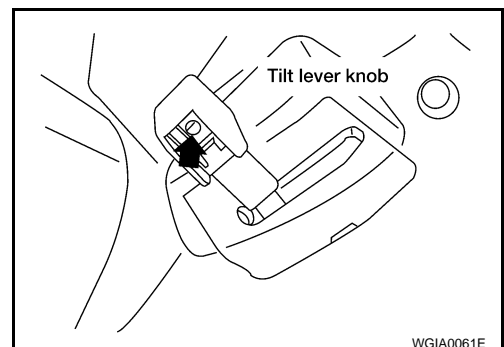
1. Remove tilt lever knob from tilt lever by inserting a suitable tool into slot of tilt knob, then depress tab and withdraw tilt lever knob.

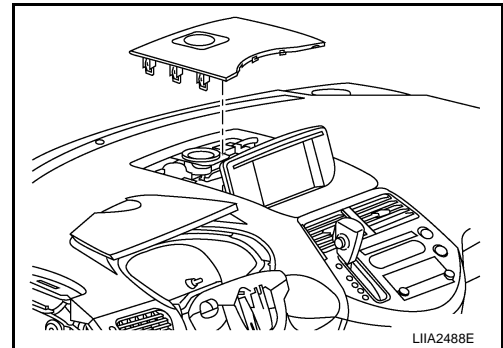
1. Pull up to release clips and remove cluster lid D.

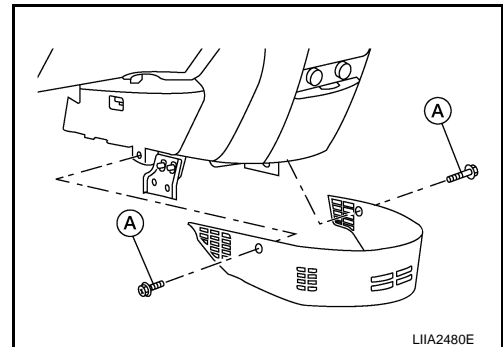
1. Remove instrument lower panel LH. Refer to [IP-12, "Instrument Lower Panel LH"](#).
2. Remove glove box. Refer to [IP-14, "Glove Box"](#).
3. Remove the screws (A) and center lower trim (1).

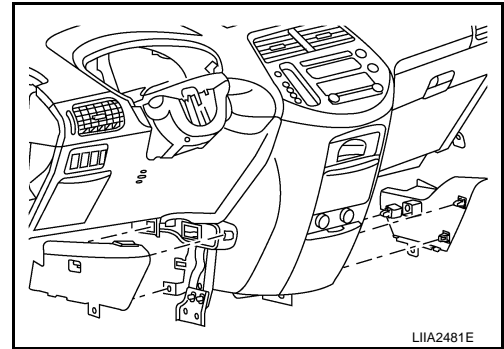
4. Remove center stack lower trim RH and LH.

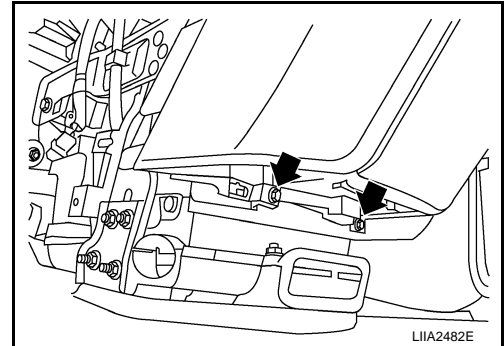
5. Remove lower screws using power tool.

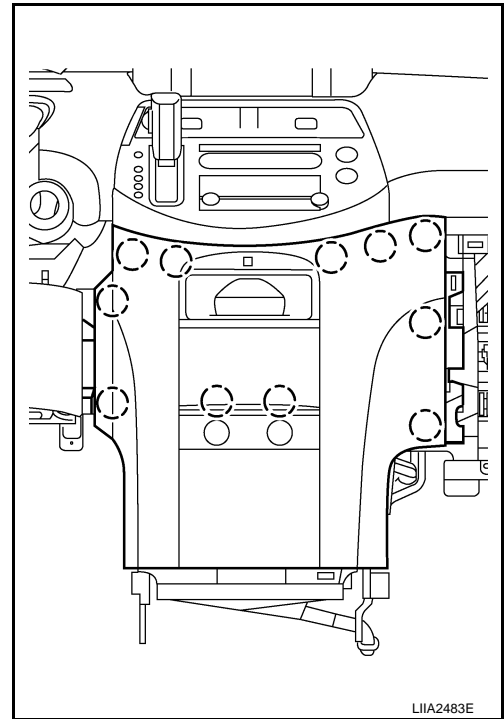
6. Pull to release clips and remove center stack trim panel.

7. Disconnect both power point electrical connectors.

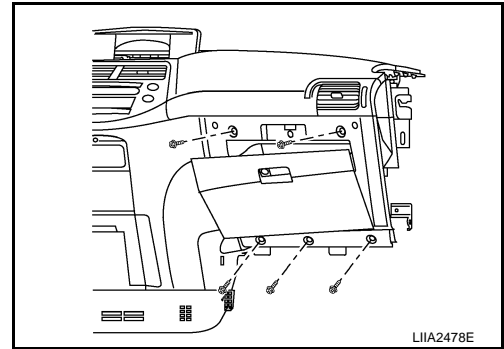
2. Remove glove box screws using power tool.
3. Carefully remove the clips by prying loose.
4. Disconnect glove box lamp harness.

To prevent damage, do not let the glove box hang from glove box lamp harness.

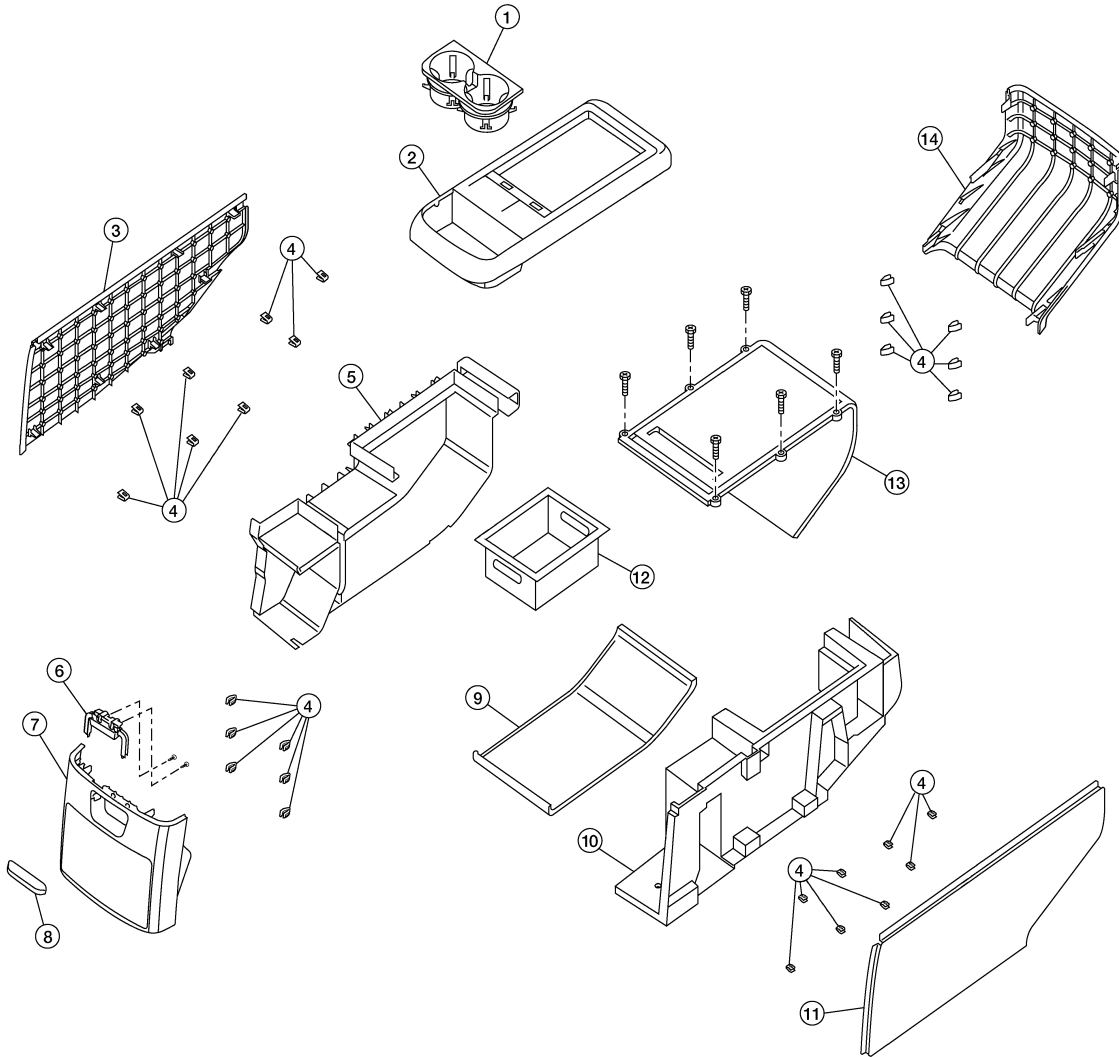
LIA2468E

| 1. Cup holder | 2. Top cover assembly | 3. RH console side trim panel |
| 4. Clip | 5. RH case | 6. Front bin latch assembly |
| 7. Front bin assembly | 8. Front bin latch handle | 9. Console mat |
| 10. LH case | 11. LH console side trim panel | 12. Storage bin insert |
| 13. Storage bin door assembly | 14. Rear console trim cover | |

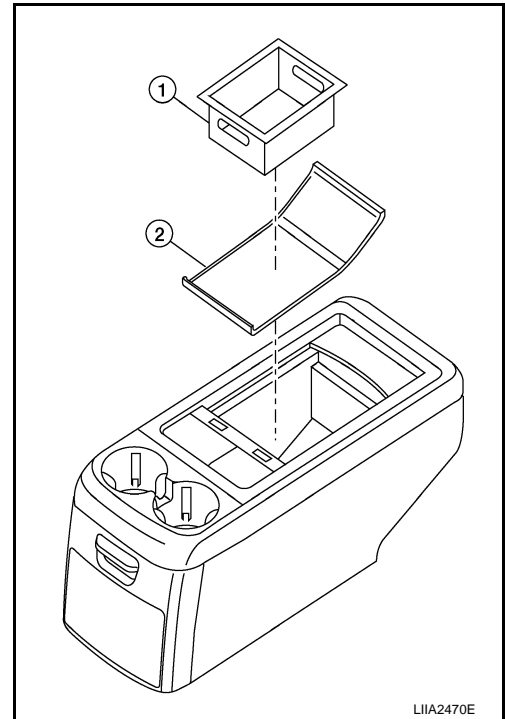
1. Remove storage bin insert (1) and console mat (2).

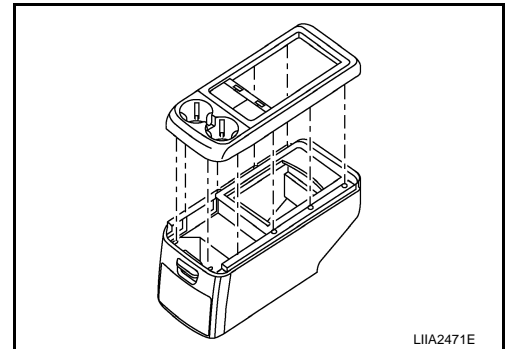
2. Remove top cover assembly.

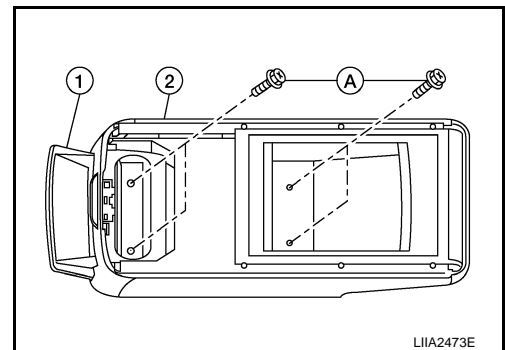
3. Open the front bin (1), remove the bolts (A), and center console (2).

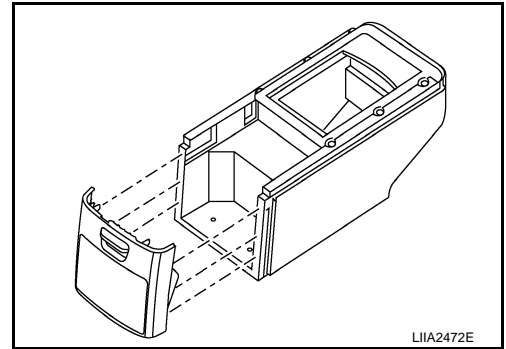
2. Remove front bin assembly.

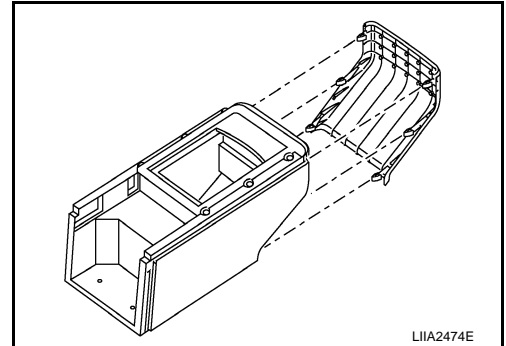
3. Remove rear console trim cover.

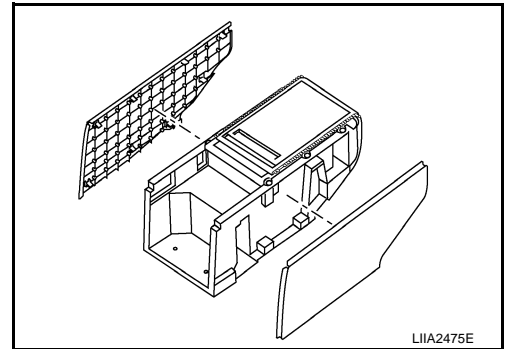
4. Remove RH and LH console side trim panels.

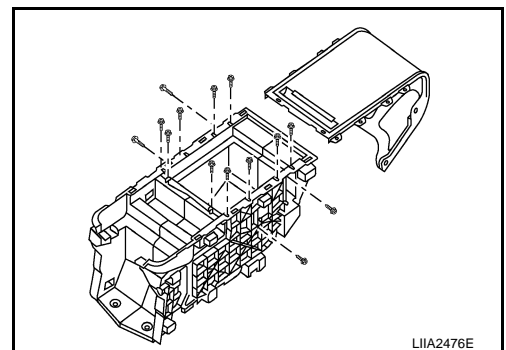
5. Remove storage bin door assembly.

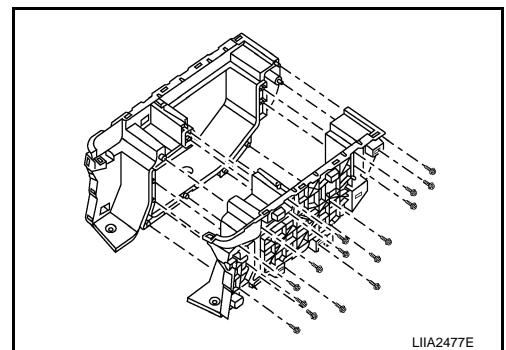
6. Remove screws and split RH from LH case.
