# HEATER & AIR CONDITIONER

# SECTION HA

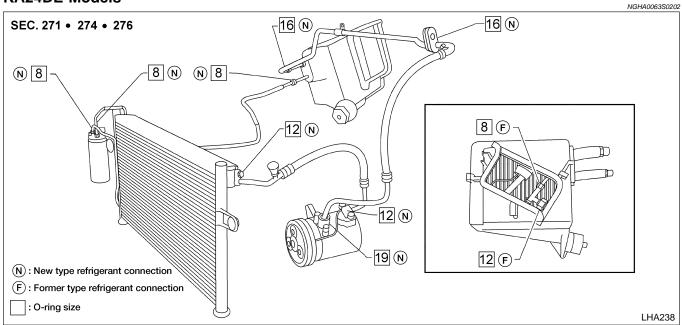
# O-RING AND REFRIGERANT CONNECTION KA24DE Models

Refrigerant connections in some systems use different O-ring configurations. Do not confuse O-rings since they are not interchangeable. If a wrong O-ring is installed, refrigerant will leak at, or around, the connection.

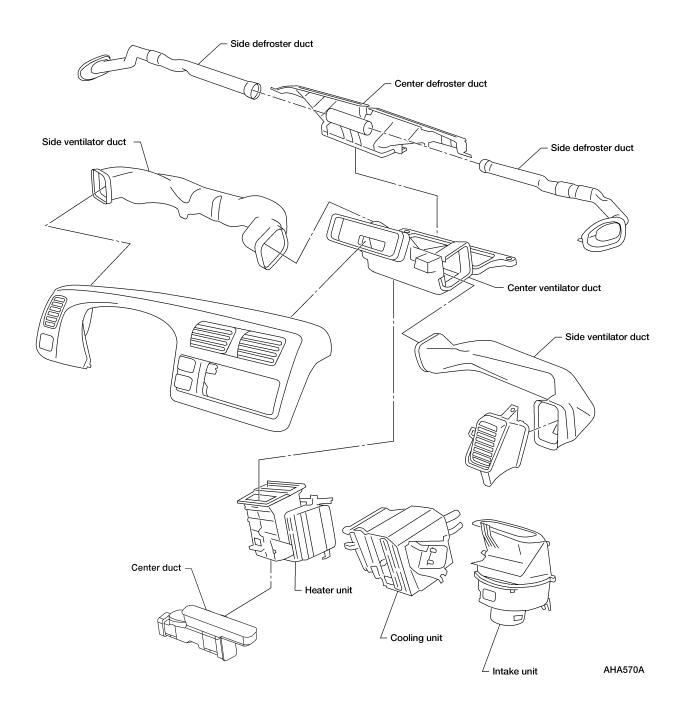
# **Component Layout** FRONT

SEC. 270 • 271 • 272 • 273 • 685

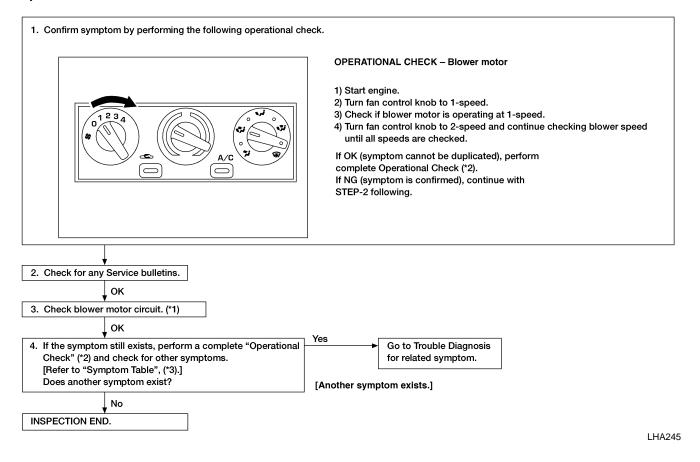
#### Inspection Flow

Blower motor does not rotate.

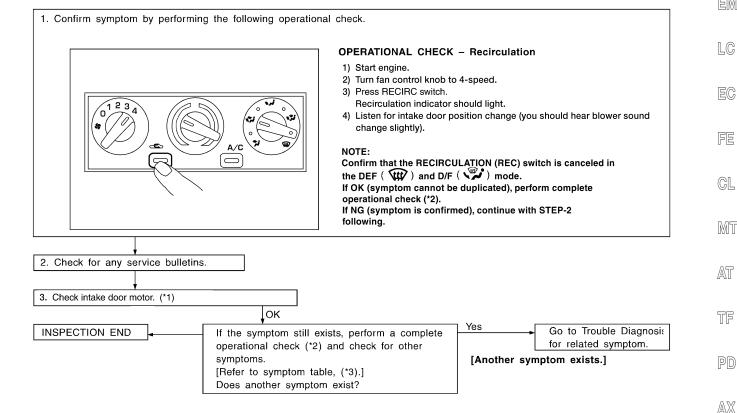
Inspection Flow

Intake door position does not change in VENT, B/L or FOOT mode.

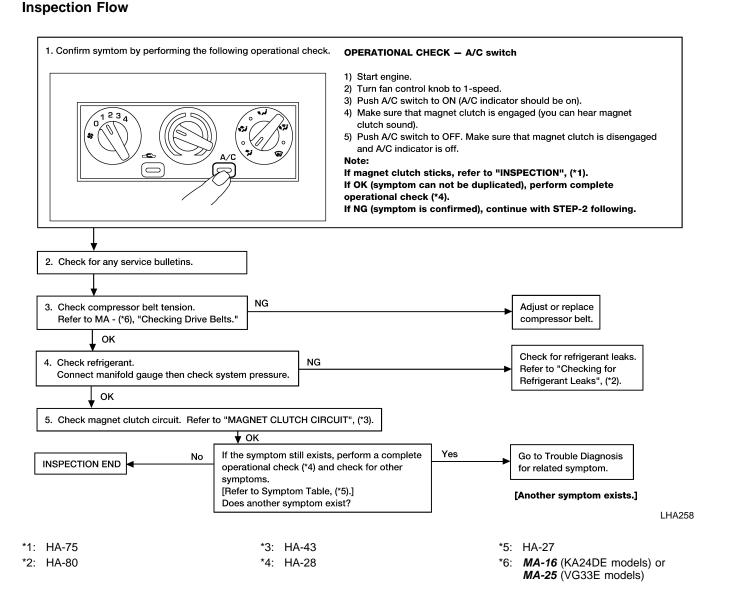
Magnet clutch does not engage when A/C switch and fan switch are ON.

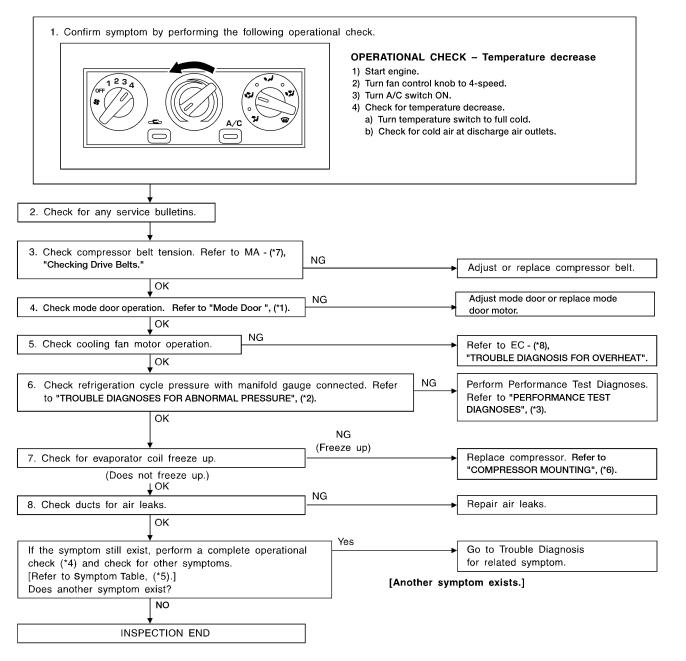
Inspection Flow

Insufficient cooling

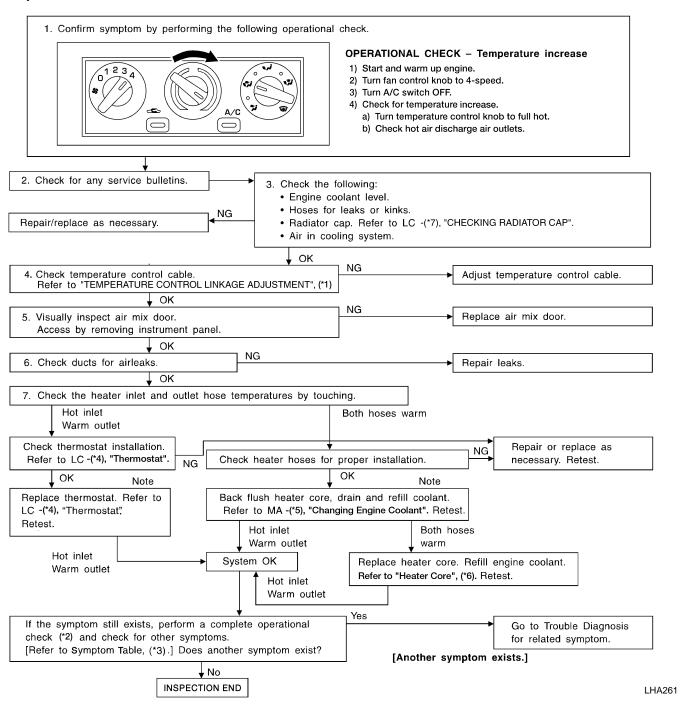
#### Inspection Flow

Insufficient heating

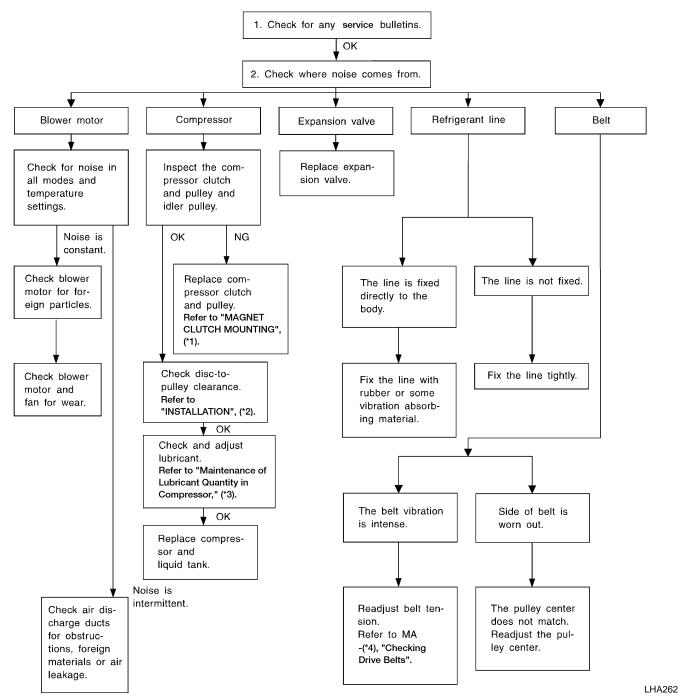
Inspection Flow

Noise

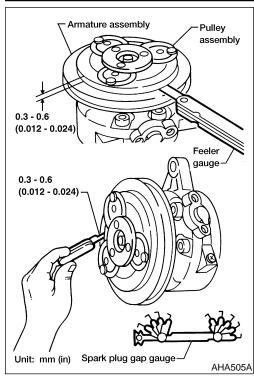
Check clearance all the way around the clutch disc.

#### **Disc-to-pulley clearance:**
